SKOENMAKERS RIVER REHABILITATION ASSESSMENT  
ZONE 9

Date:	08/02/2016	Compiled by:	PAUJ
Project No:	472748	Scale:	1:8,000

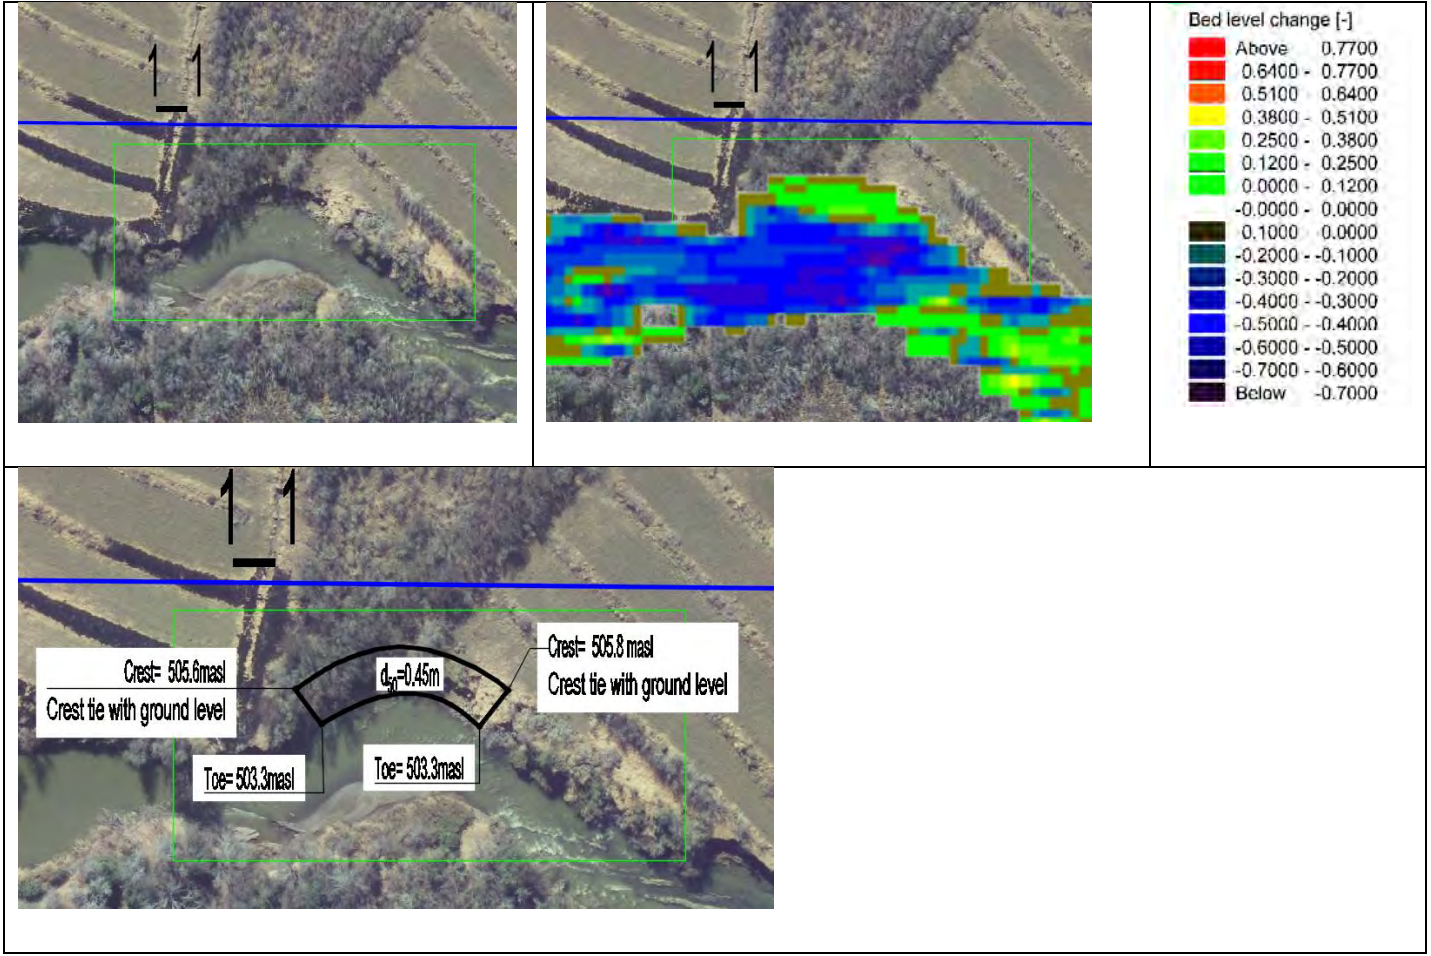
**Zone 1\_1** This area is within the servitude and has unstable banks encroaching farmland.

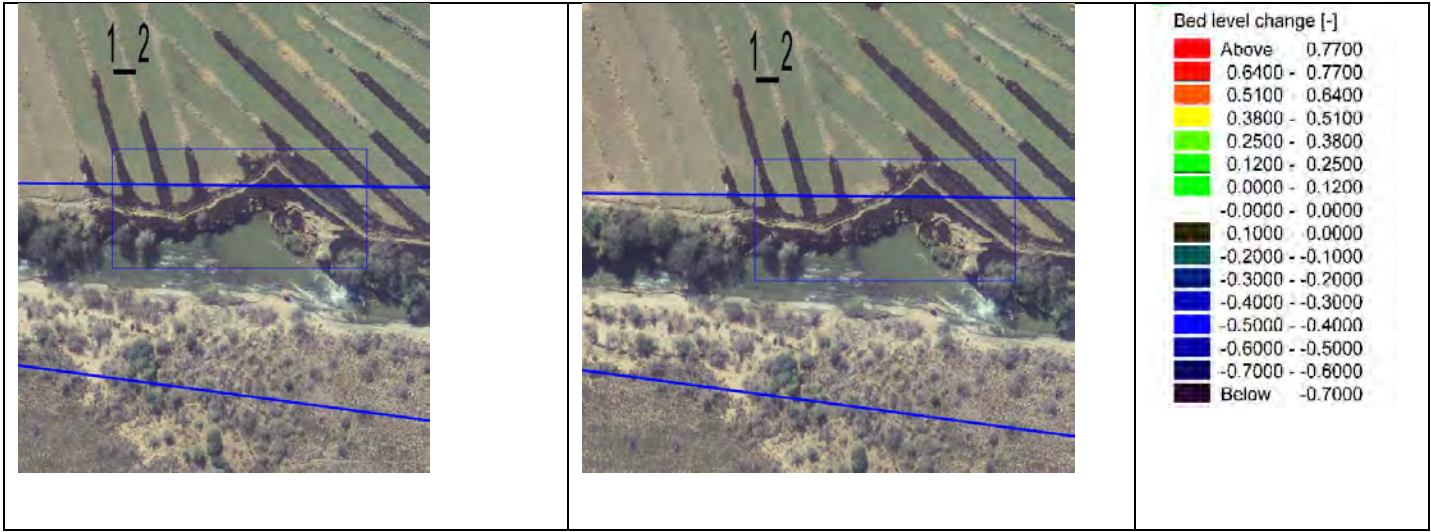
**Zone 1\_2** This area is within the servitude and has unstable banks. Due to the bedrock at the location, the banks do not need protection and the servitude seems incorrect.

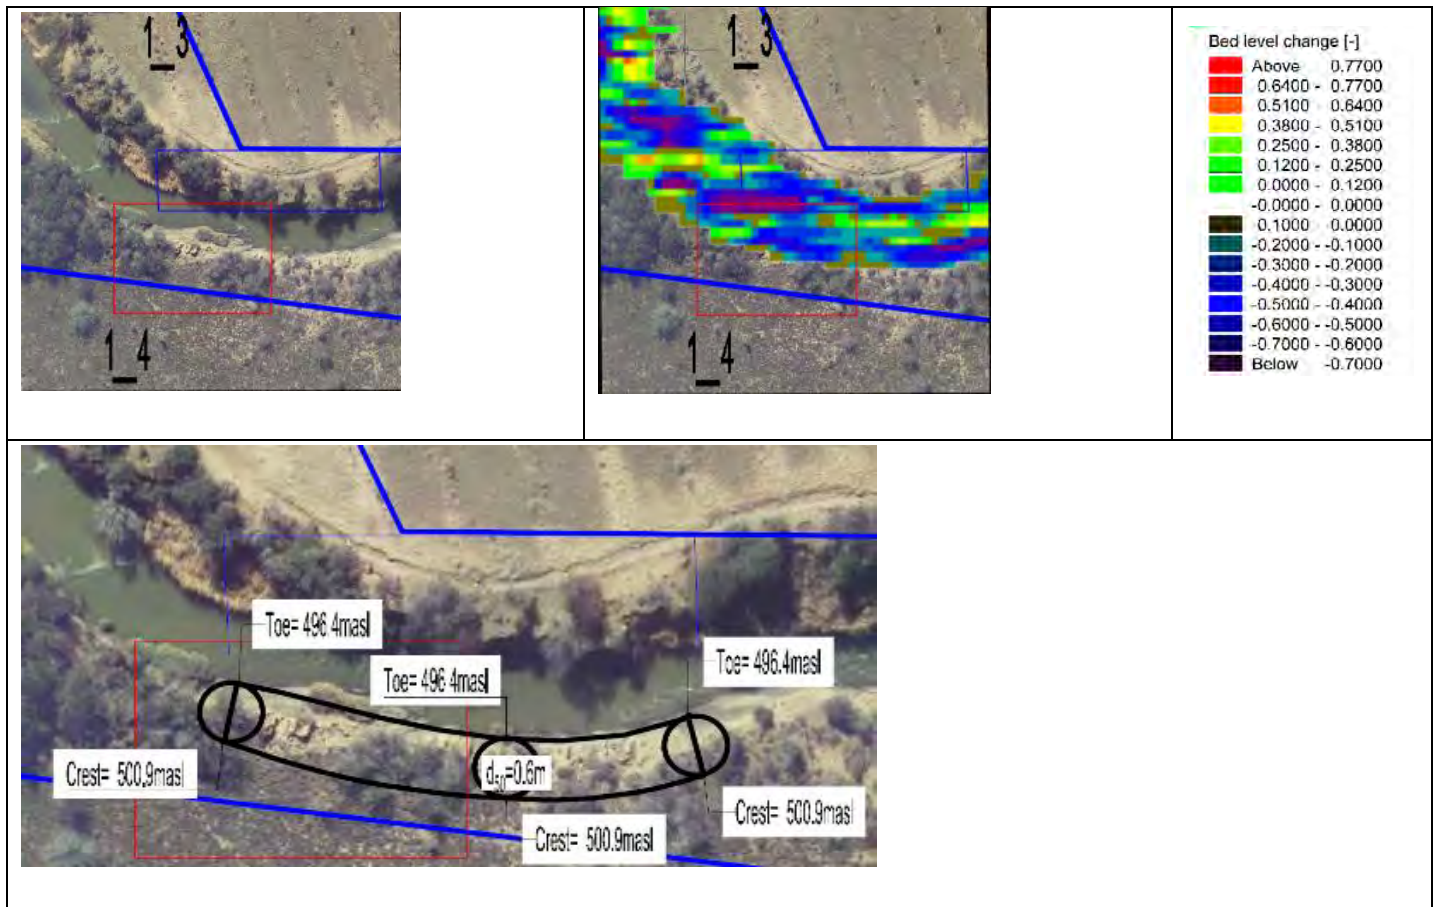
**Zone 1\_3 and 1\_4** This area is within the servitude and protection does not seem necessary.

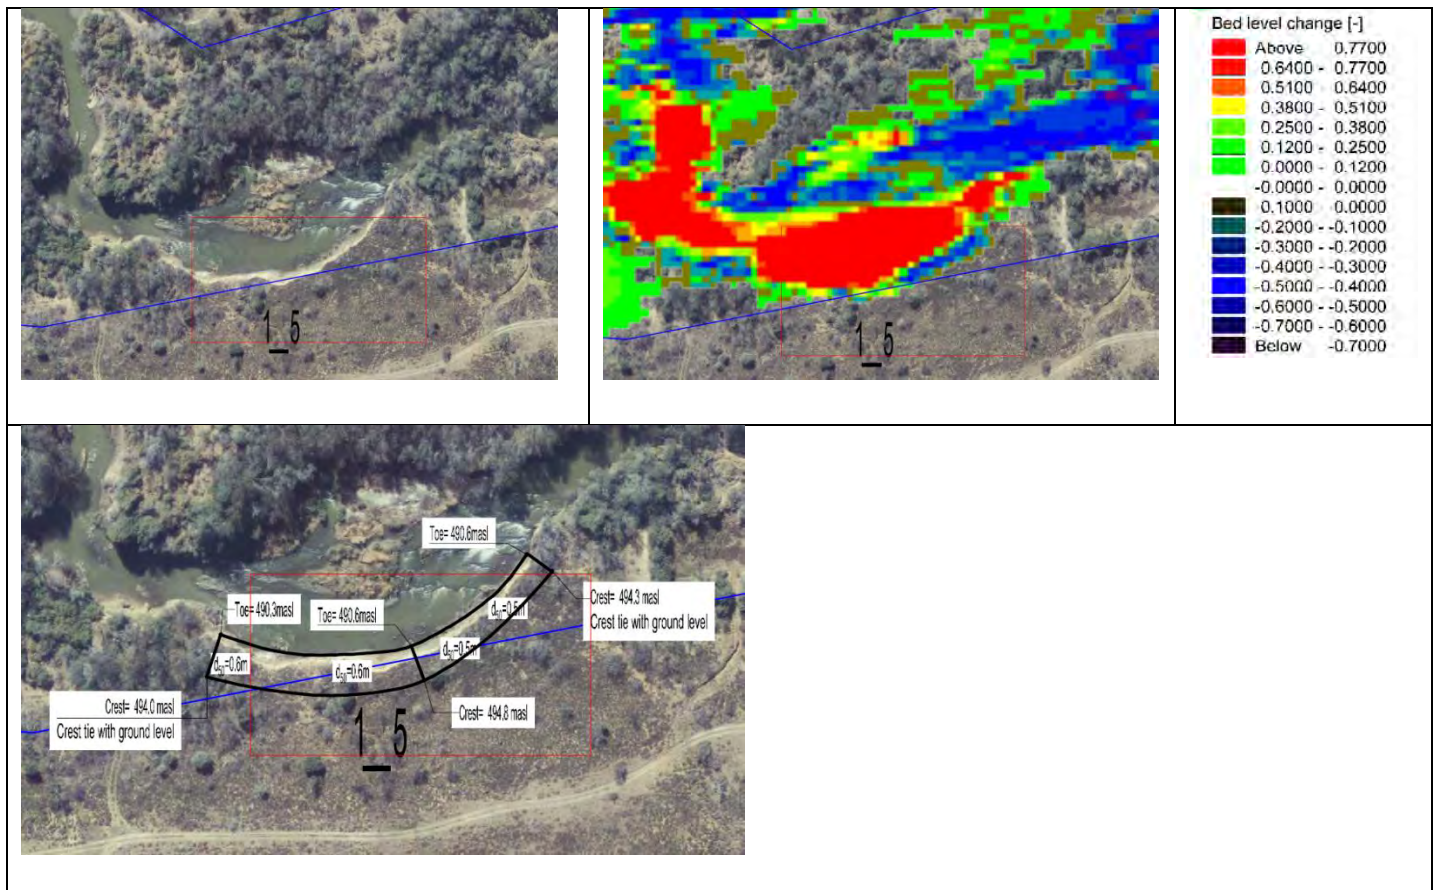
**Zone 1\_5** This area is within the servitude and has unstable banks encroaching a road.

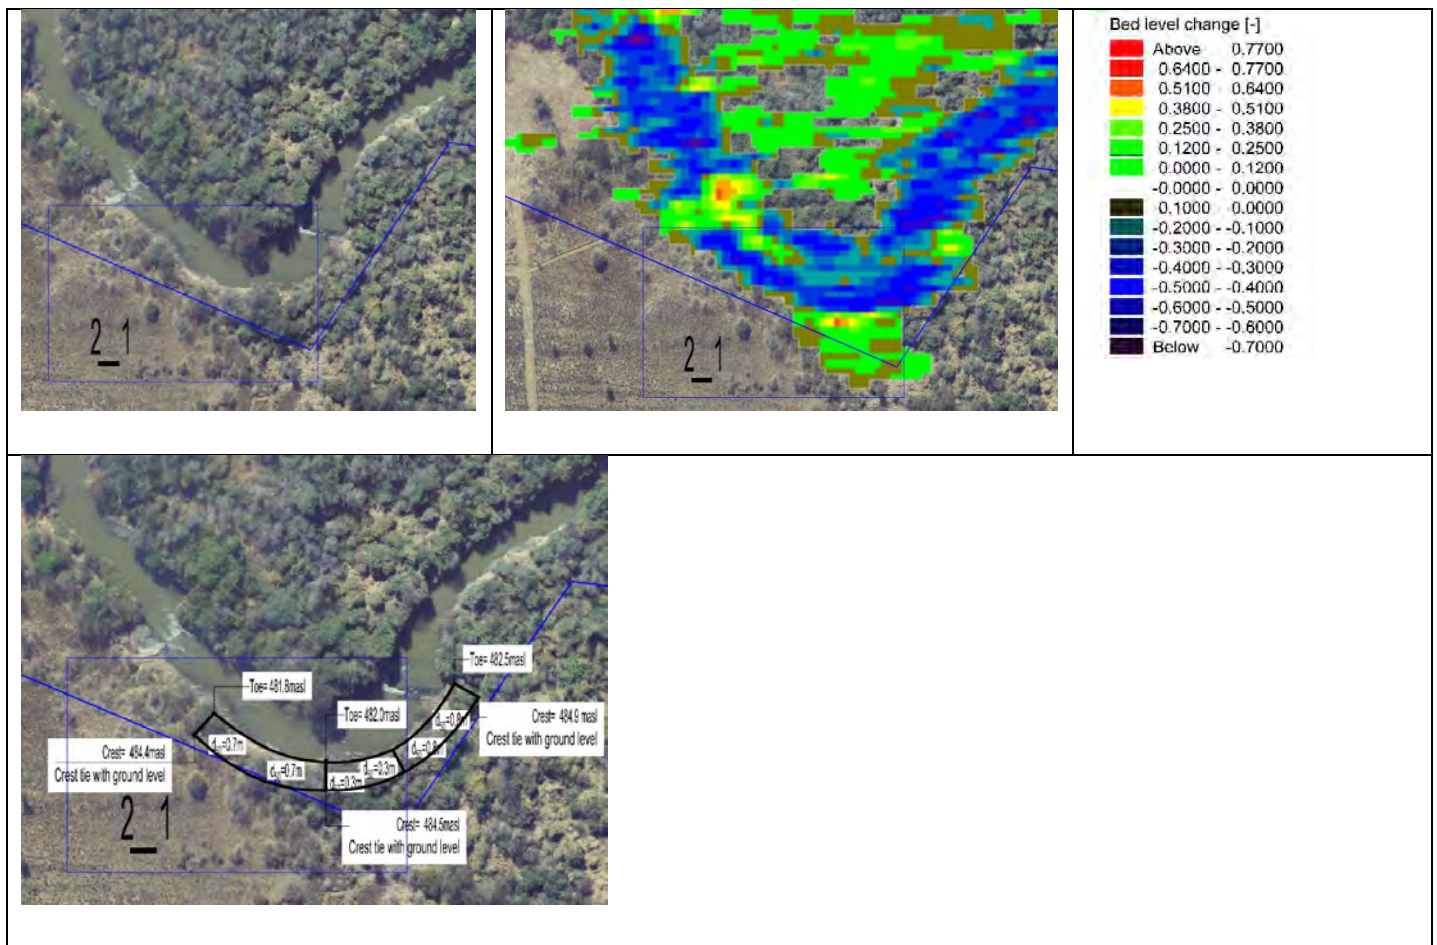
**Zone 2\_1** The banks are encroaching the servitude but protection does not seem necessary.

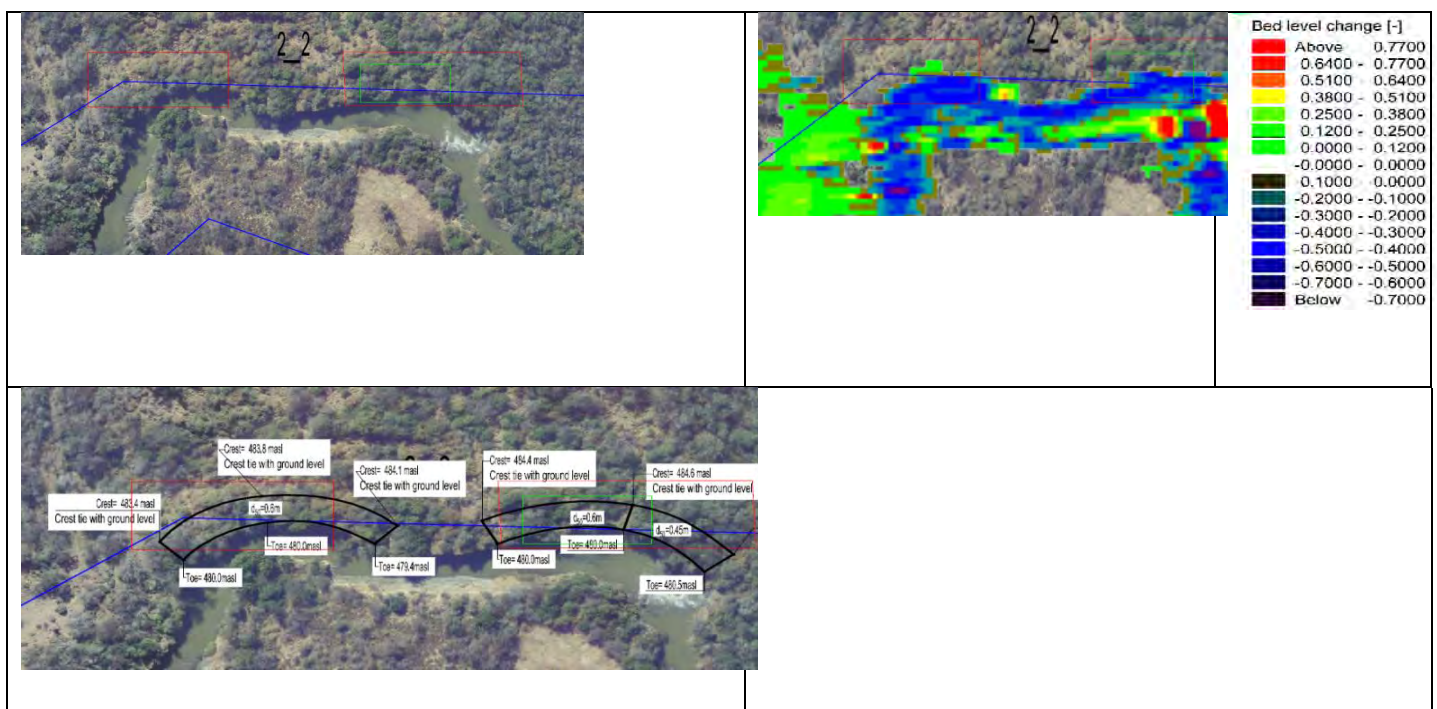
**Zone 2\_2** This area has unstable banks crossing the servitude.

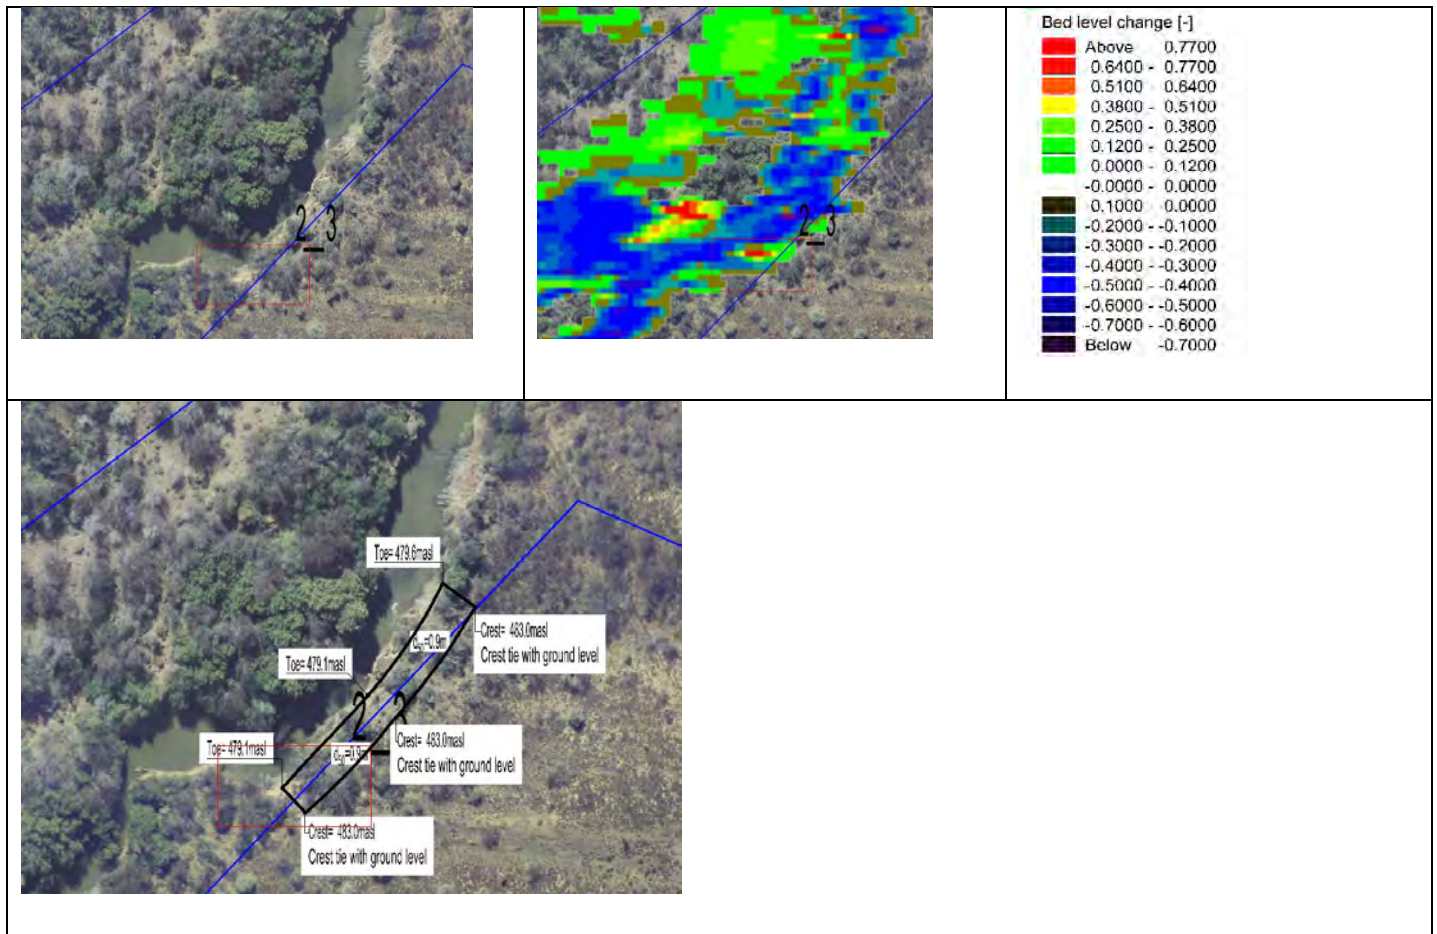
**Zone 2\_3** This area has unstable banks are encroaching on the servitude.

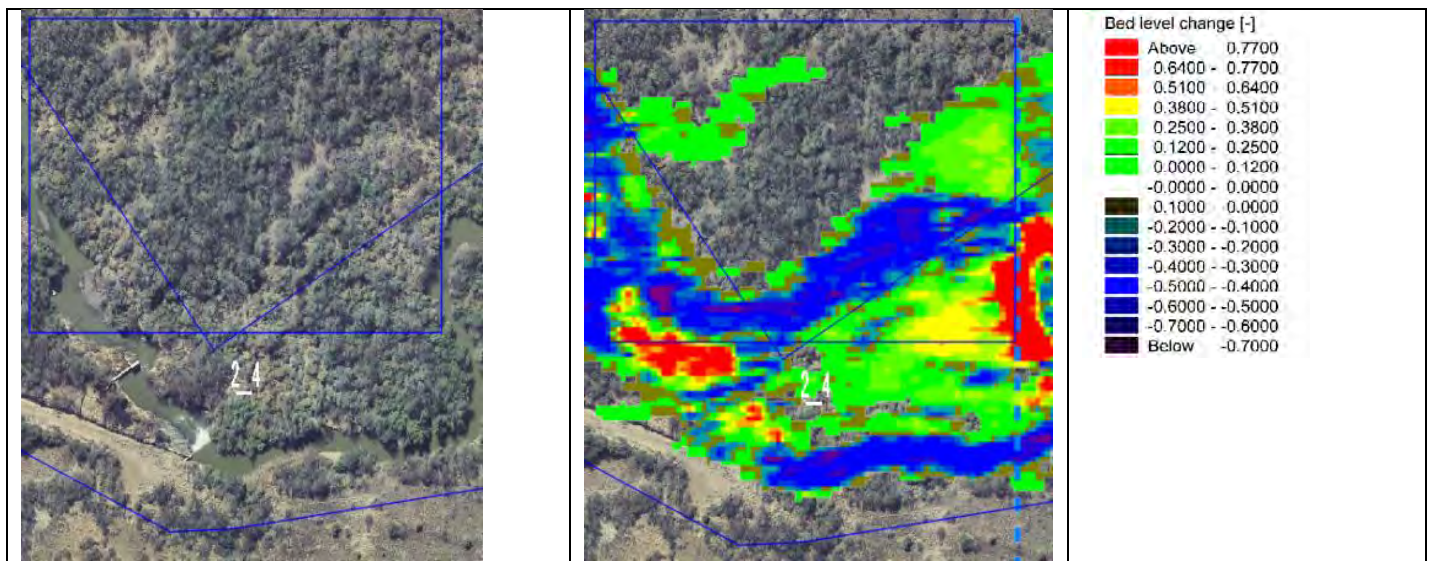
**Zone 2\_4** This area crosses the servitude but due the wide flood plain flow, protection is not viable

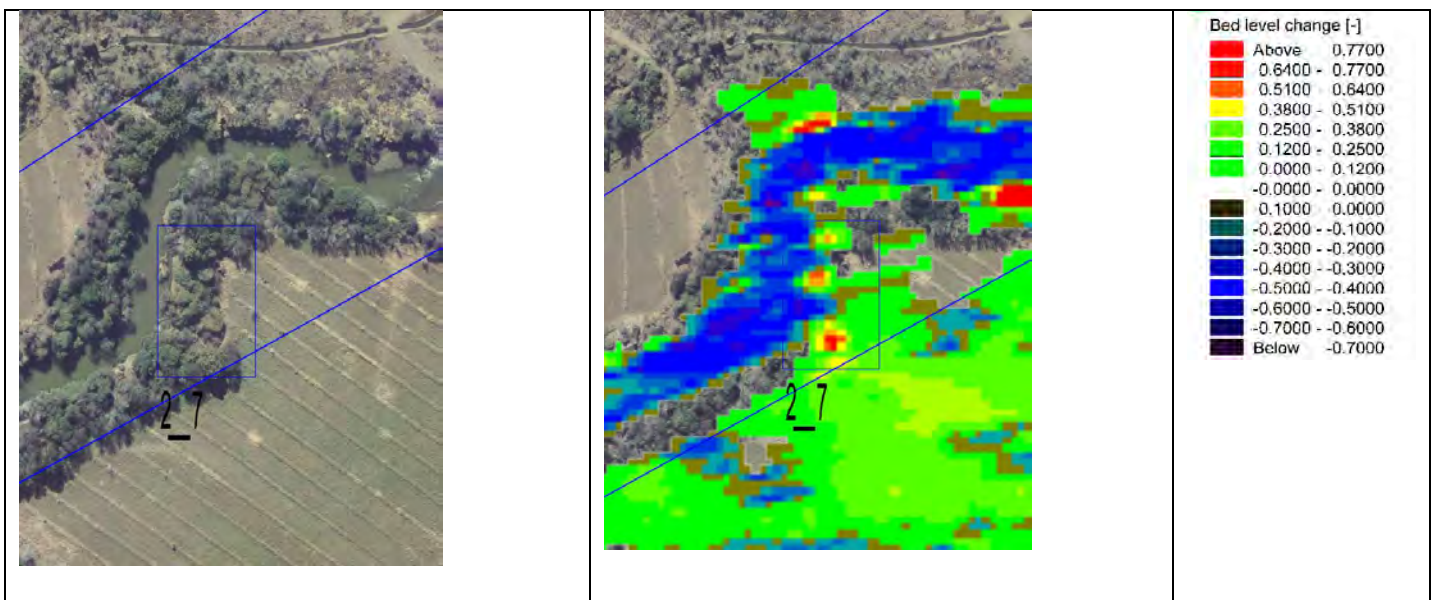
**Zone 2\_7** This area is within the servitude but encroaches farmland that is within the servitude. Protection does not seem necessary.

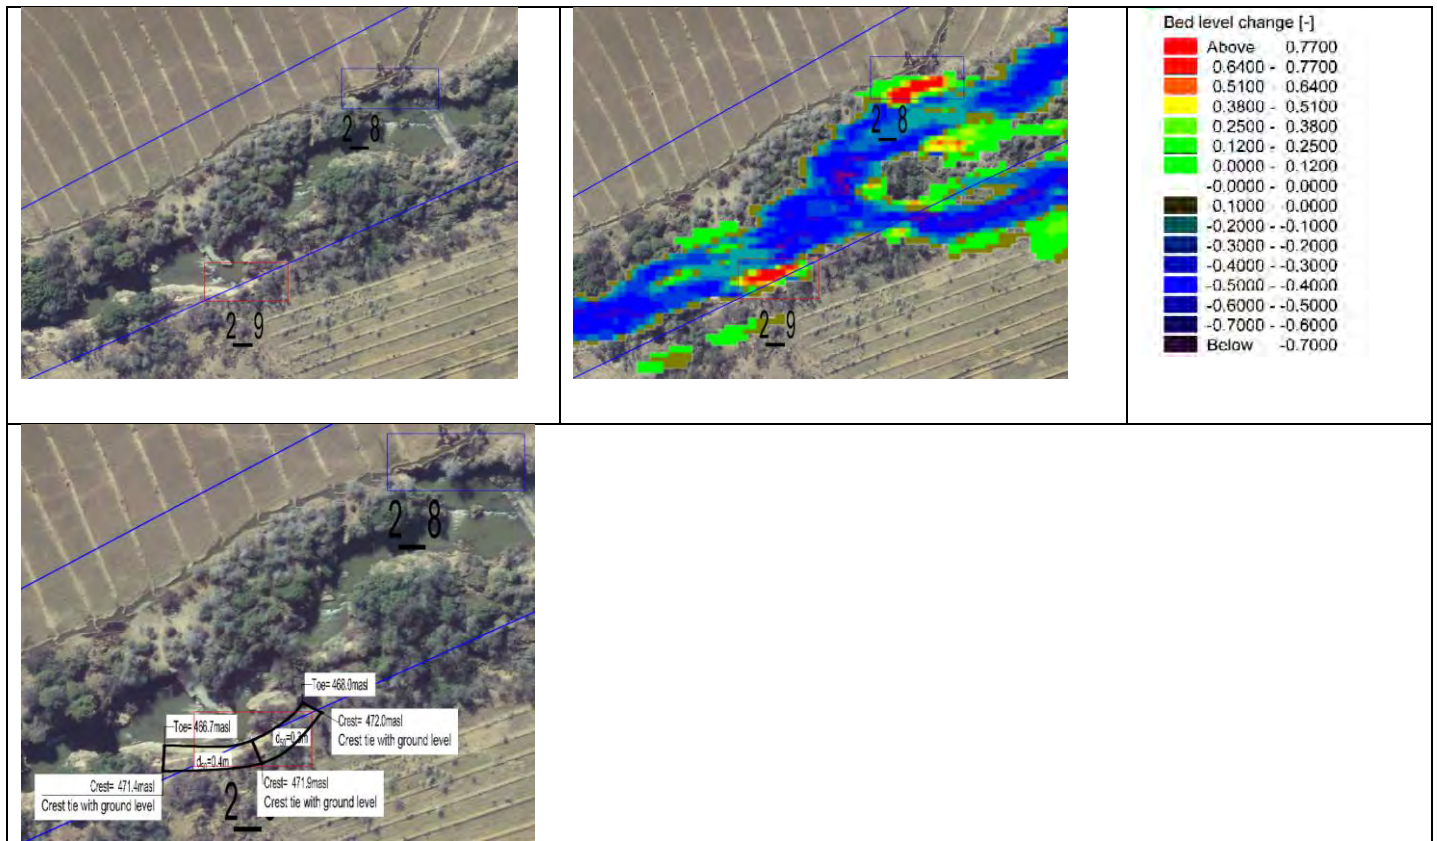
**Zone 2\_8 and 2\_9** The banks are encroaching the servitude and farmland

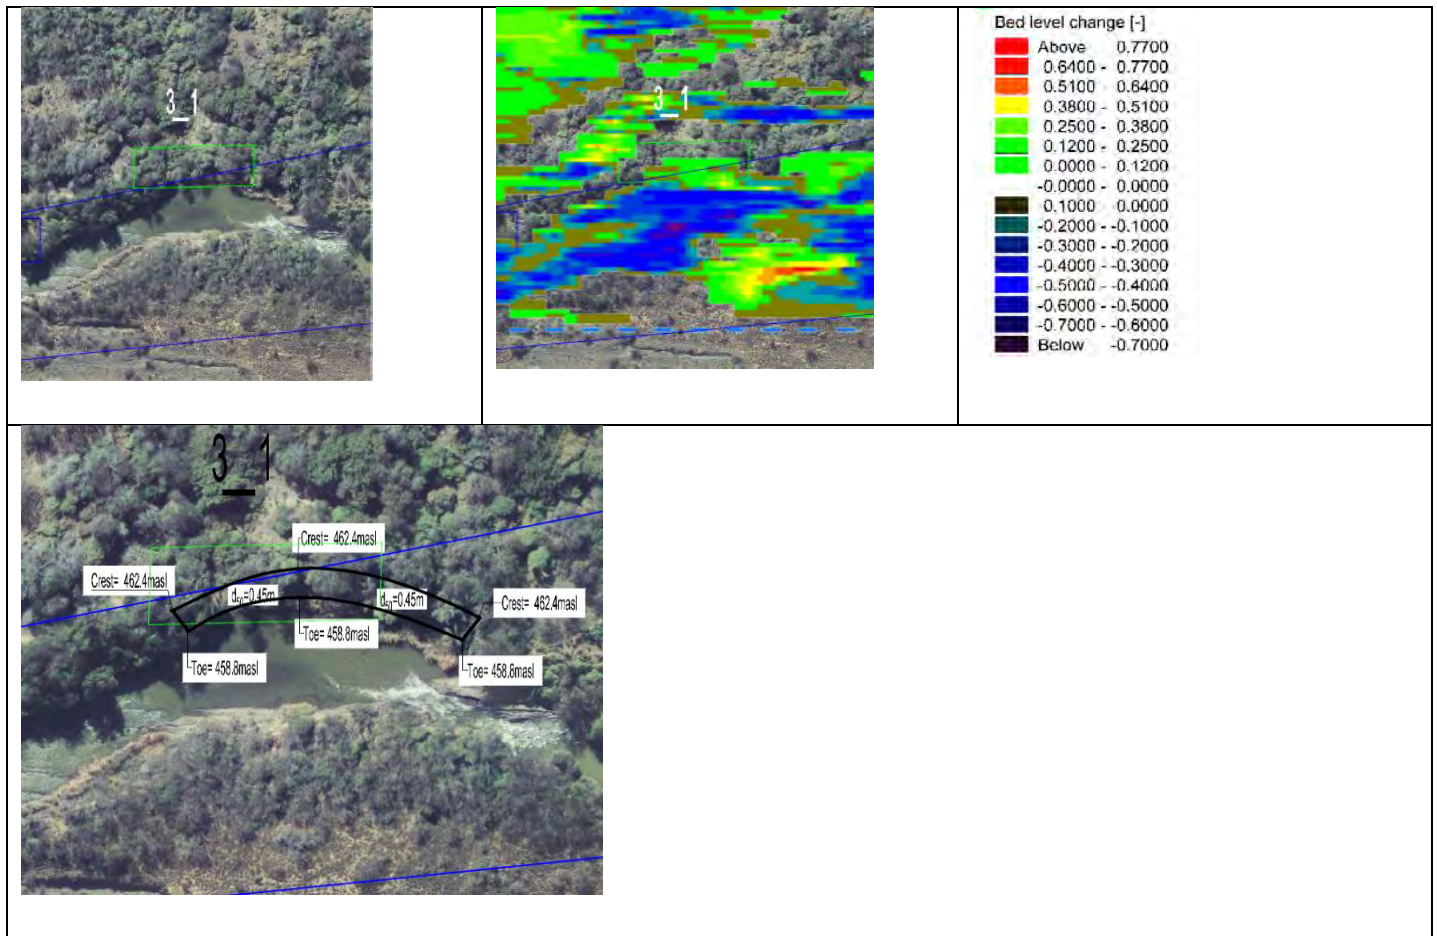
**Zone 3\_1** The zone has unstable banks crossing the servitude.

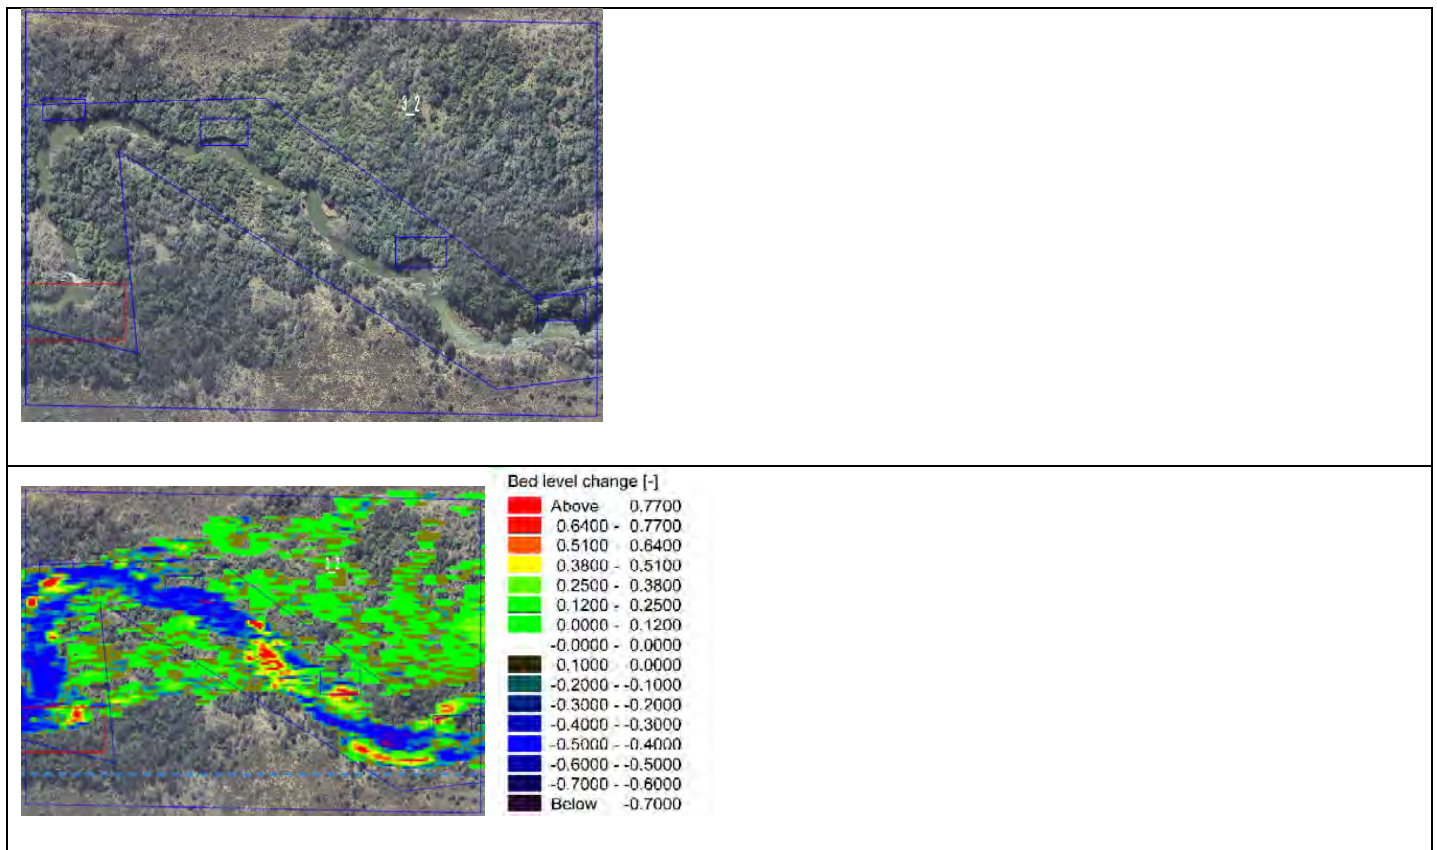
**Zone 3\_2** Flow in this area is in a wide floodplain crossing the servitude and protection in not viable.

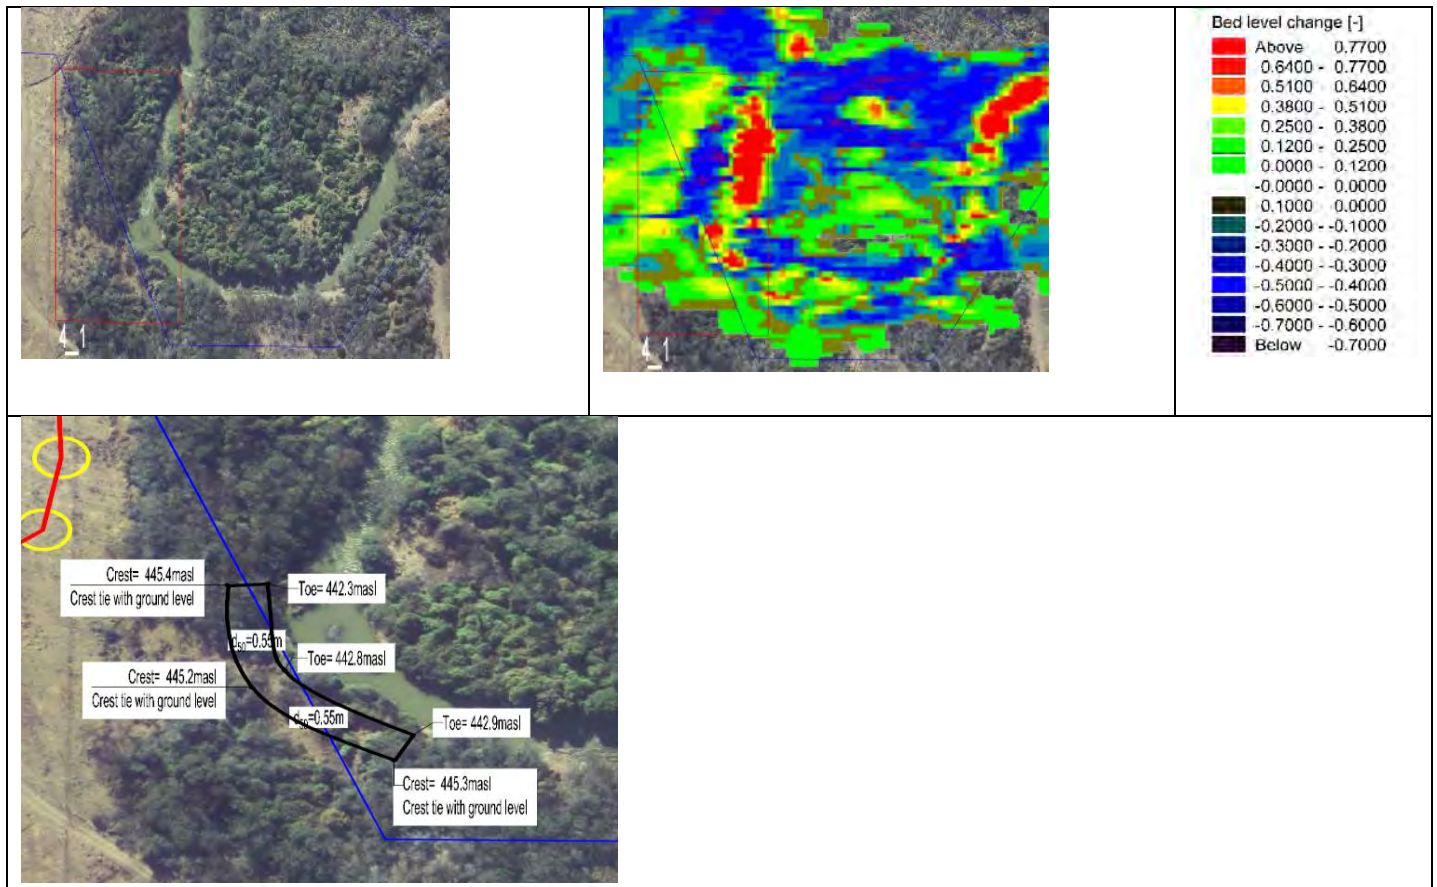
**Zone 4\_1** The zone has unstable banks crossing the servitude and encroaching the road.

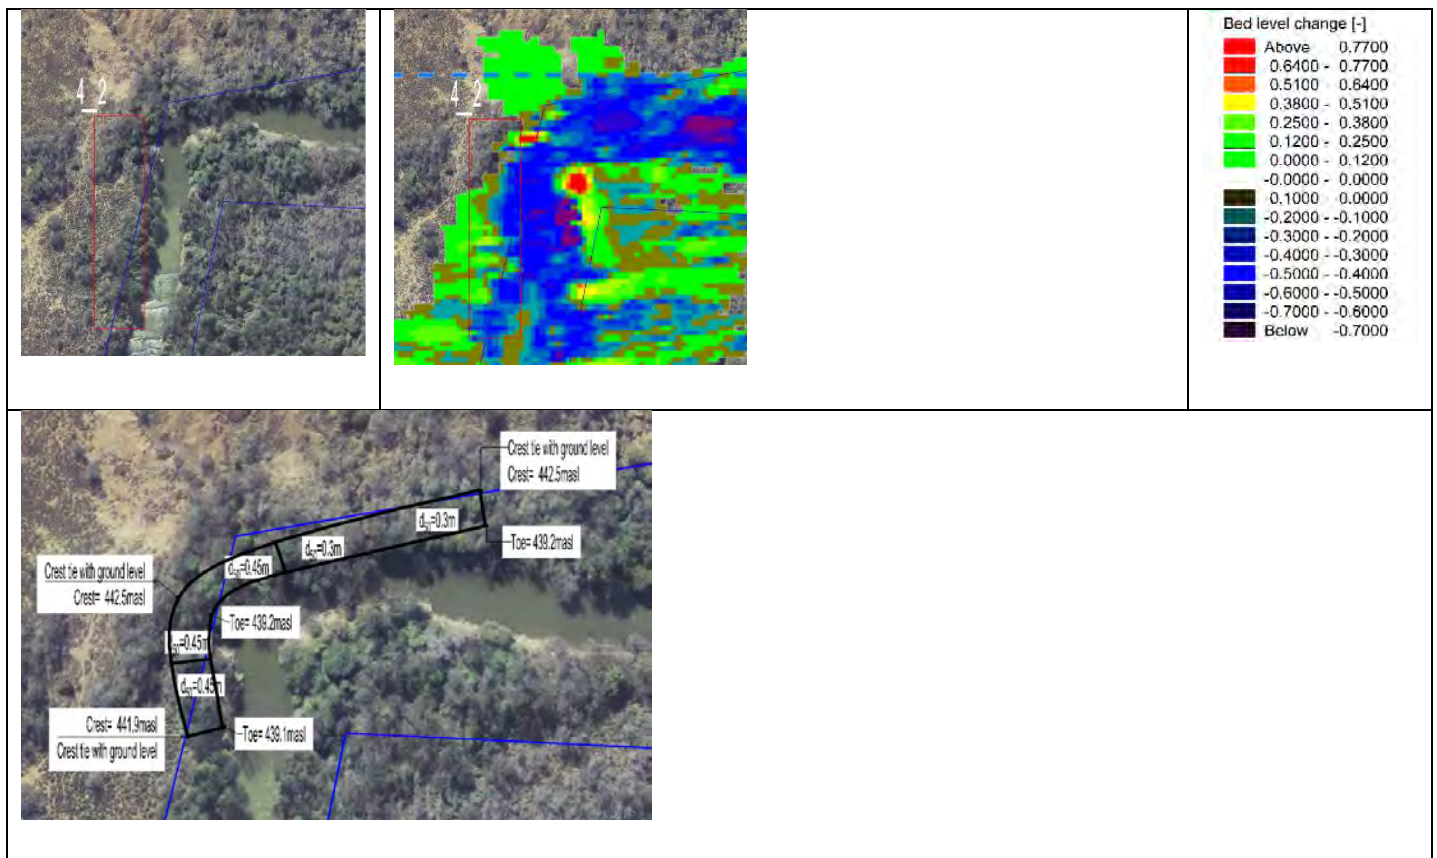
**Zone 4\_2** The zone has unstable banks crossing the servitude and encroaching the road.

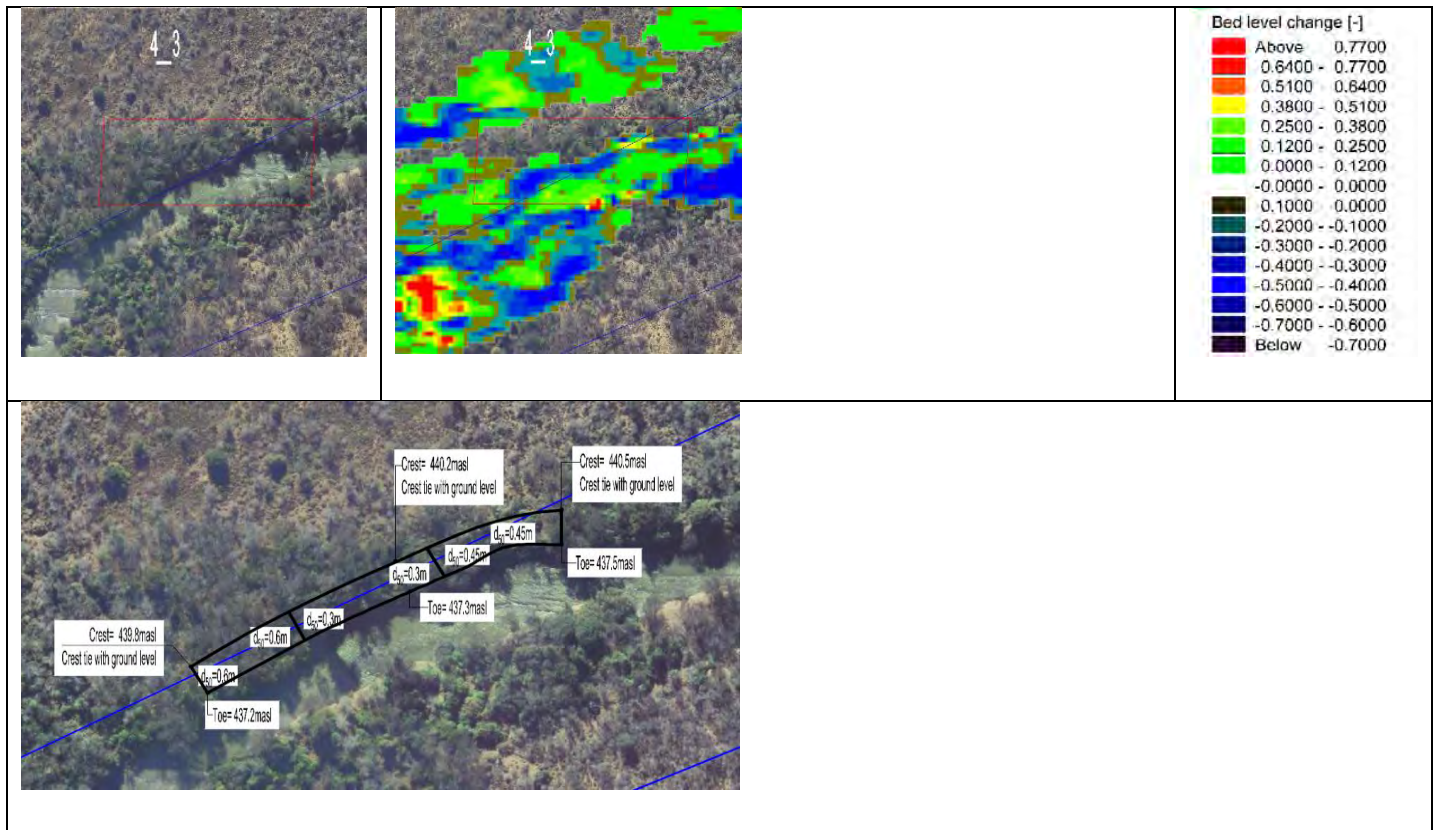
**Zone 4\_3** The zone has unstable banks crossing the servitude.

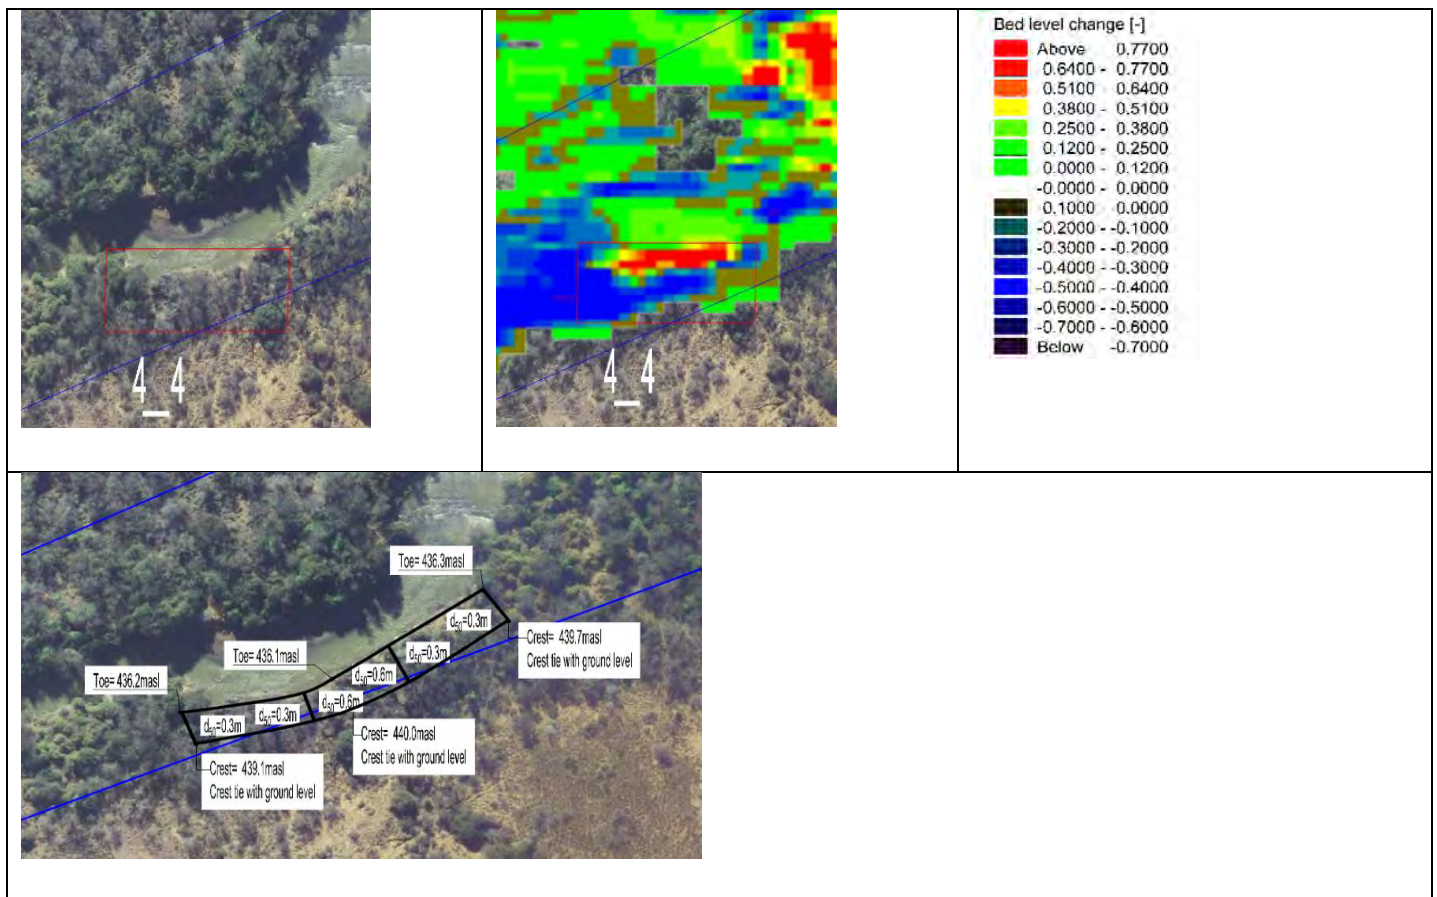
**Zone 4\_4** The zone has unstable banks crossing the servitude and encroaching the road.

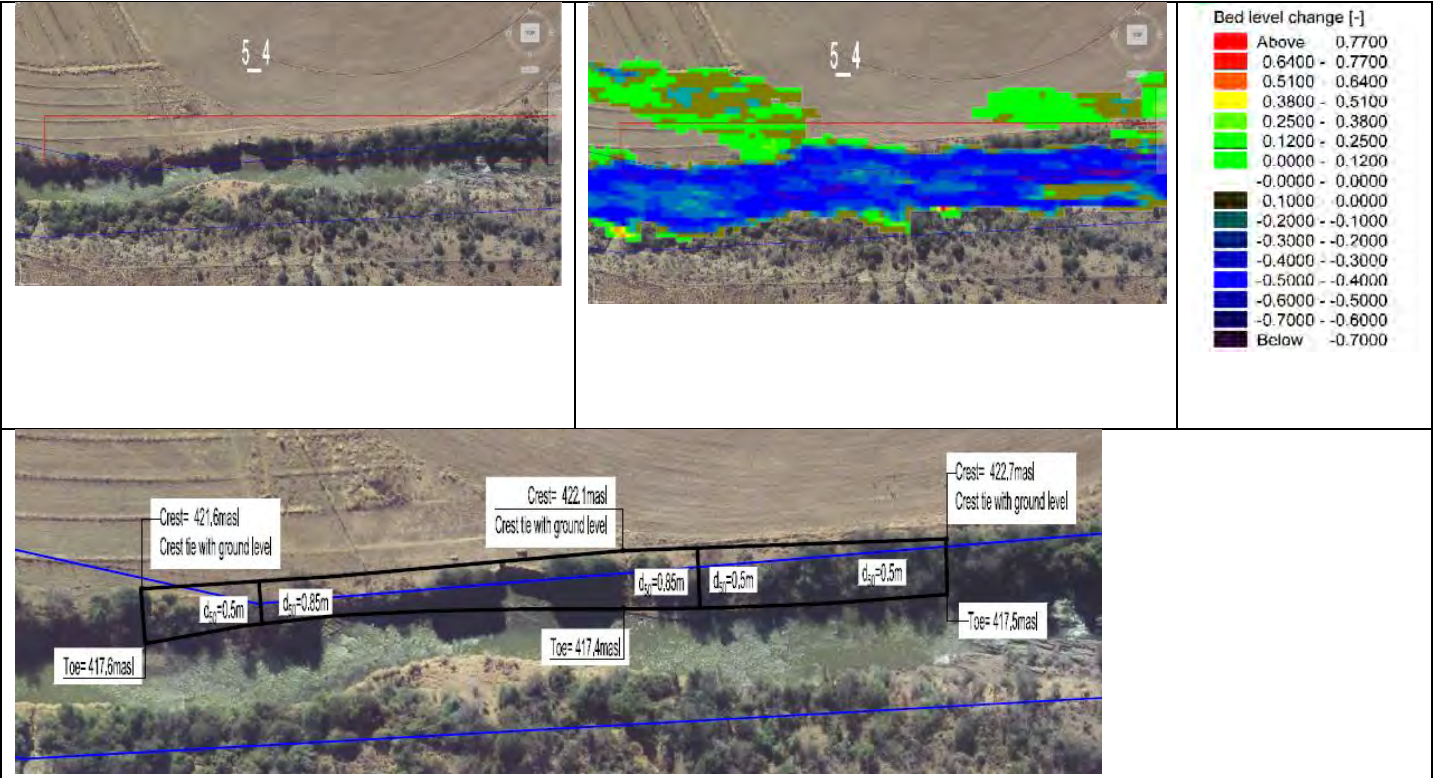
**Zone 5\_4** The zone has banks crossing the servitude.

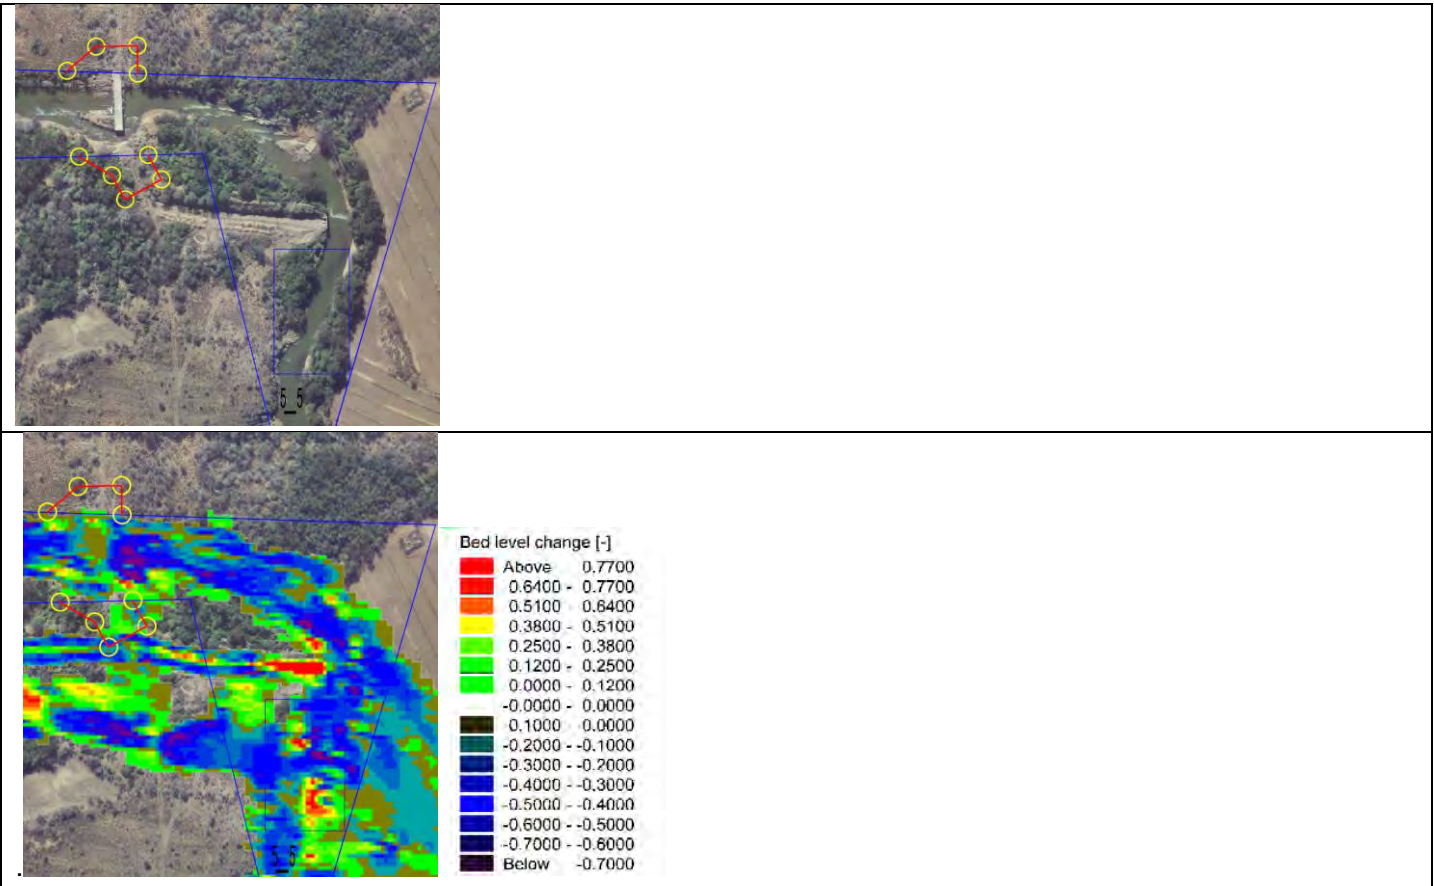
**Zone 5\_5** The zone has banks within the servitude. Flows are wide in the floodplain and protection not necessary.

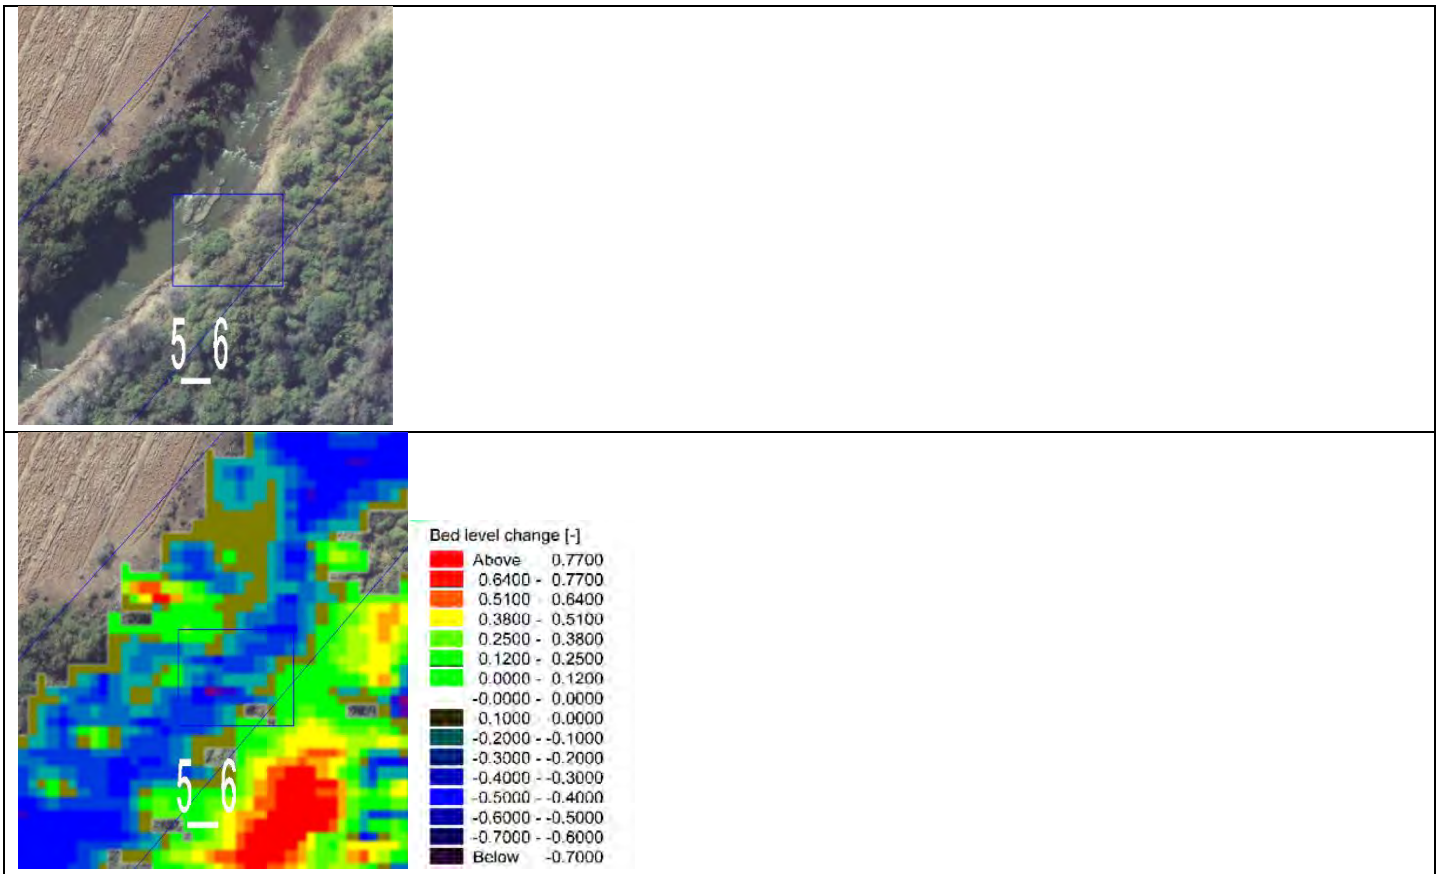
**Zone 5\_6** The zone has banks within the servitude. Flows are wide on the floodplain and protection not necessary.
