SKOENMAKERS RIVER REHABILITATION ASSESSMENT  
ZONE 9

Date:	08/02/2016	Compiled by:	PAUJ
Project No:	472748	Scale:	1:8,000

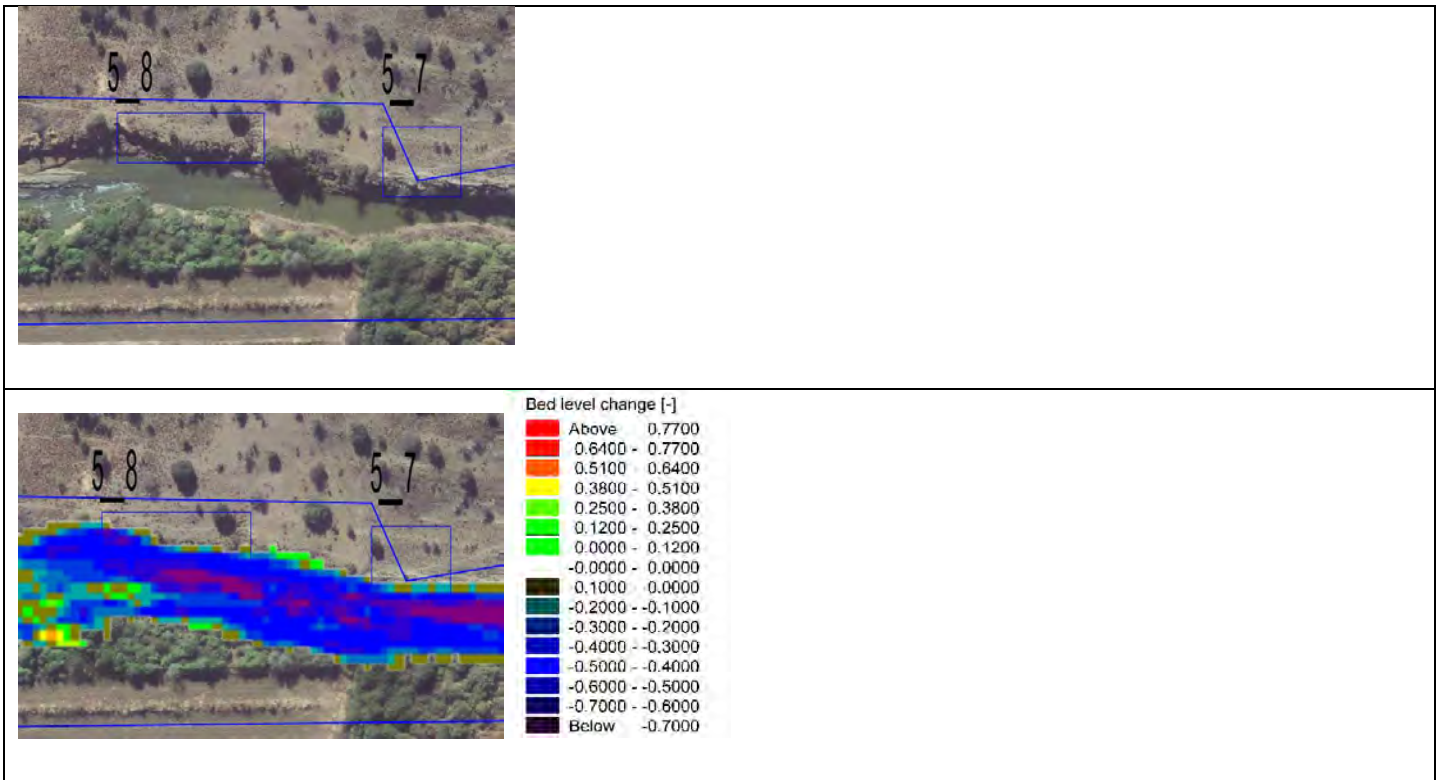
**Zone 5\_7and 5\_8** Unstable banks within the servitude. The servitude seems to be incorrect and protection is deemed not necessary.

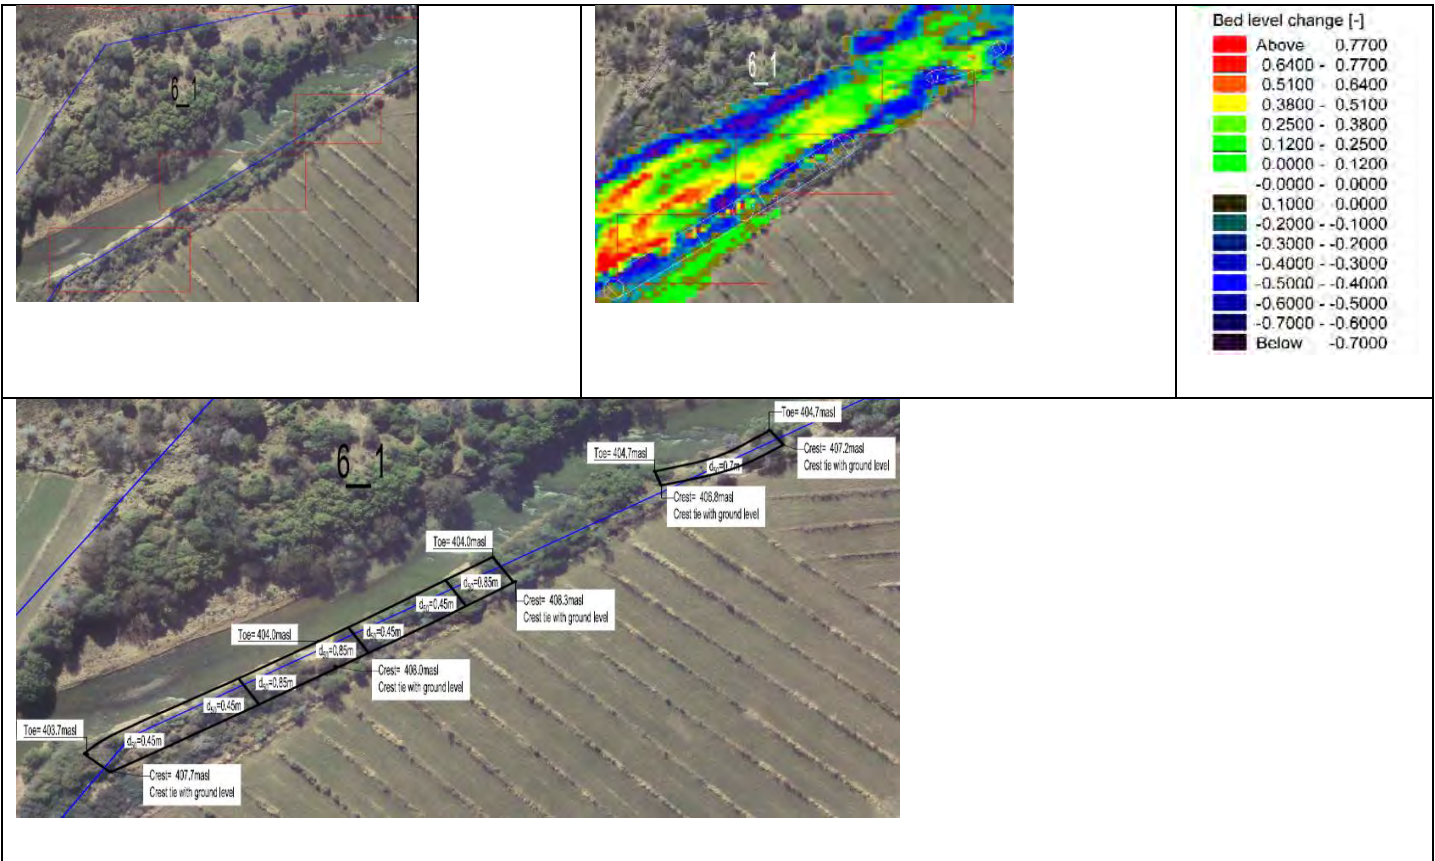
**Zone 6\_1** The zone has banks crossing the servitude and encroaching farmland.

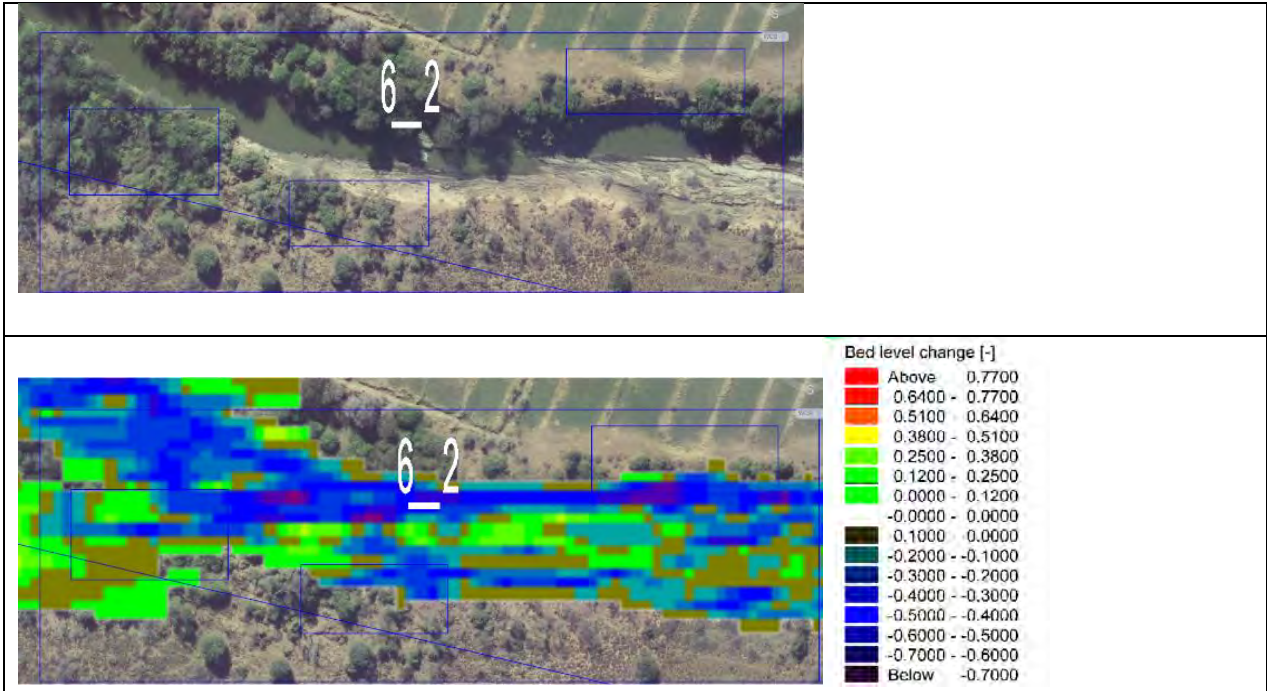
**Zone 6\_2** The zone has banks within the servitude. Upstream tributary flow induces the erosion and protection will constrict the flow thus not necessary.

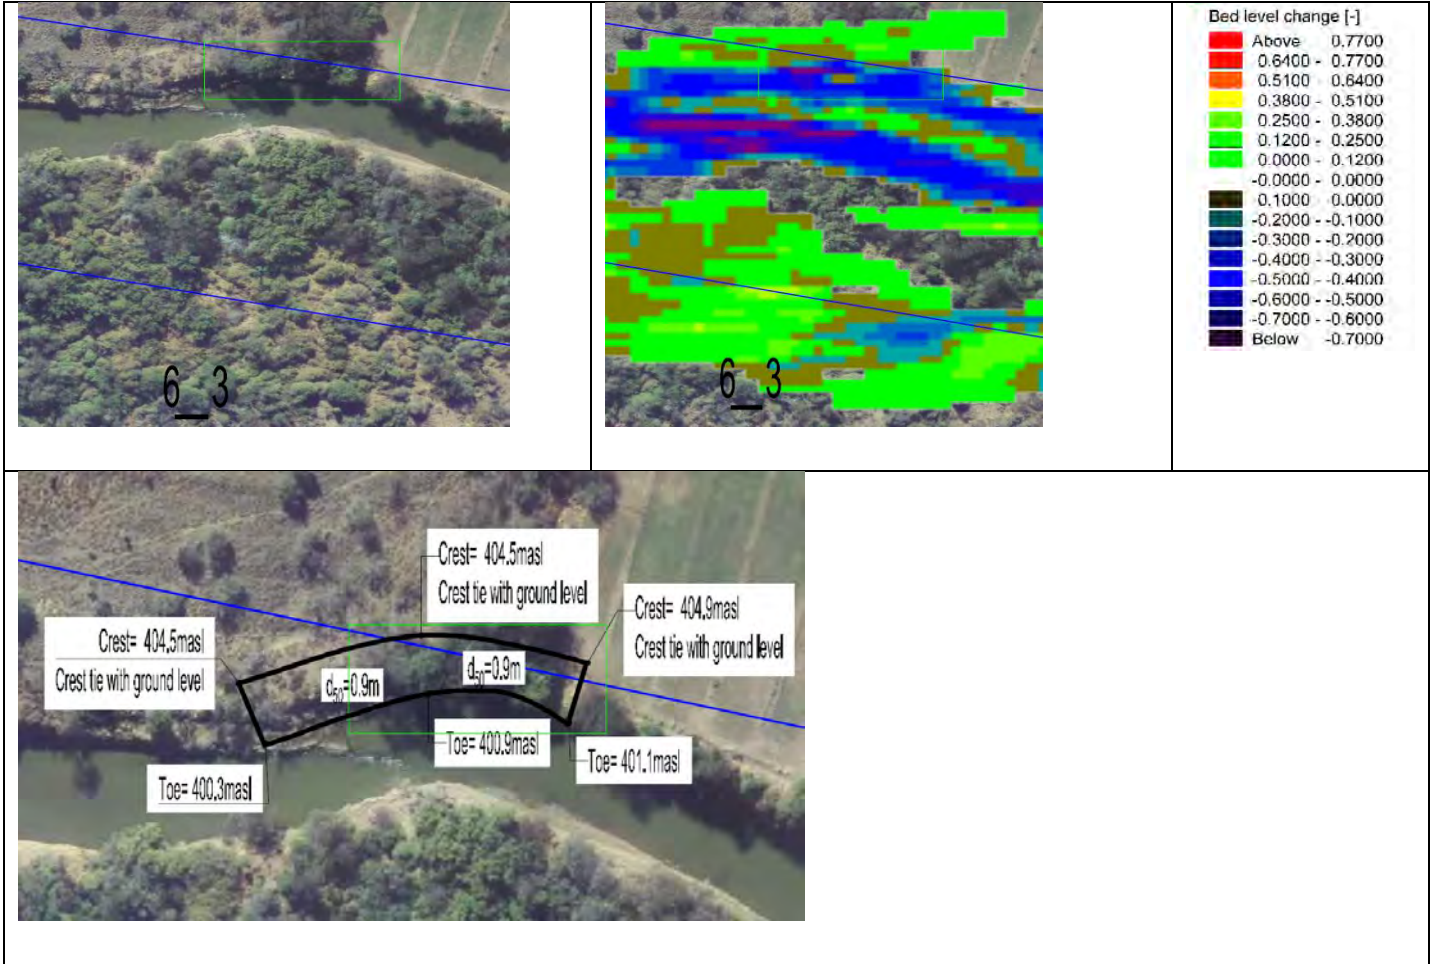
**Zone 6\_3** The zone has banks crossing the servitude and encroaching farmland.

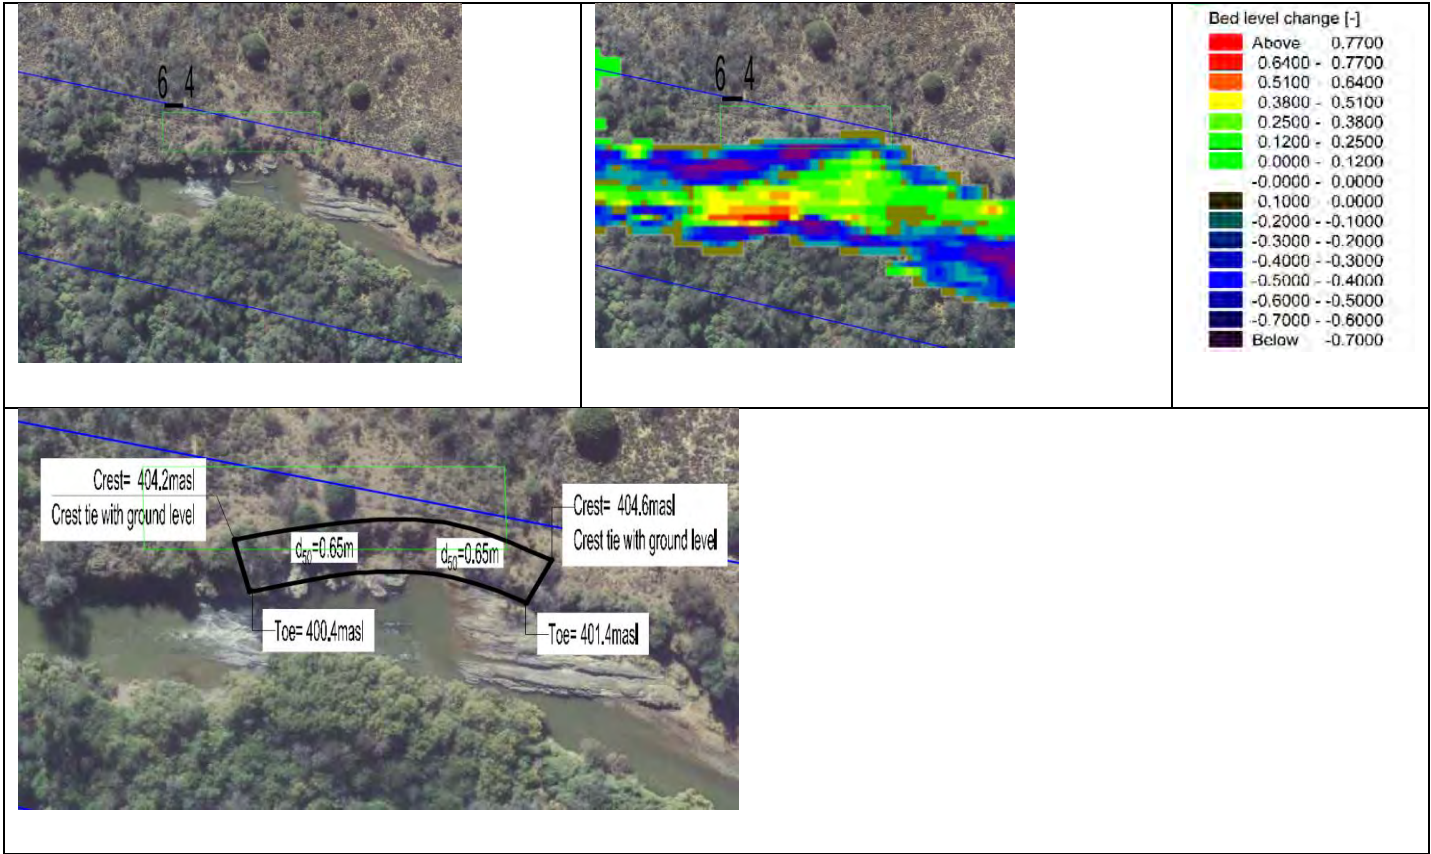
**Zone 6\_4** The zone has banks crossing the servitude but with bedrock outcropping.

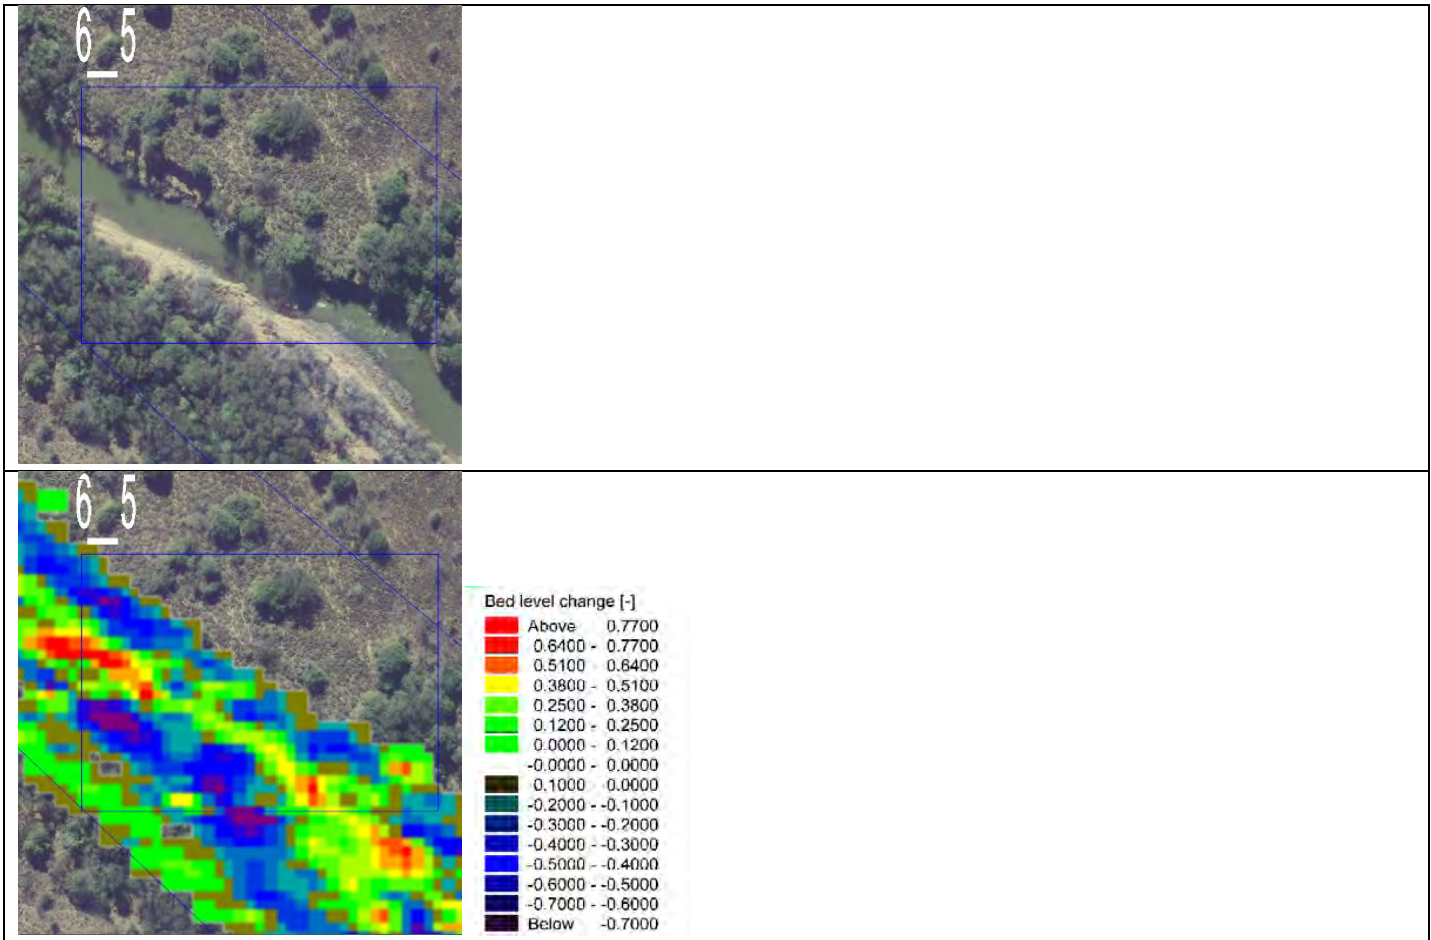
**Zone 6\_5** The zone has unstable banks within the servitude and protection is not necessary.

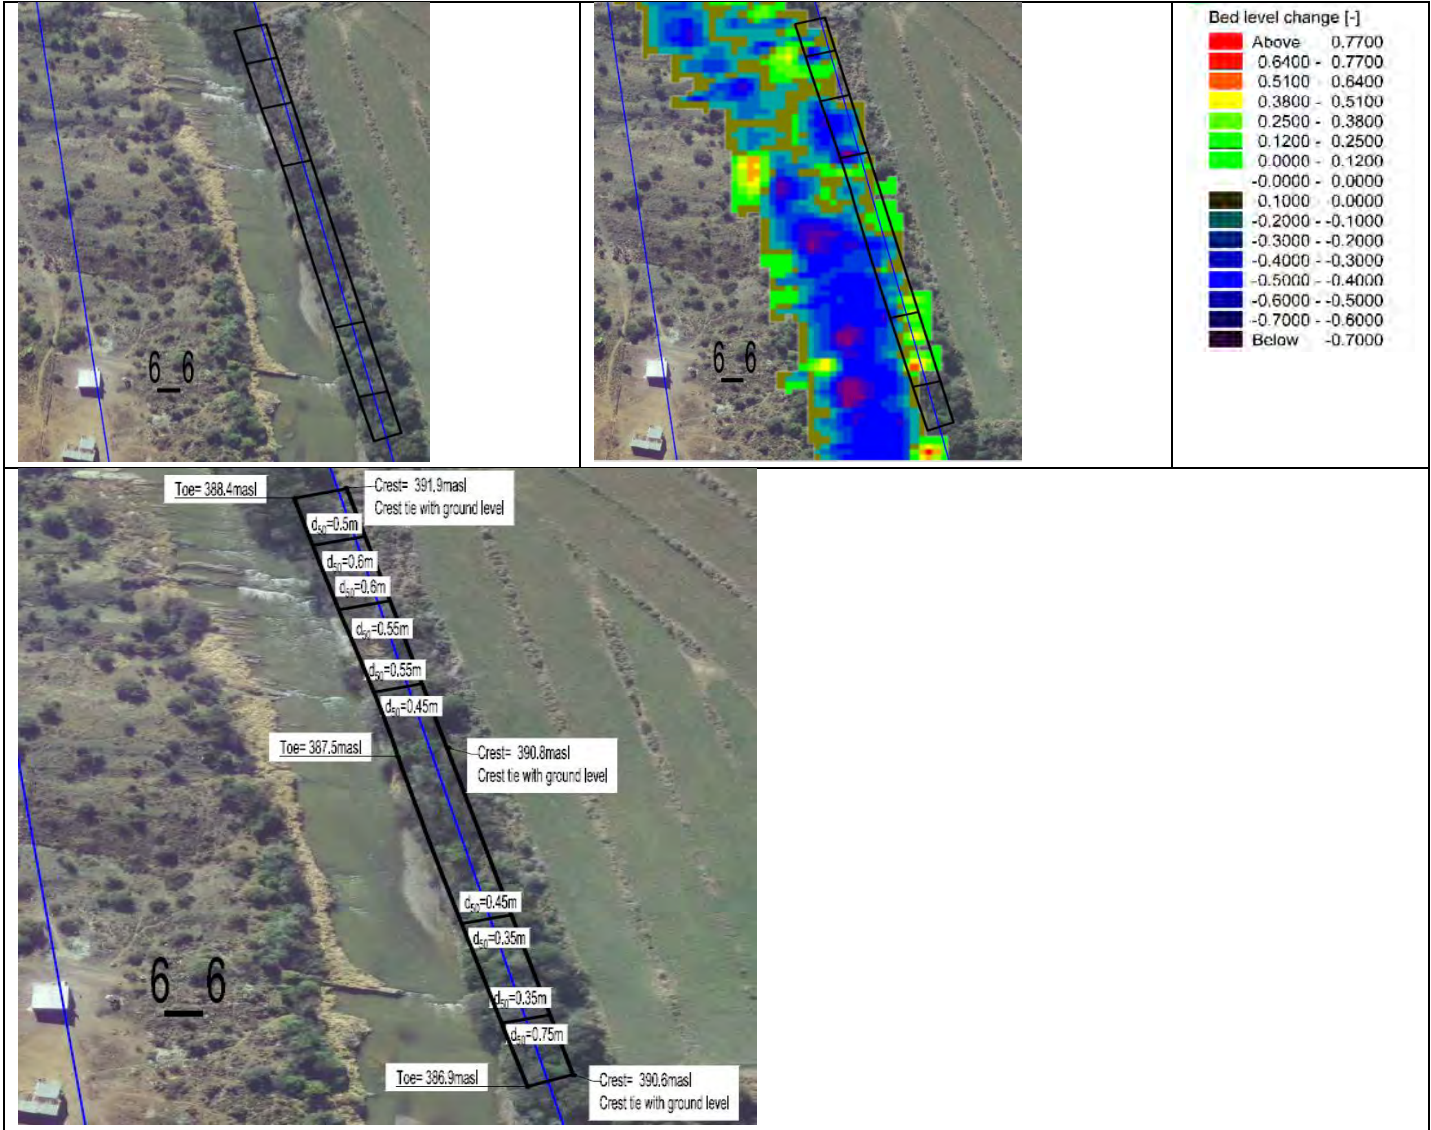
**Zone 6\_6** The zone has banks crossing the servitude and encroaching farmland

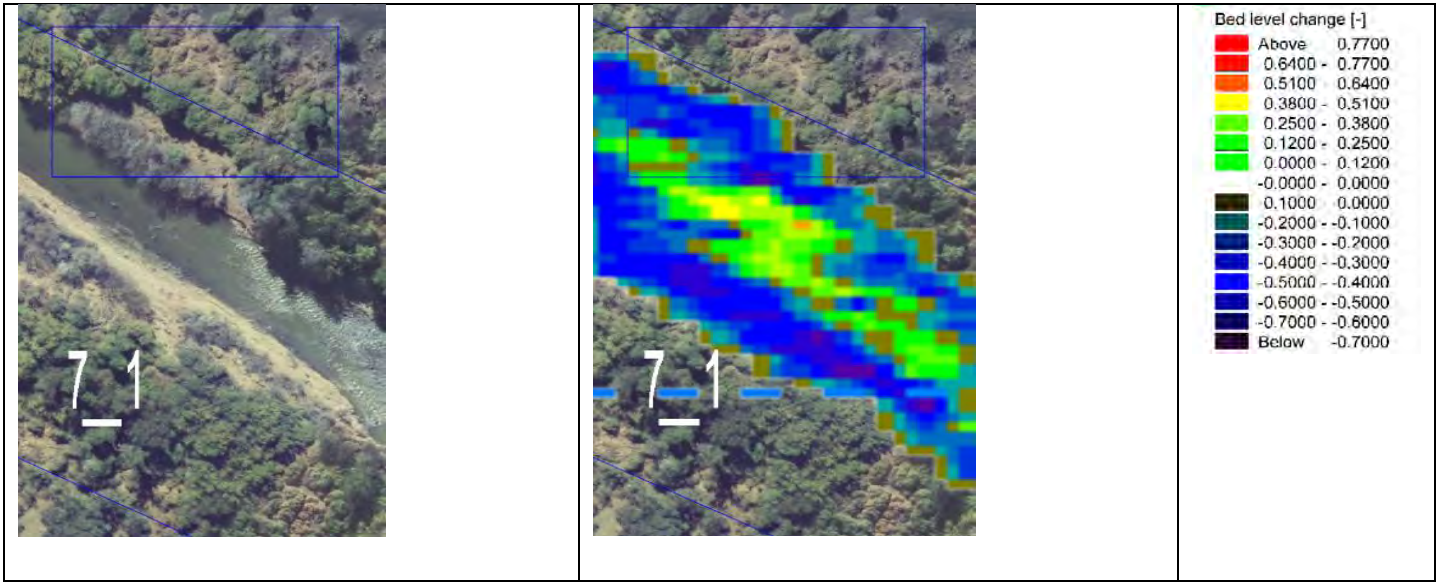
**Zone 7\_1** The zone has unstable banks within the servitude and protection is not necessary

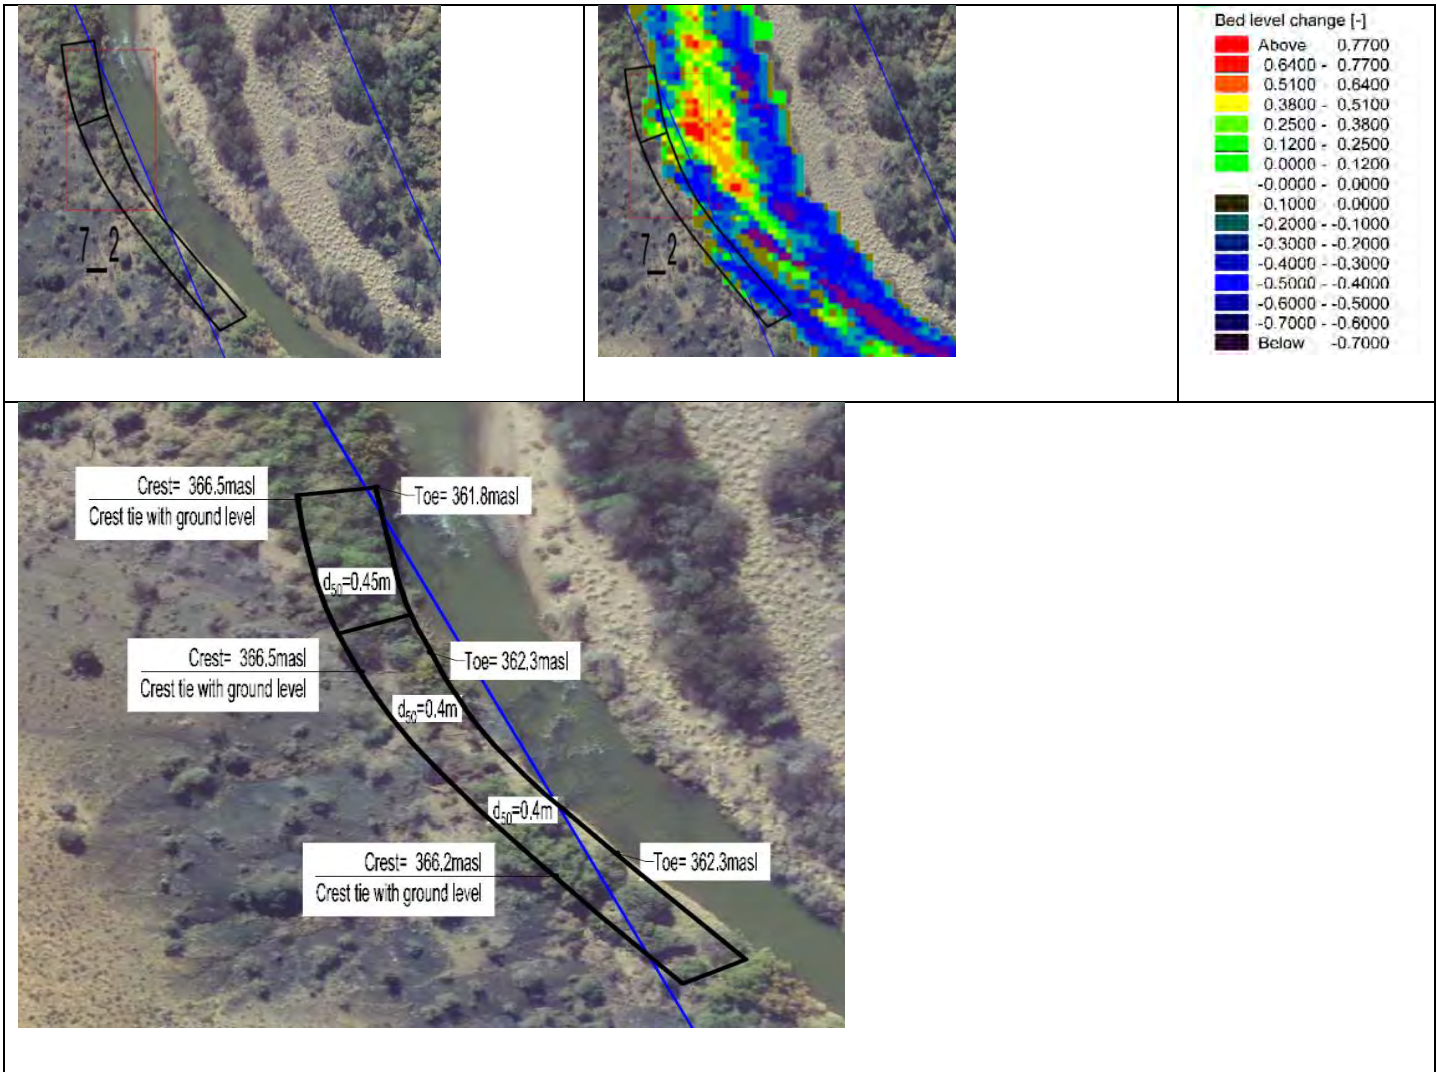
**Zone 7\_2** The zone has banks crossing the servitude

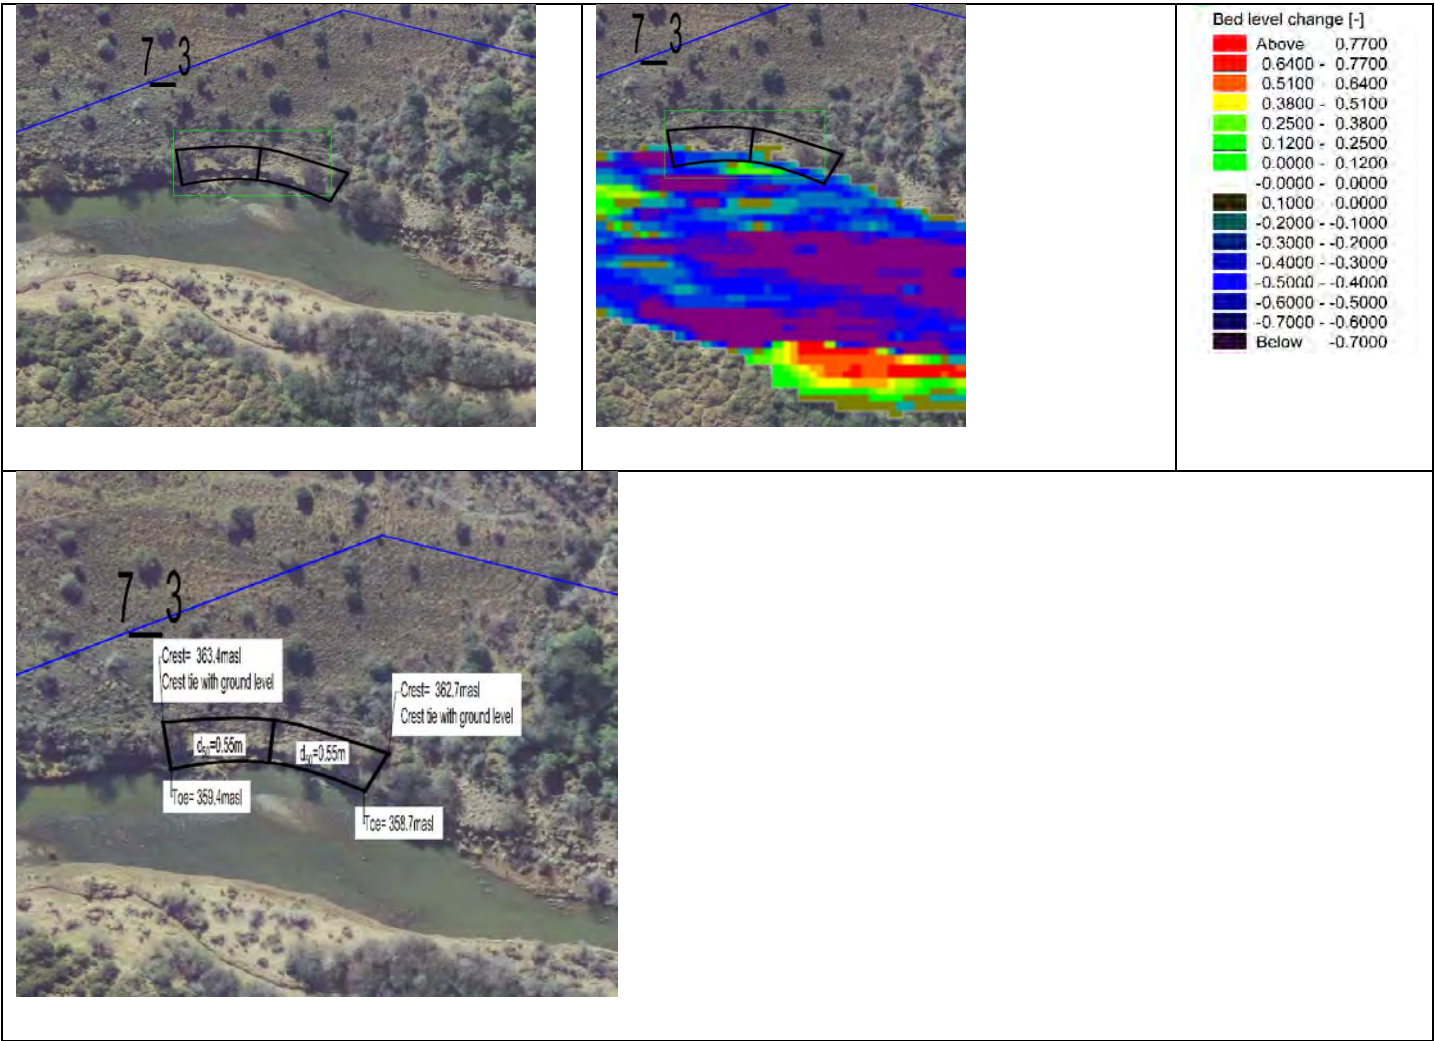
**Zone 7\_3** The zone has unstable banks within the servitude.

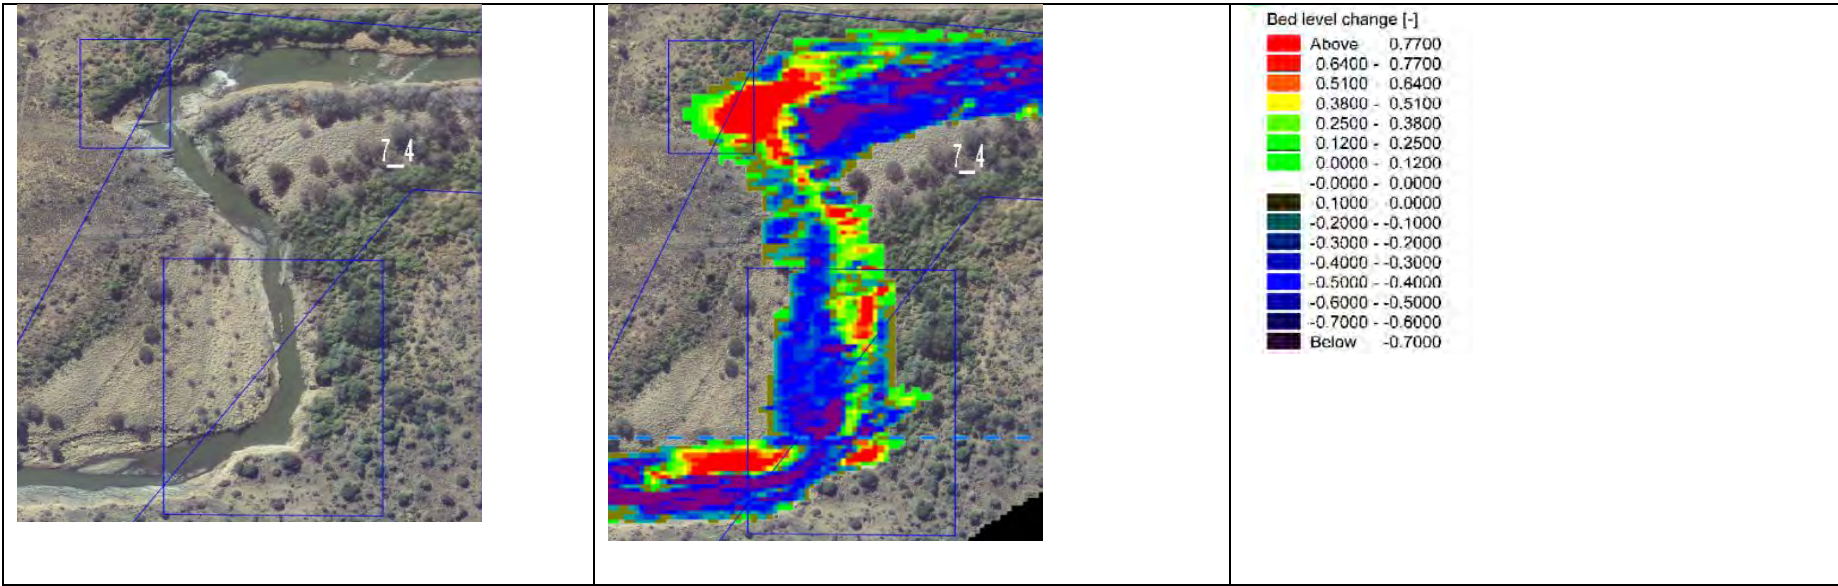
**Zone 7\_4** This area's river servitude seems inaccurate.

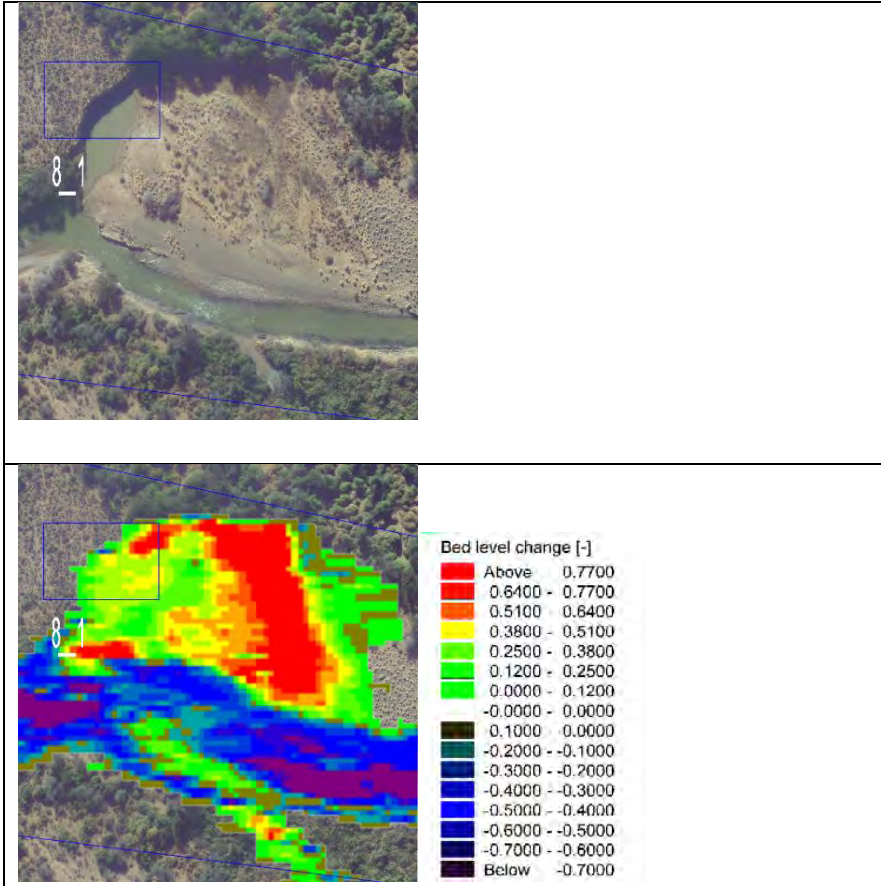
**Zone 8\_1** The zone has unstable banks within the servitude thus protection is not necessary.

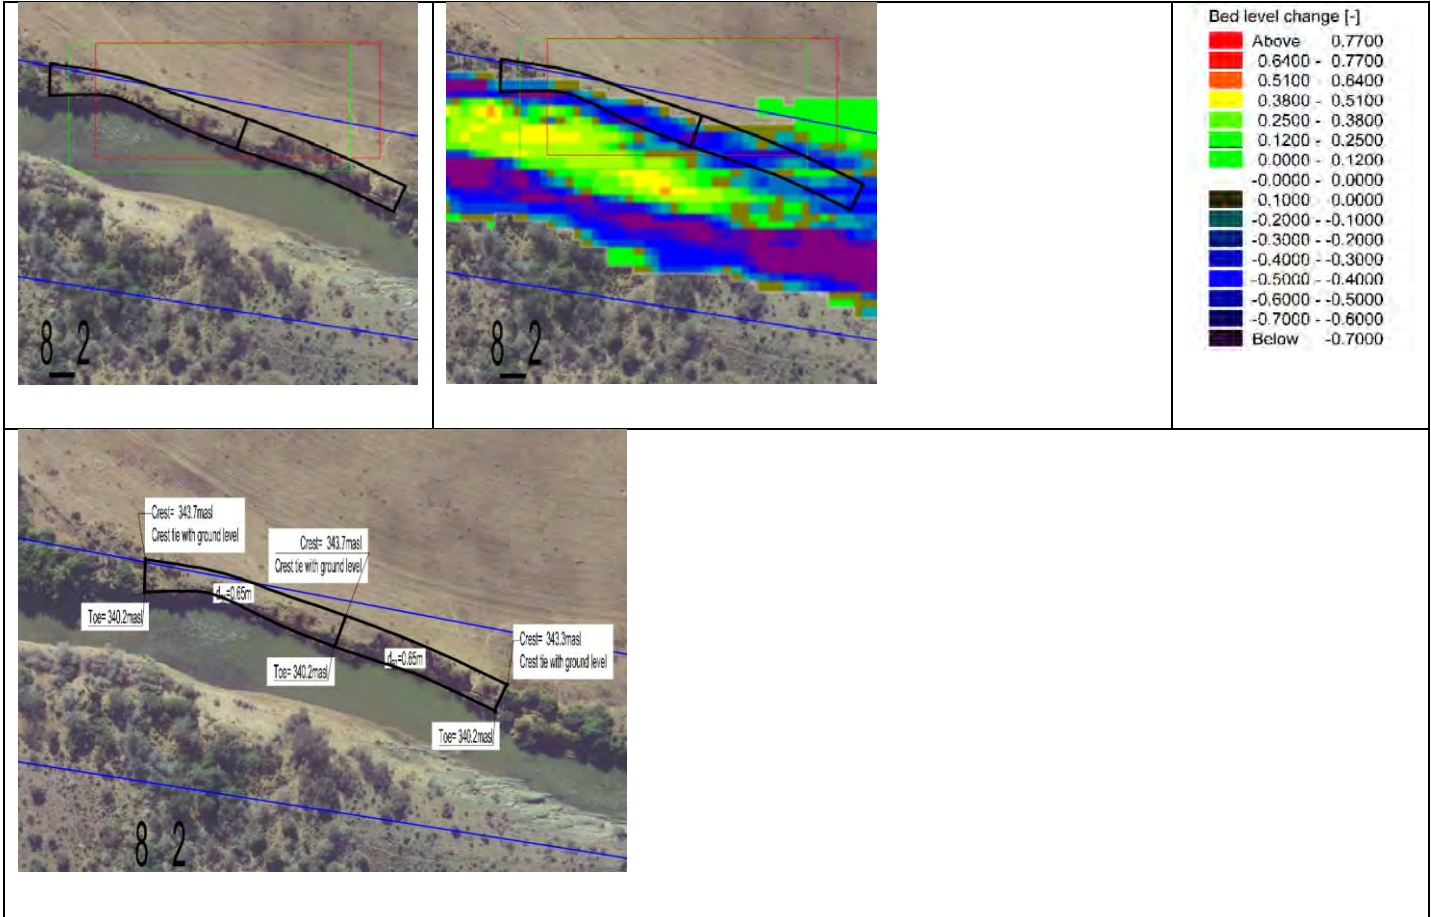
**Zone 8\_2** The zone has unstable banks crossing the servitude and encroaching onto farm land

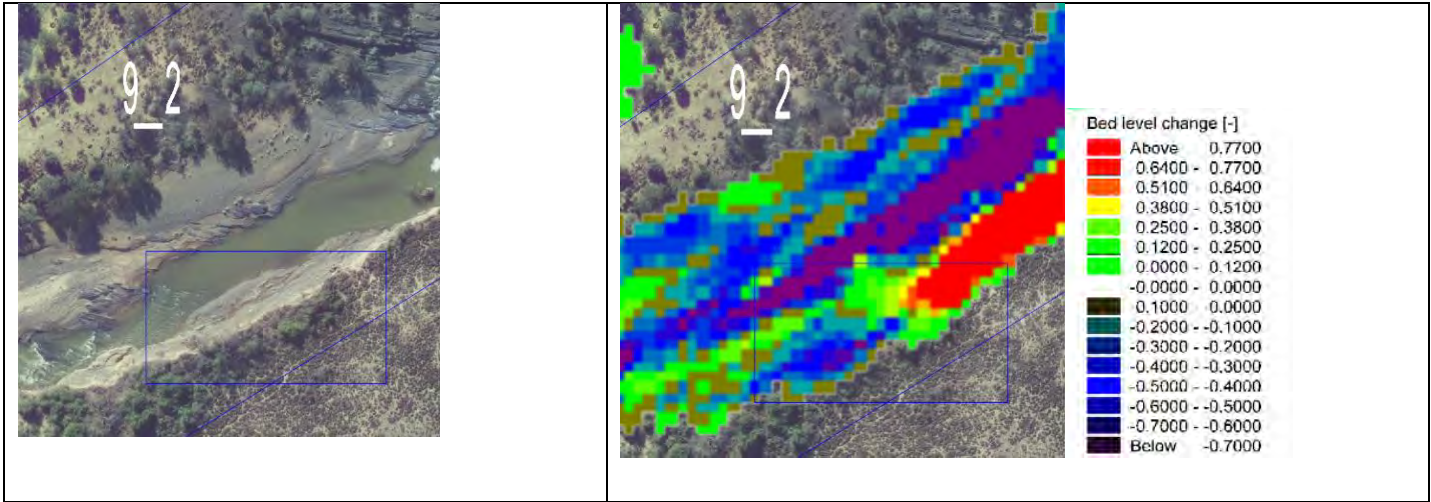
**Zone 9\_2** The zone has unstable banks within the servitude thus protection is not necessary.

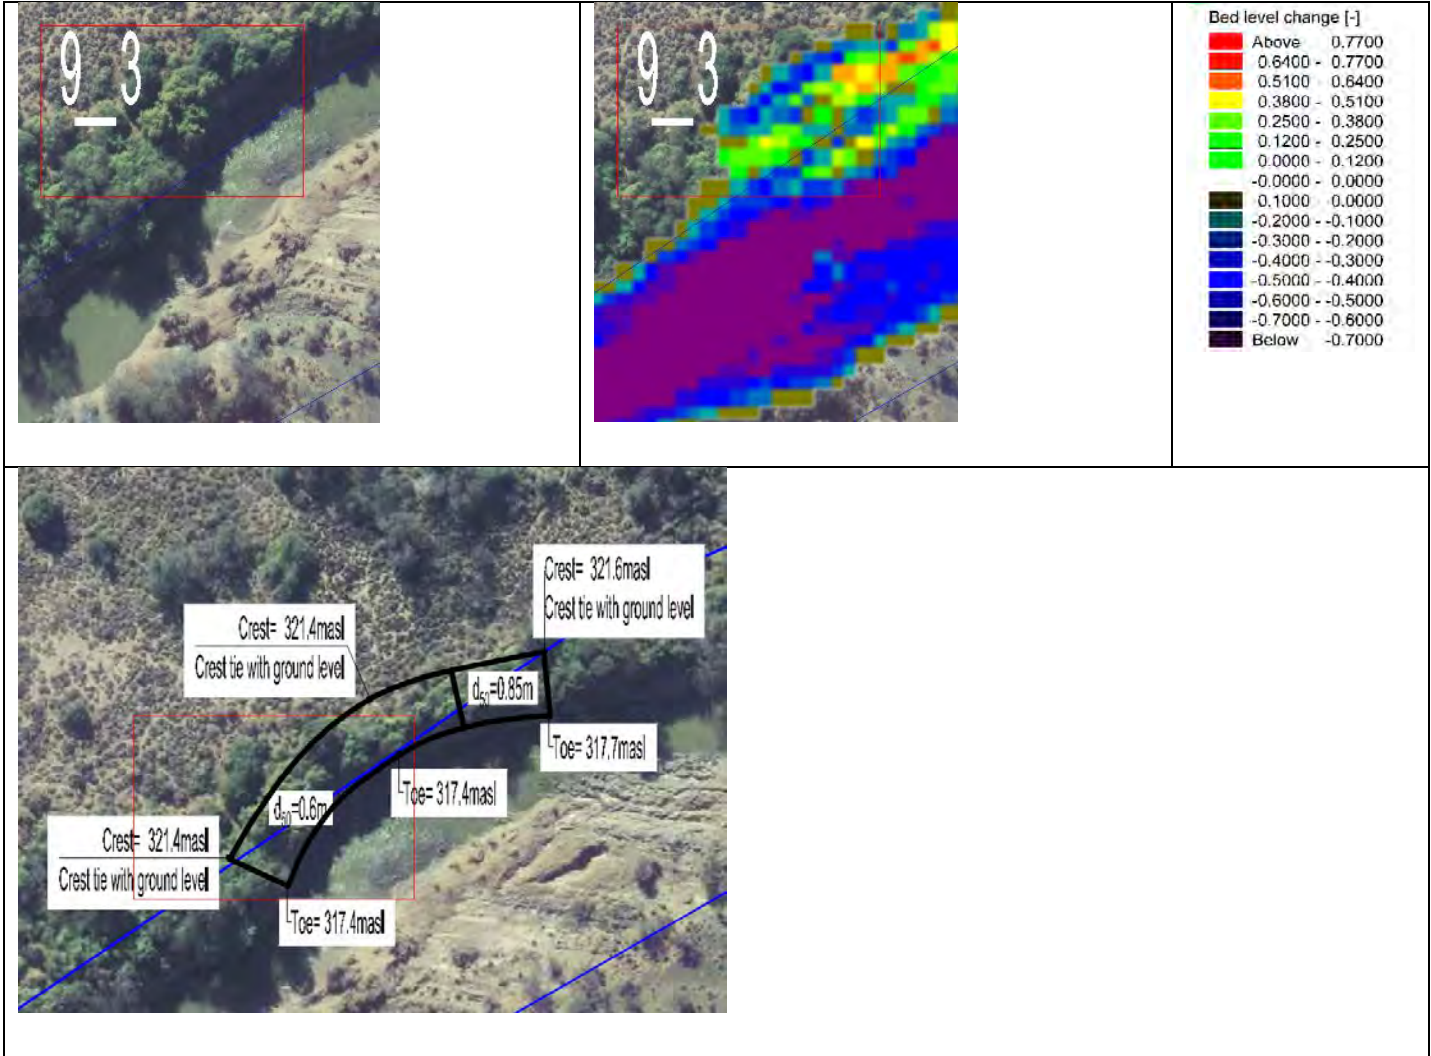
**Zone 9\_3** The zone has unstable banks crossing the servitude which seemed to be inaccurate

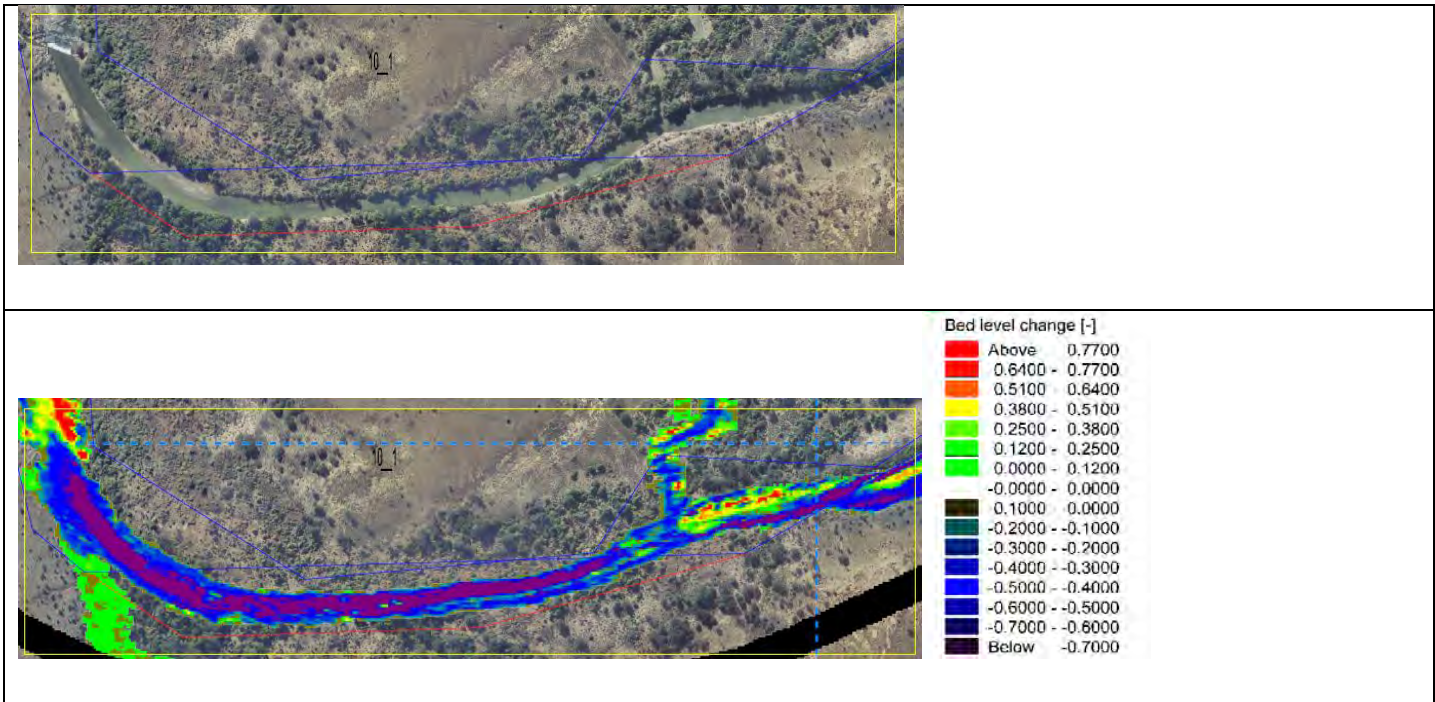
**Zone 10\_1** The area's river servitude seems to be inaccurate

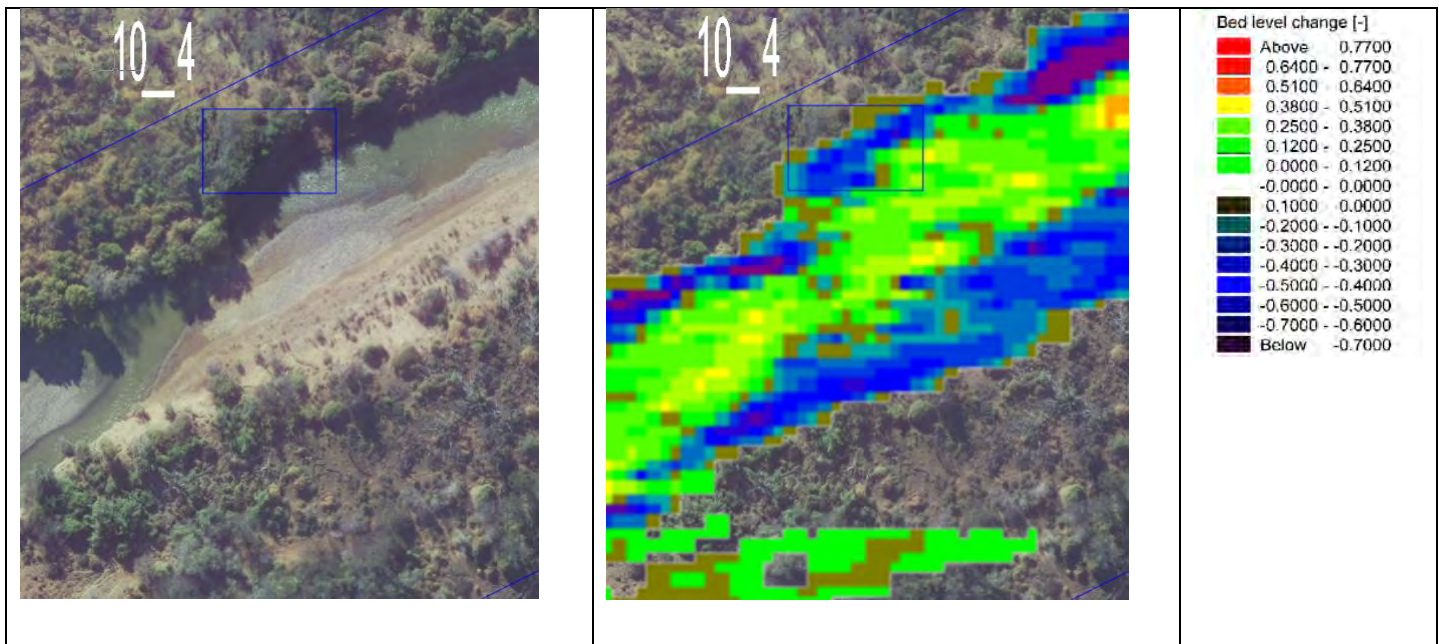
**Zone 10\_4** The zone has banks within the servitude. Upstream tributary flow induces the erosion and protection will constrict the flow thus not necessary.

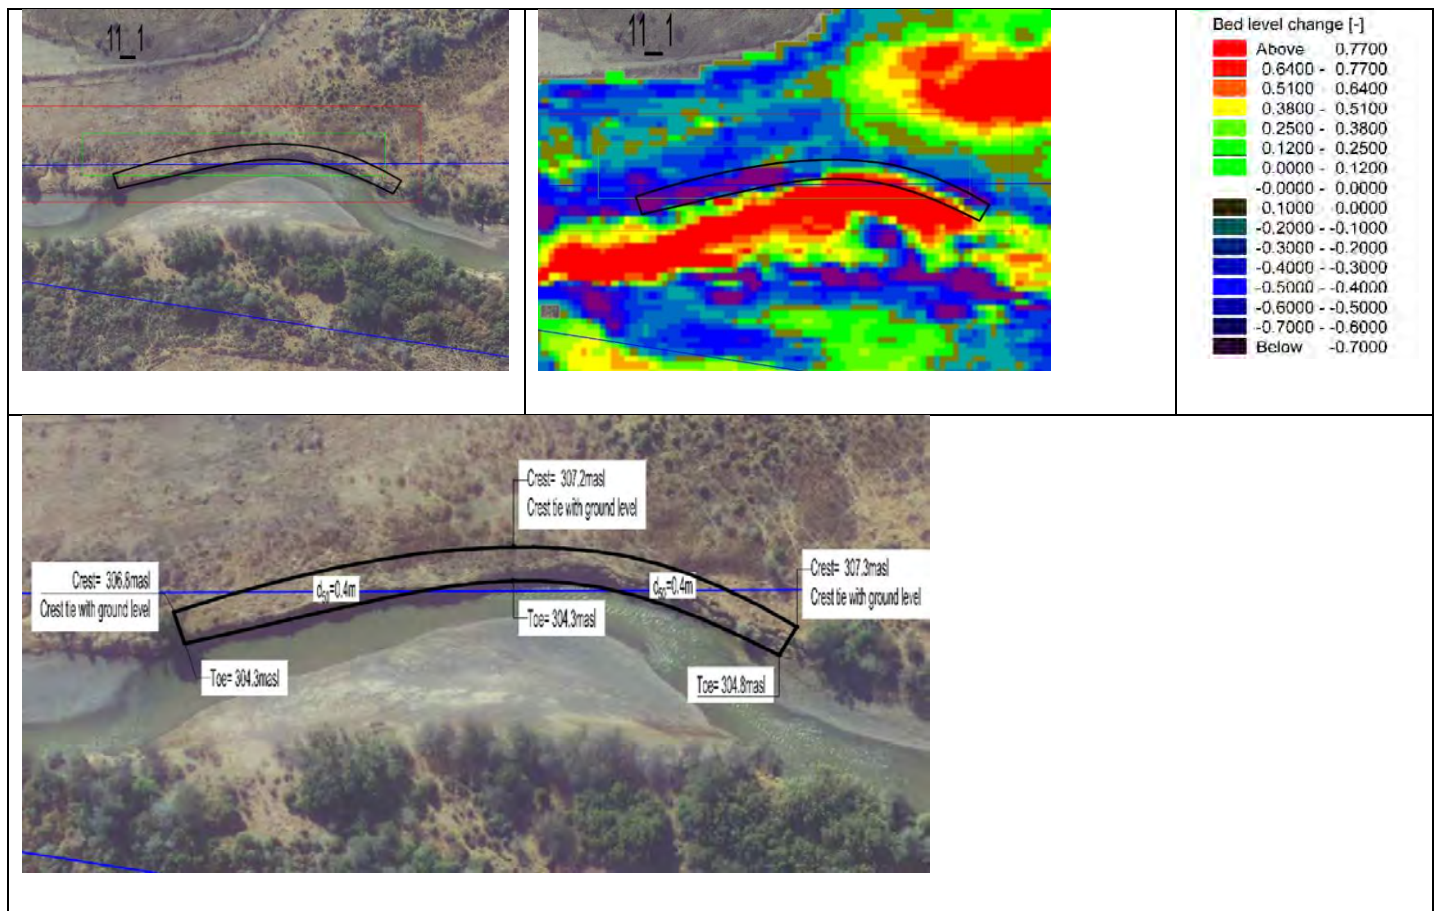
**Zone 11\_1** The zone has unstable banks crossing the servitude and flow is on a wide floodplain.

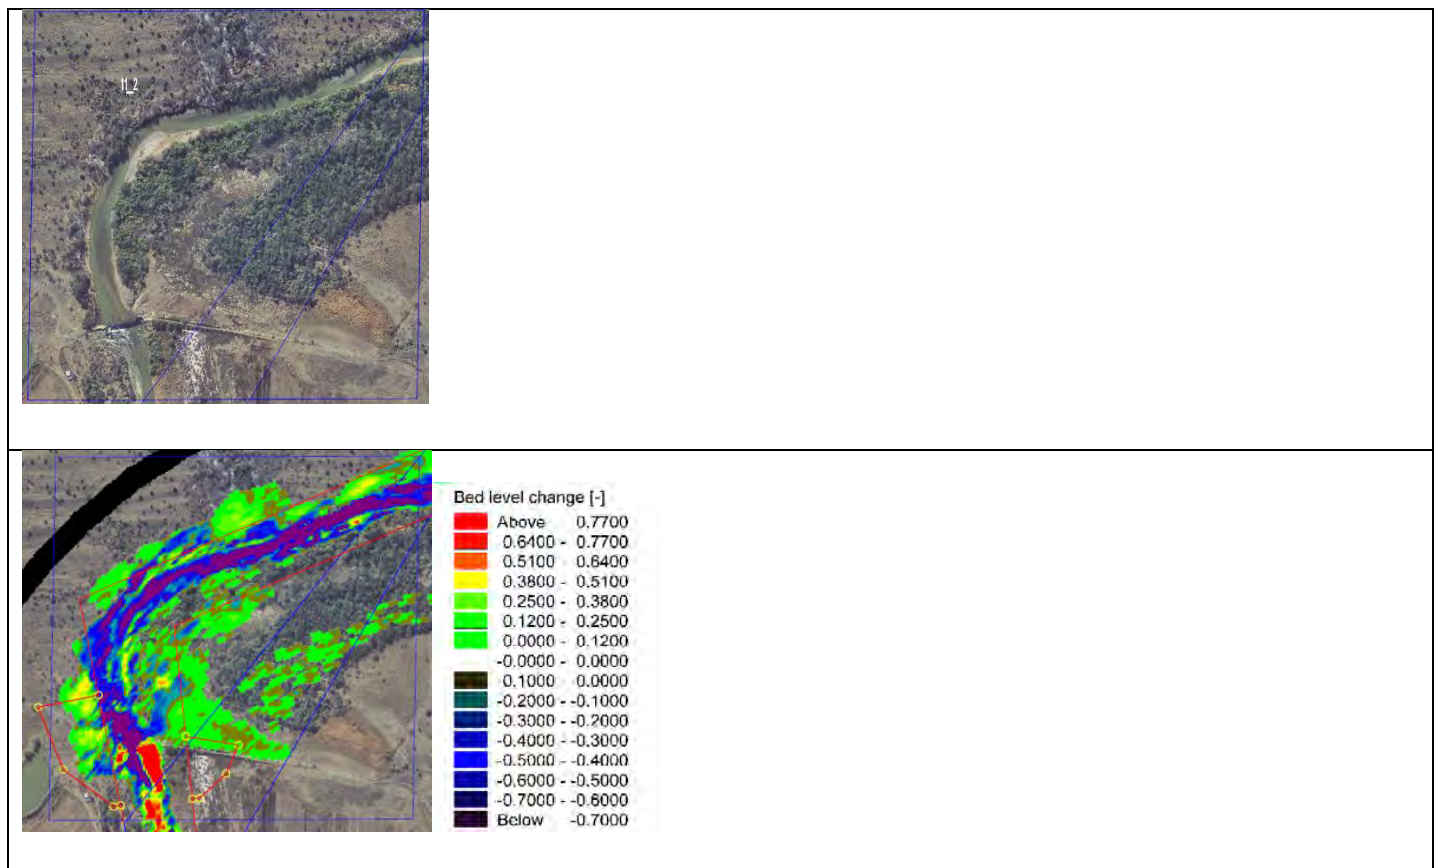
**Zone 11\_2** The area river servitude is inaccurate
