SKOENMAKERS RIVER REHABILITATION ASSESSMENT  
ZONE 9

Date:	08/02/2016	Compiled by:	PAUJ
Project No:	472748	Scale:	1:8,000

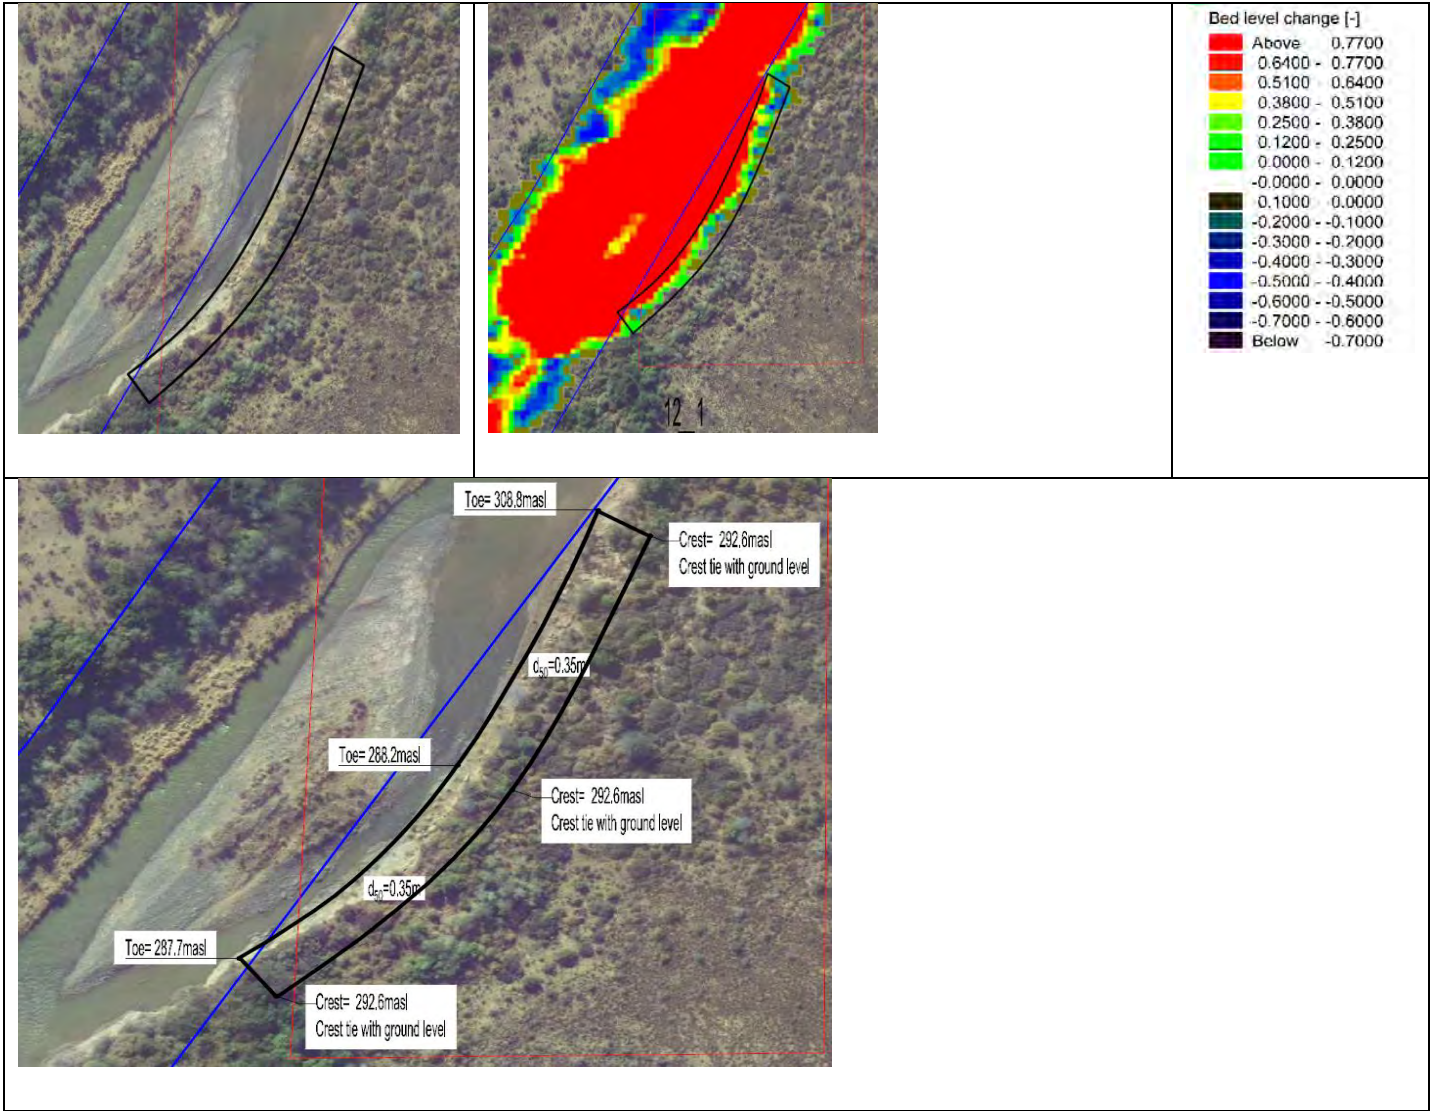
Zone 12\_1 The zone has unstable banks crossing the servitude.
