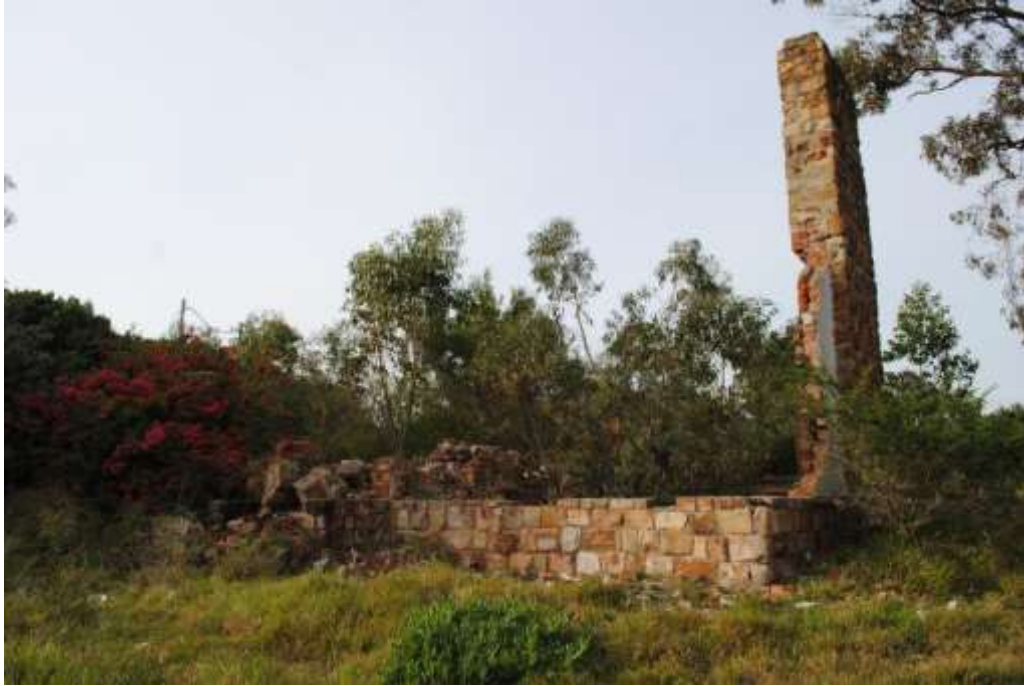
QBE3 - View taken from the approach pathway of the remains of the building. The stone plinth with partial stone chimney is visible. Widespread vegetation has established itself within the confines of the building footprint.

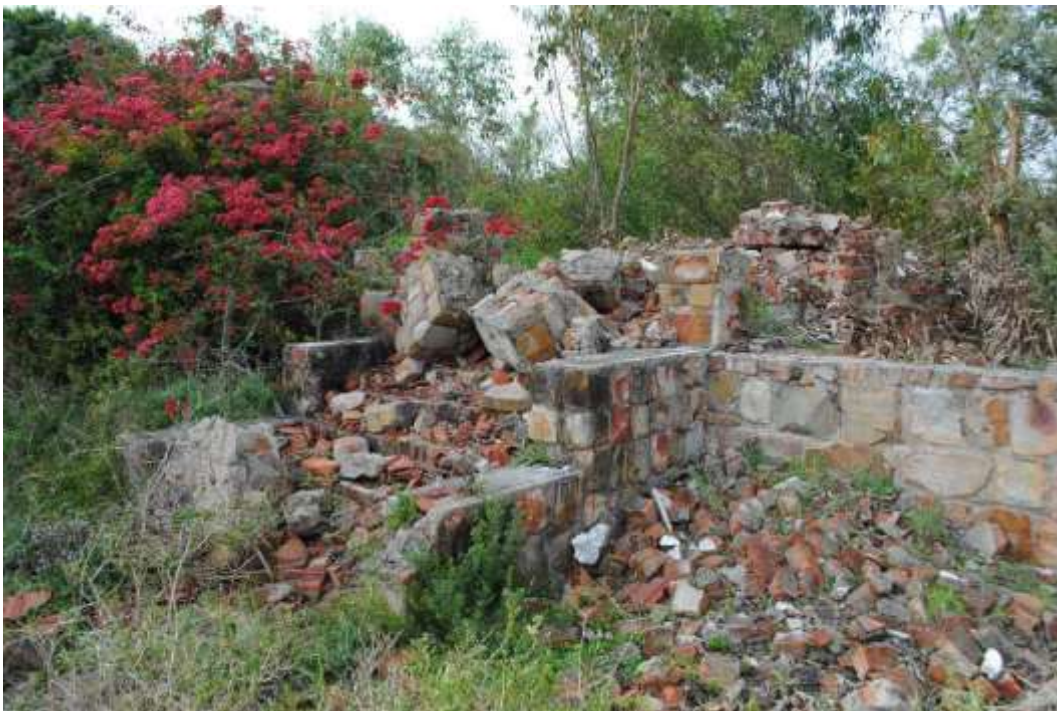
QBE3 - Remnants of the staircase of what would have been considered the front door to the building. Note the excessive building rubble as a result of the demolition and dismantling of the building.

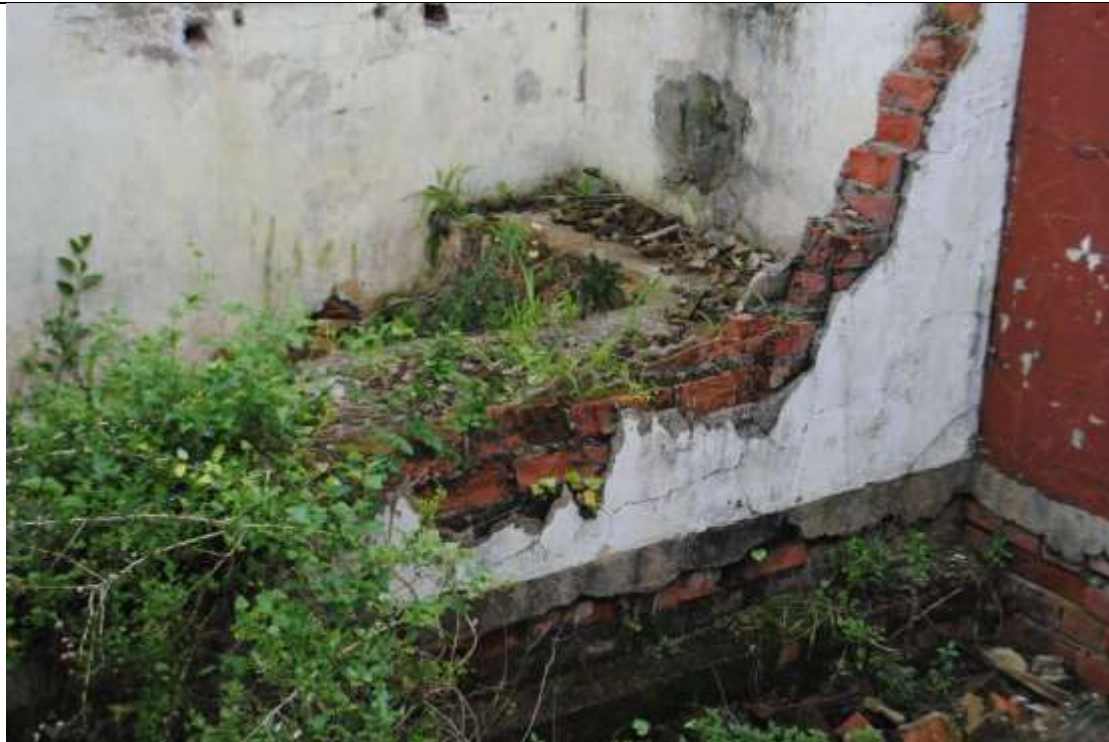
QBE3 – The remaining walls of outbuildings walls are damaged, with exposed brickwork and vegetation growing in the walls.

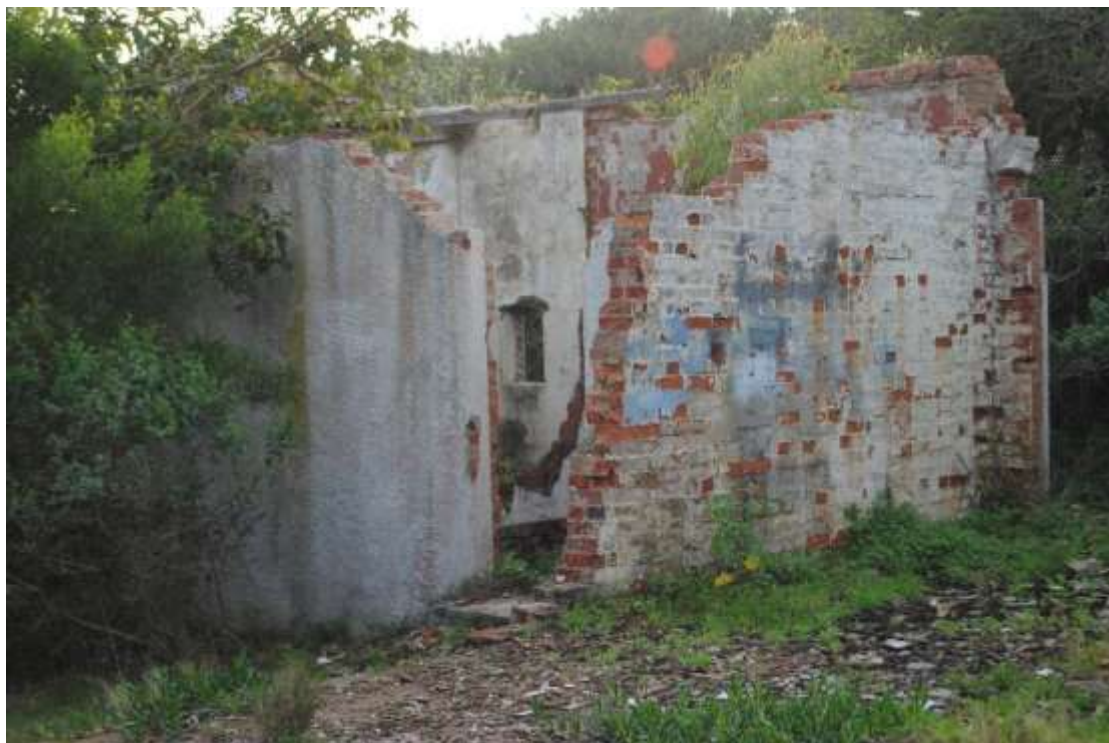
QBE3 – There are no doors, windows, roofs or fittings left and the remaining walls appear to have started crumbling in places.

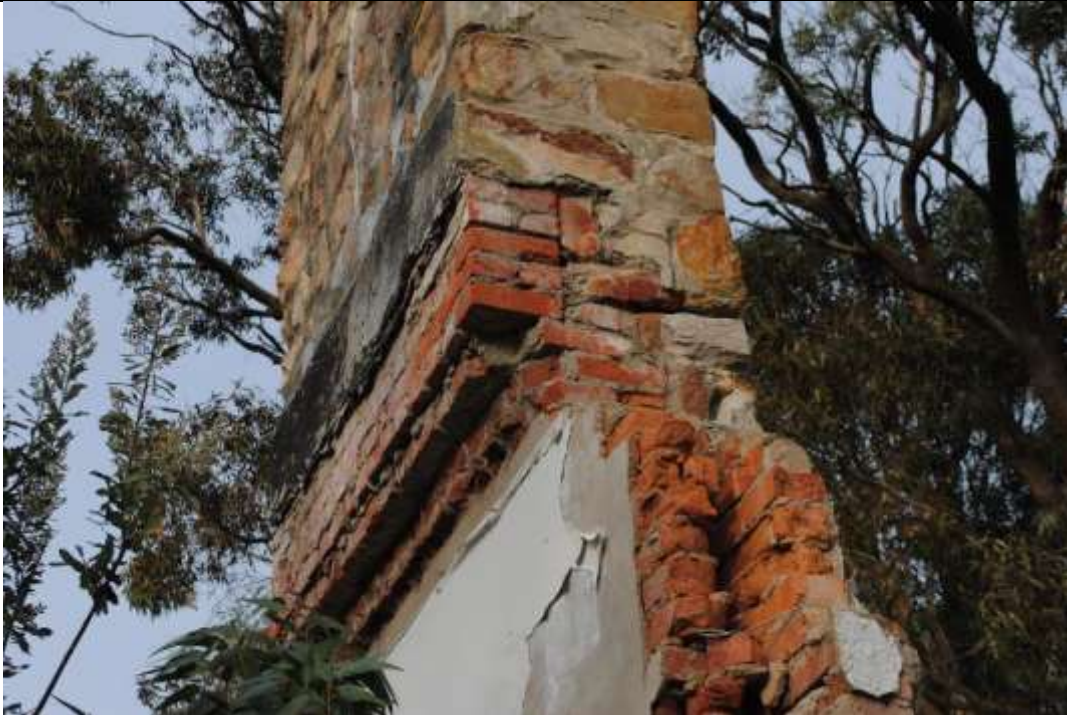
QBE3 – The chimney is partially intact and built of bricks with some stone masonry. The bricks have become brittle, while the stonework has remained in a reasonable condition.

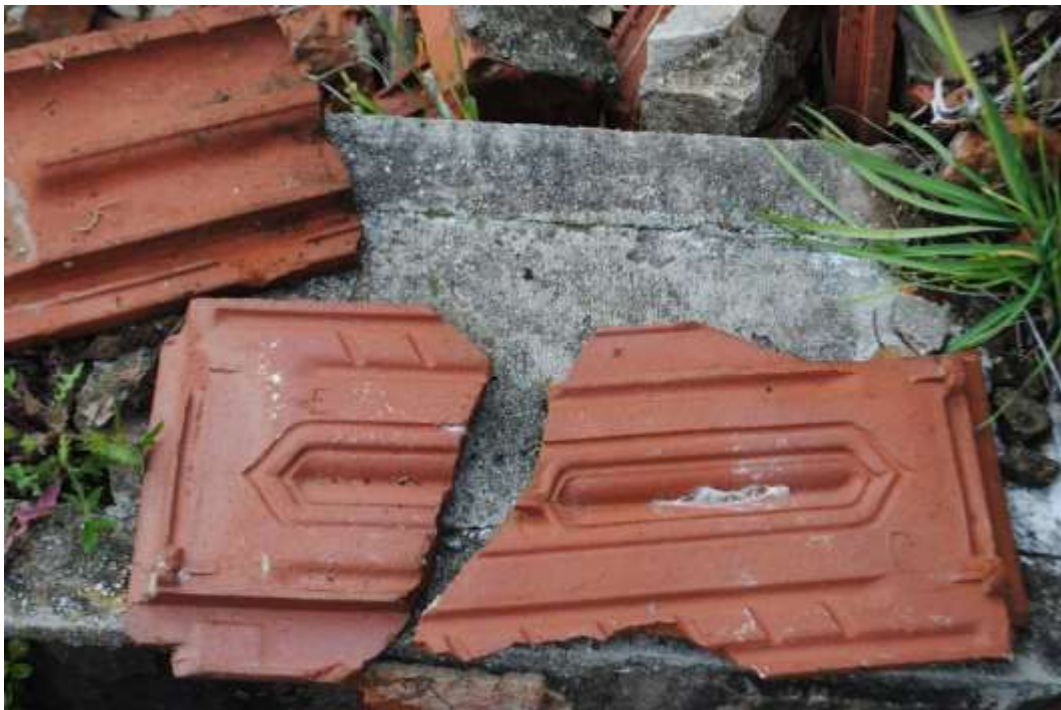
QBE3 – Broken clay roof tile that was presumably used as the roof covering of the farmstead prior to demolition.

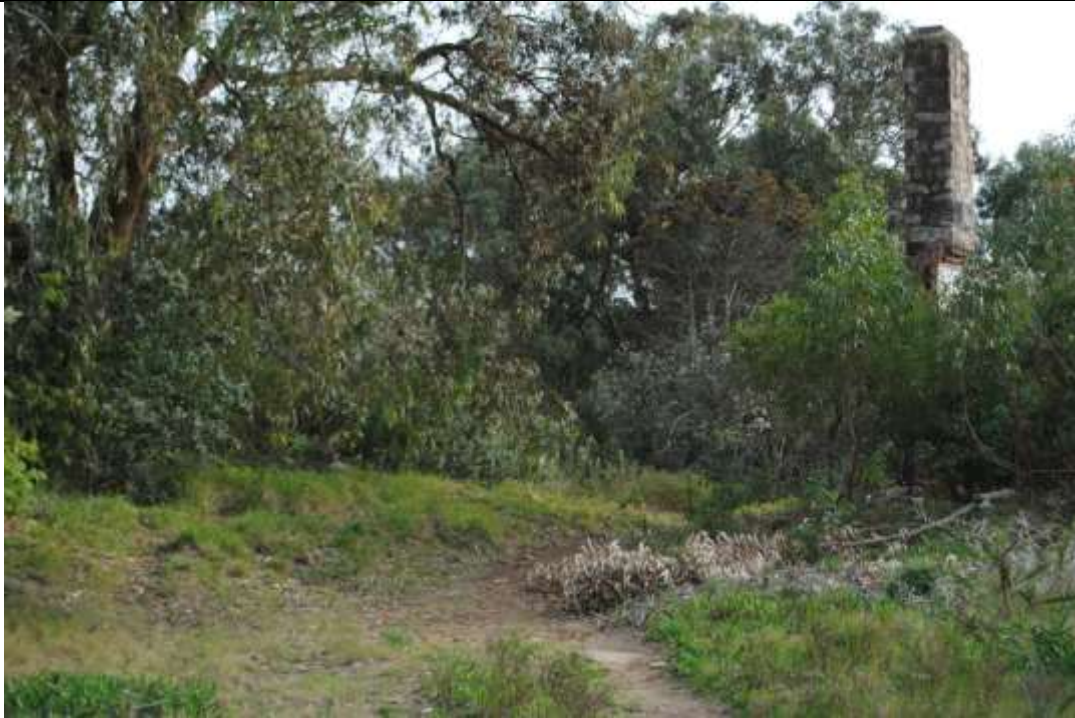
View of the typical dense vegetation limiting access to the sites. Access is gained mainly via foot paths.

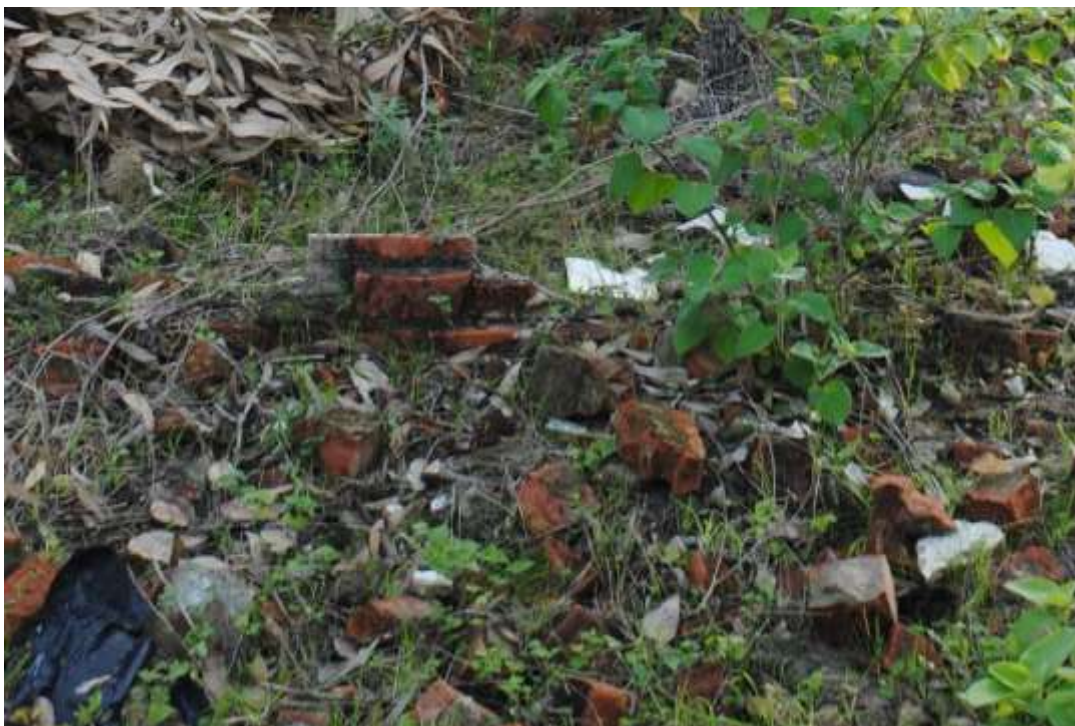
The site is littered with building rubble where buildings have been demolished and stripped bare.

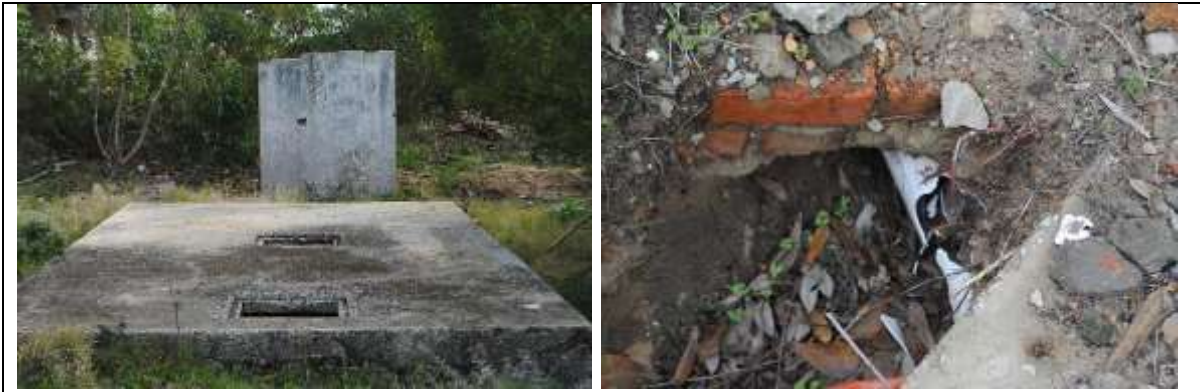
QBE3 – The existing building service infrastructure is in poor condition.

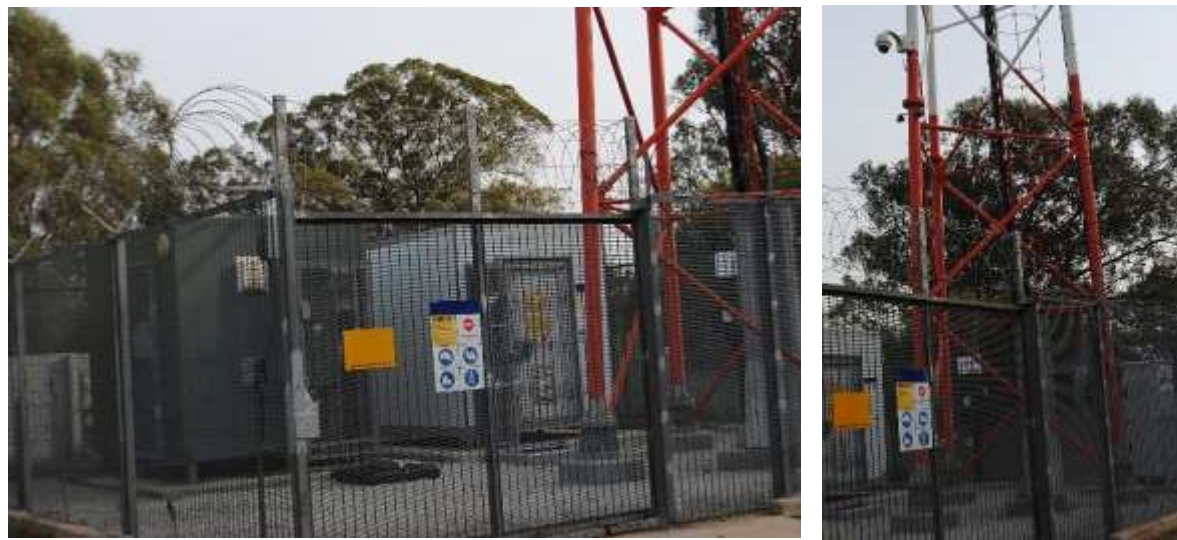
QBE4 - Transmission tower positioned at point QBE4. The facility is accessed via a narrow bush track and is fenced off with razor wire for security purposes.
