**Anglo American Platinum  
Rustenburg Process Division**

Annual Integrated Surface and  
Groundwater Quality, Biomonitoring  
and Toxicity Testing Assessment  
Report, Vol I

September 2018 to August 2019

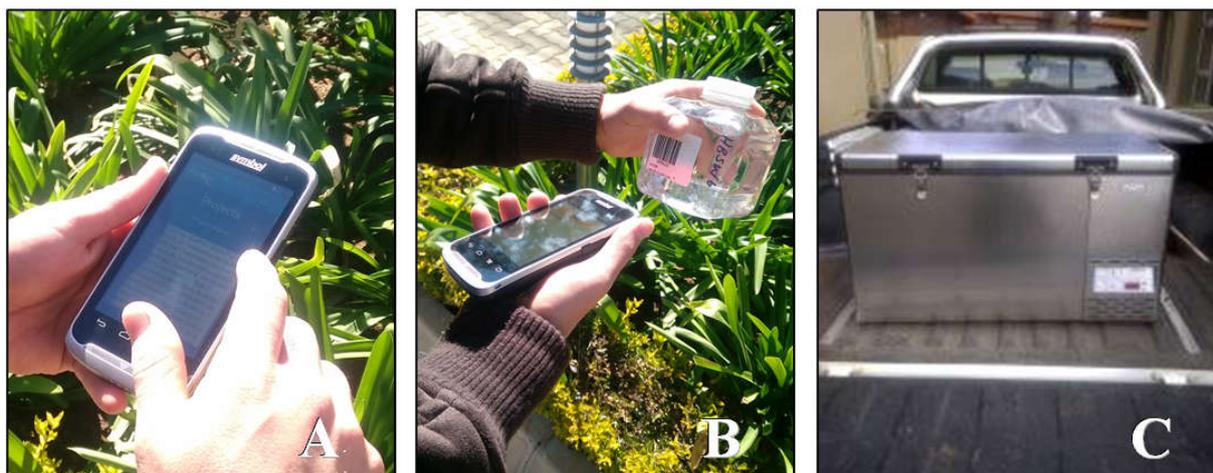
**Figure 6: A –The field PDA units that are being used during sampling. B – Field technician scanning a bar-coded sampling container after the sample has been taken. C – National Luna cooling units fitted on all field vehicles to ensure proper sample transport to the laboratory (at 4C)**

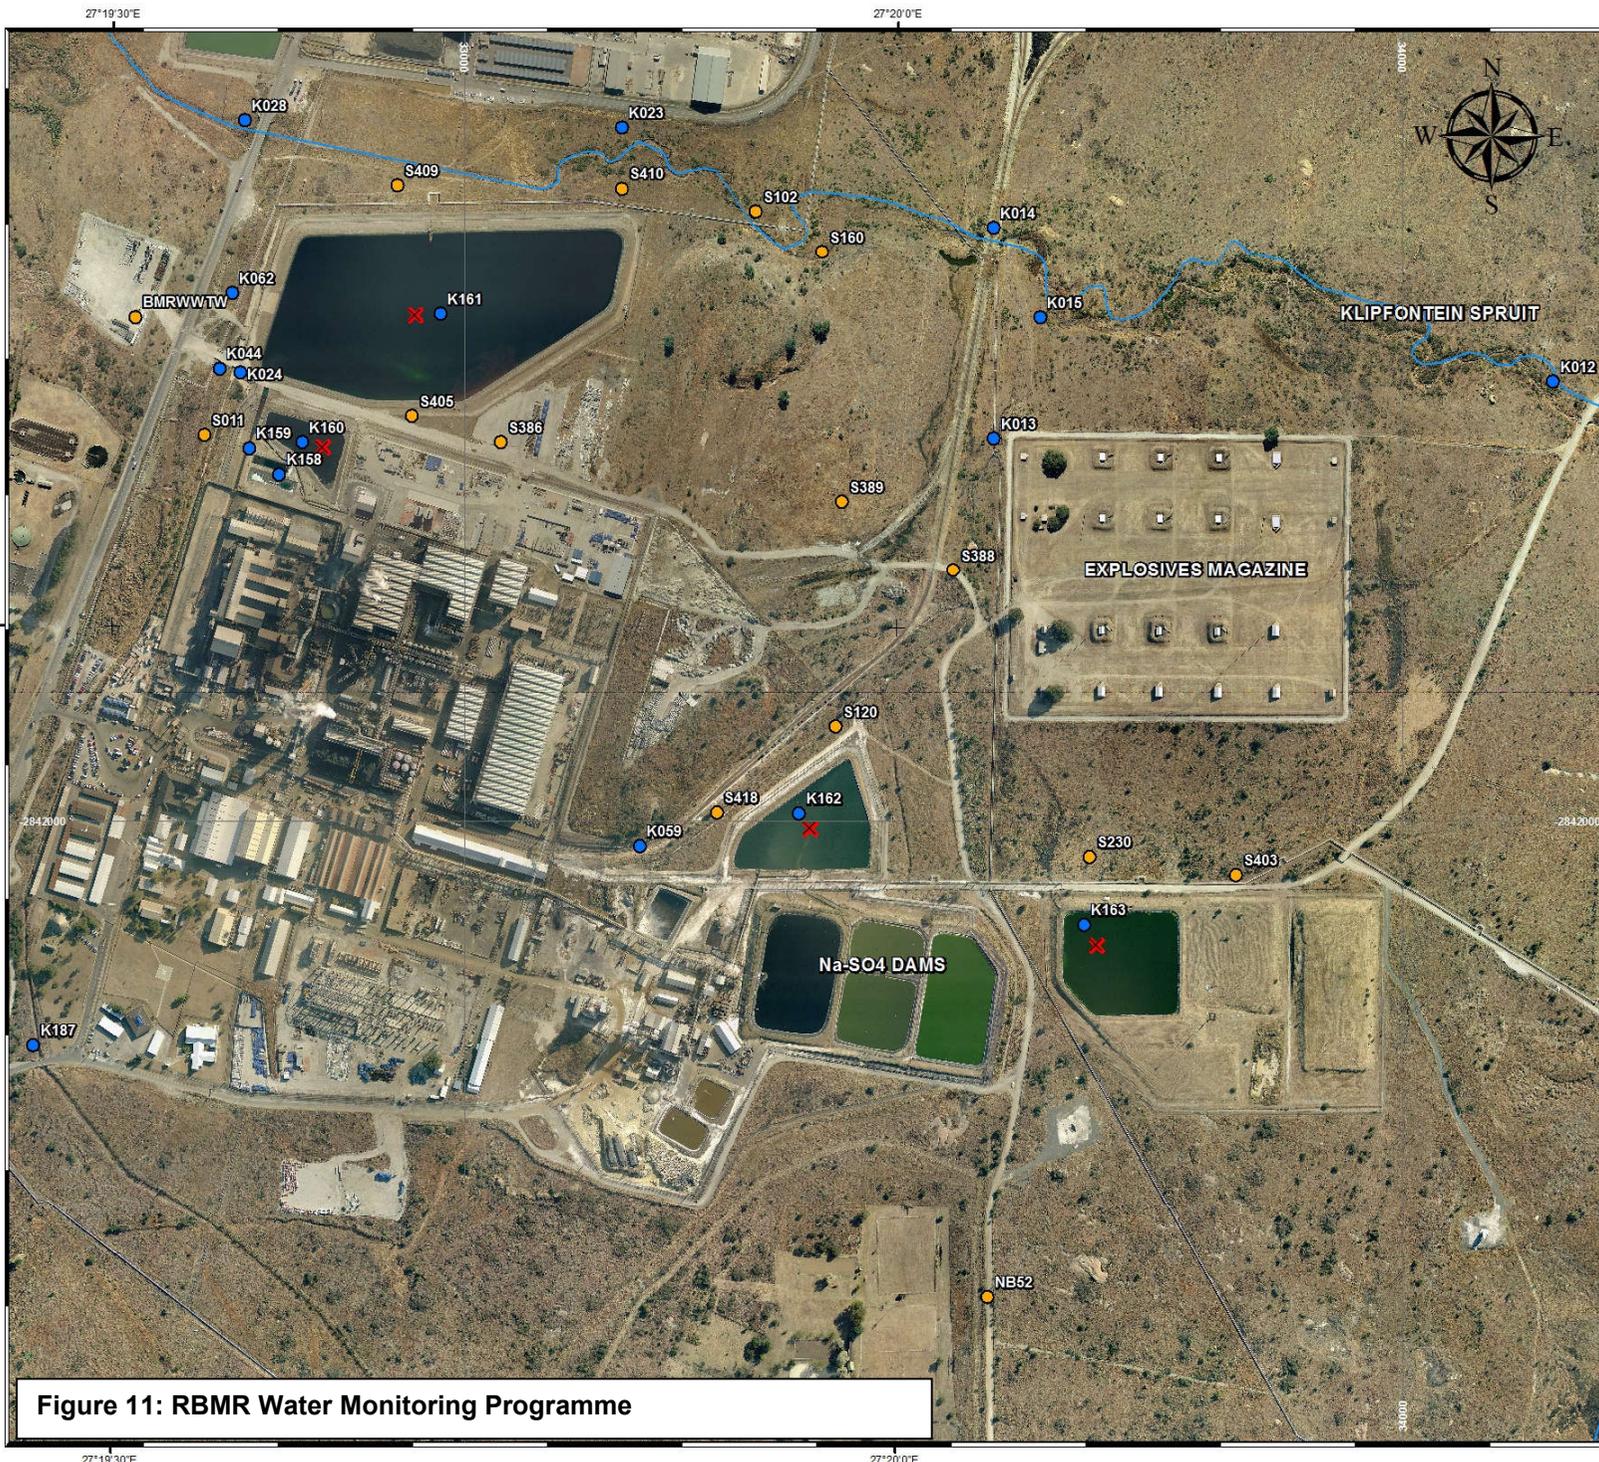
**Figure 11: RBMR Water Monitoring Programme**
