**Preliminary Feasibility Study Report for the East Residue
Storage Facility #6
at the Tronox Namakwa Sand EOFS Project**

PROJECT NUMBER 126-005 REPORT NO.1 EIA Rev 0 February 2021

Tronox Mineral Sands (Pty) LRD

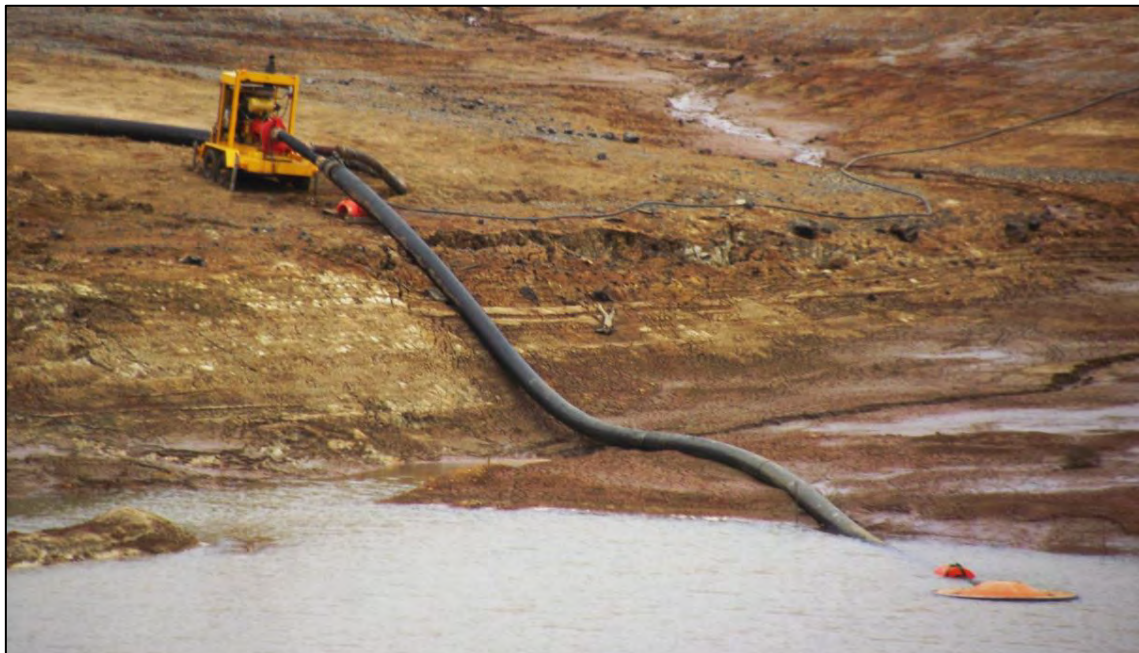
FIGURE 14-4: TURRET SYSTEM POSITIONED IN THE SUPERNATANT WATER CONNECTED TO AN EXTERNAL PUMP

Supernatant water from the RSF will be decanted and released by means of a floating pump system. The system is specially designed to operate in shallow water and cause minimal agitation of the settled residue. The system incorporates an external pump, which is positioned on the pool access ramp. The external pump is moved up the ramp as the residue level and supernatant pond level raises. The system has a floating inlet structure, known as the Turret (illustrated in Figure 14-4), which is placed in the supernatant pond and allows water to be extracted through the suction end without agitating or collecting the settled residue below the pond. Figure 14-5 illustrates how the turret extracts water from the pond. The manufacturer states that a single Turret can operate at flows up to 1 000 m³/hour, and is operable in ponds with depths not less than 400 mm. Based on this a minimum pool volume of 20 000m³ must be maintained on the RD at all times.
