# Hydrogeological Assessment for the proposed Newcastle Gas Energy Power Plant

Report Number 566508/GW

June 2021

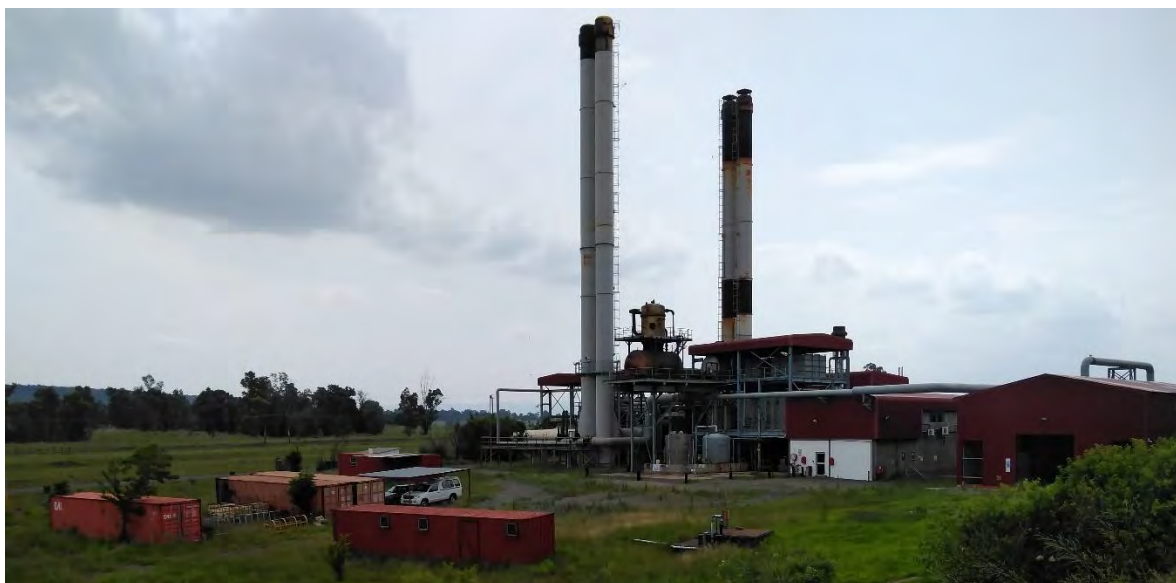
**Figure 3-1 Newcastle Energy, existing plant infrastructure**

The NGEPP Project site is situated adjacent the main gate of the Karbochem Industrial complex in Newcastle, northern KwaZulu-Natal. The Project site is within 2 km and to the south of the Newcastle Airport. It is bound by a wire fence with gated access from Karbochem Road and the proposed LNG facility is situated immediately east of the site within Karbochem complex. The current site infrastructure comprises a disused power plant and associated infrastructure (Figure 3-1).

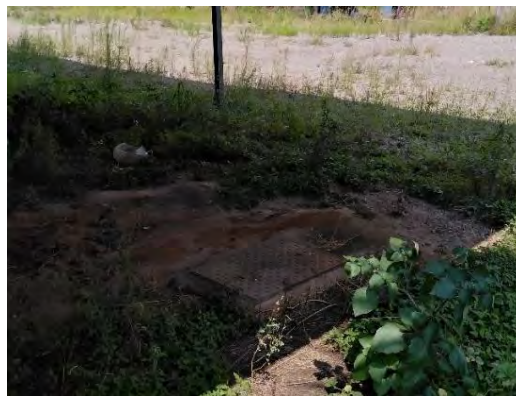
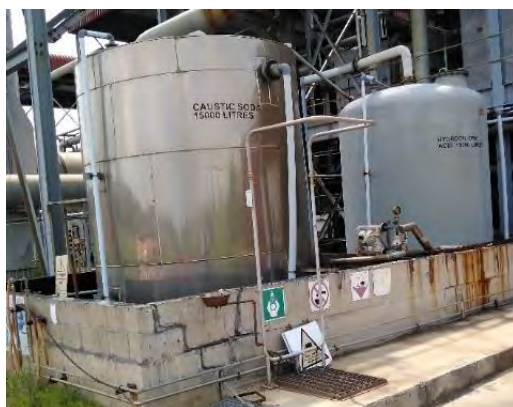
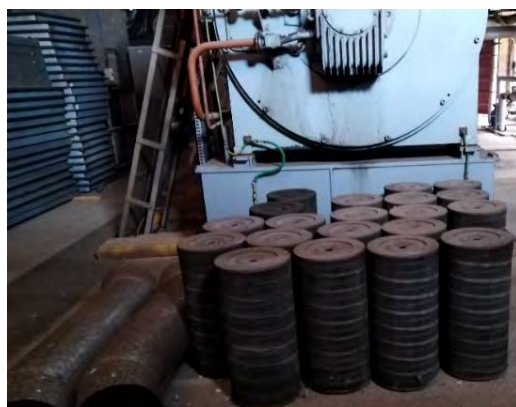
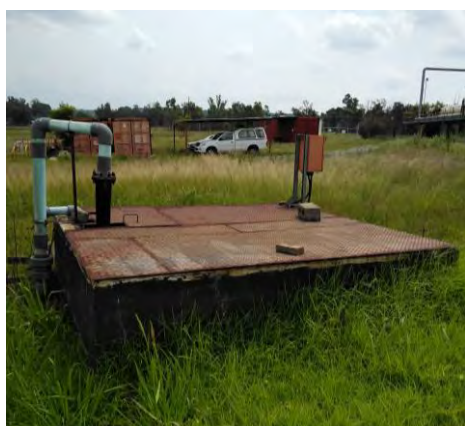
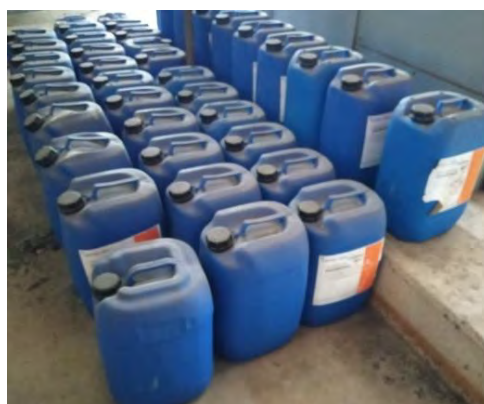
**Figure 3-2 Potential groundwater contamination sources**

The material stored onsite, including chemical storage tanks, chemical containers, filters, septic tank, and the effluent sump constitute the potential source of groundwater contamination (see Figure 3-2). However, the material identified as potential contaminants were either banded or stored on concrete hardstanding surface with no signs of spillages or leakages during the site visit. It is understood that these items will be responsibly disposed of before the construction of the new power plant.

Jet engines

Septic tank

Chemical (HCl and Caustic soda) storage Tanks

Used filters and drip trays

Effluent Sump

Stacked 25 L bottles and 250 L drums of Mono ethylene glycol

- The existing chemical storage tanks, effluent sump, chemical containers, septic tank, jet engines and filters constitute the potential sources of contamination. These potential contamination sources are either concrete lined with no signs of spillages or leakages observed. It is understood that these items will be removed before the construction of the new power station.

- The existing chemical storage tanks, chemical containers, filters, septic tank, and effluent sump constitute the potential source of groundwater contamination onsite. It is confirmed that the site infrastructure including current effluent sump is contaminating groundwater and surface water immediately downgradient. Contamination pathways and extent of contamination should be established to guide subsequent remediation process. It is however noted that all potential contamination sources will be removed before the construction of the new power plant.

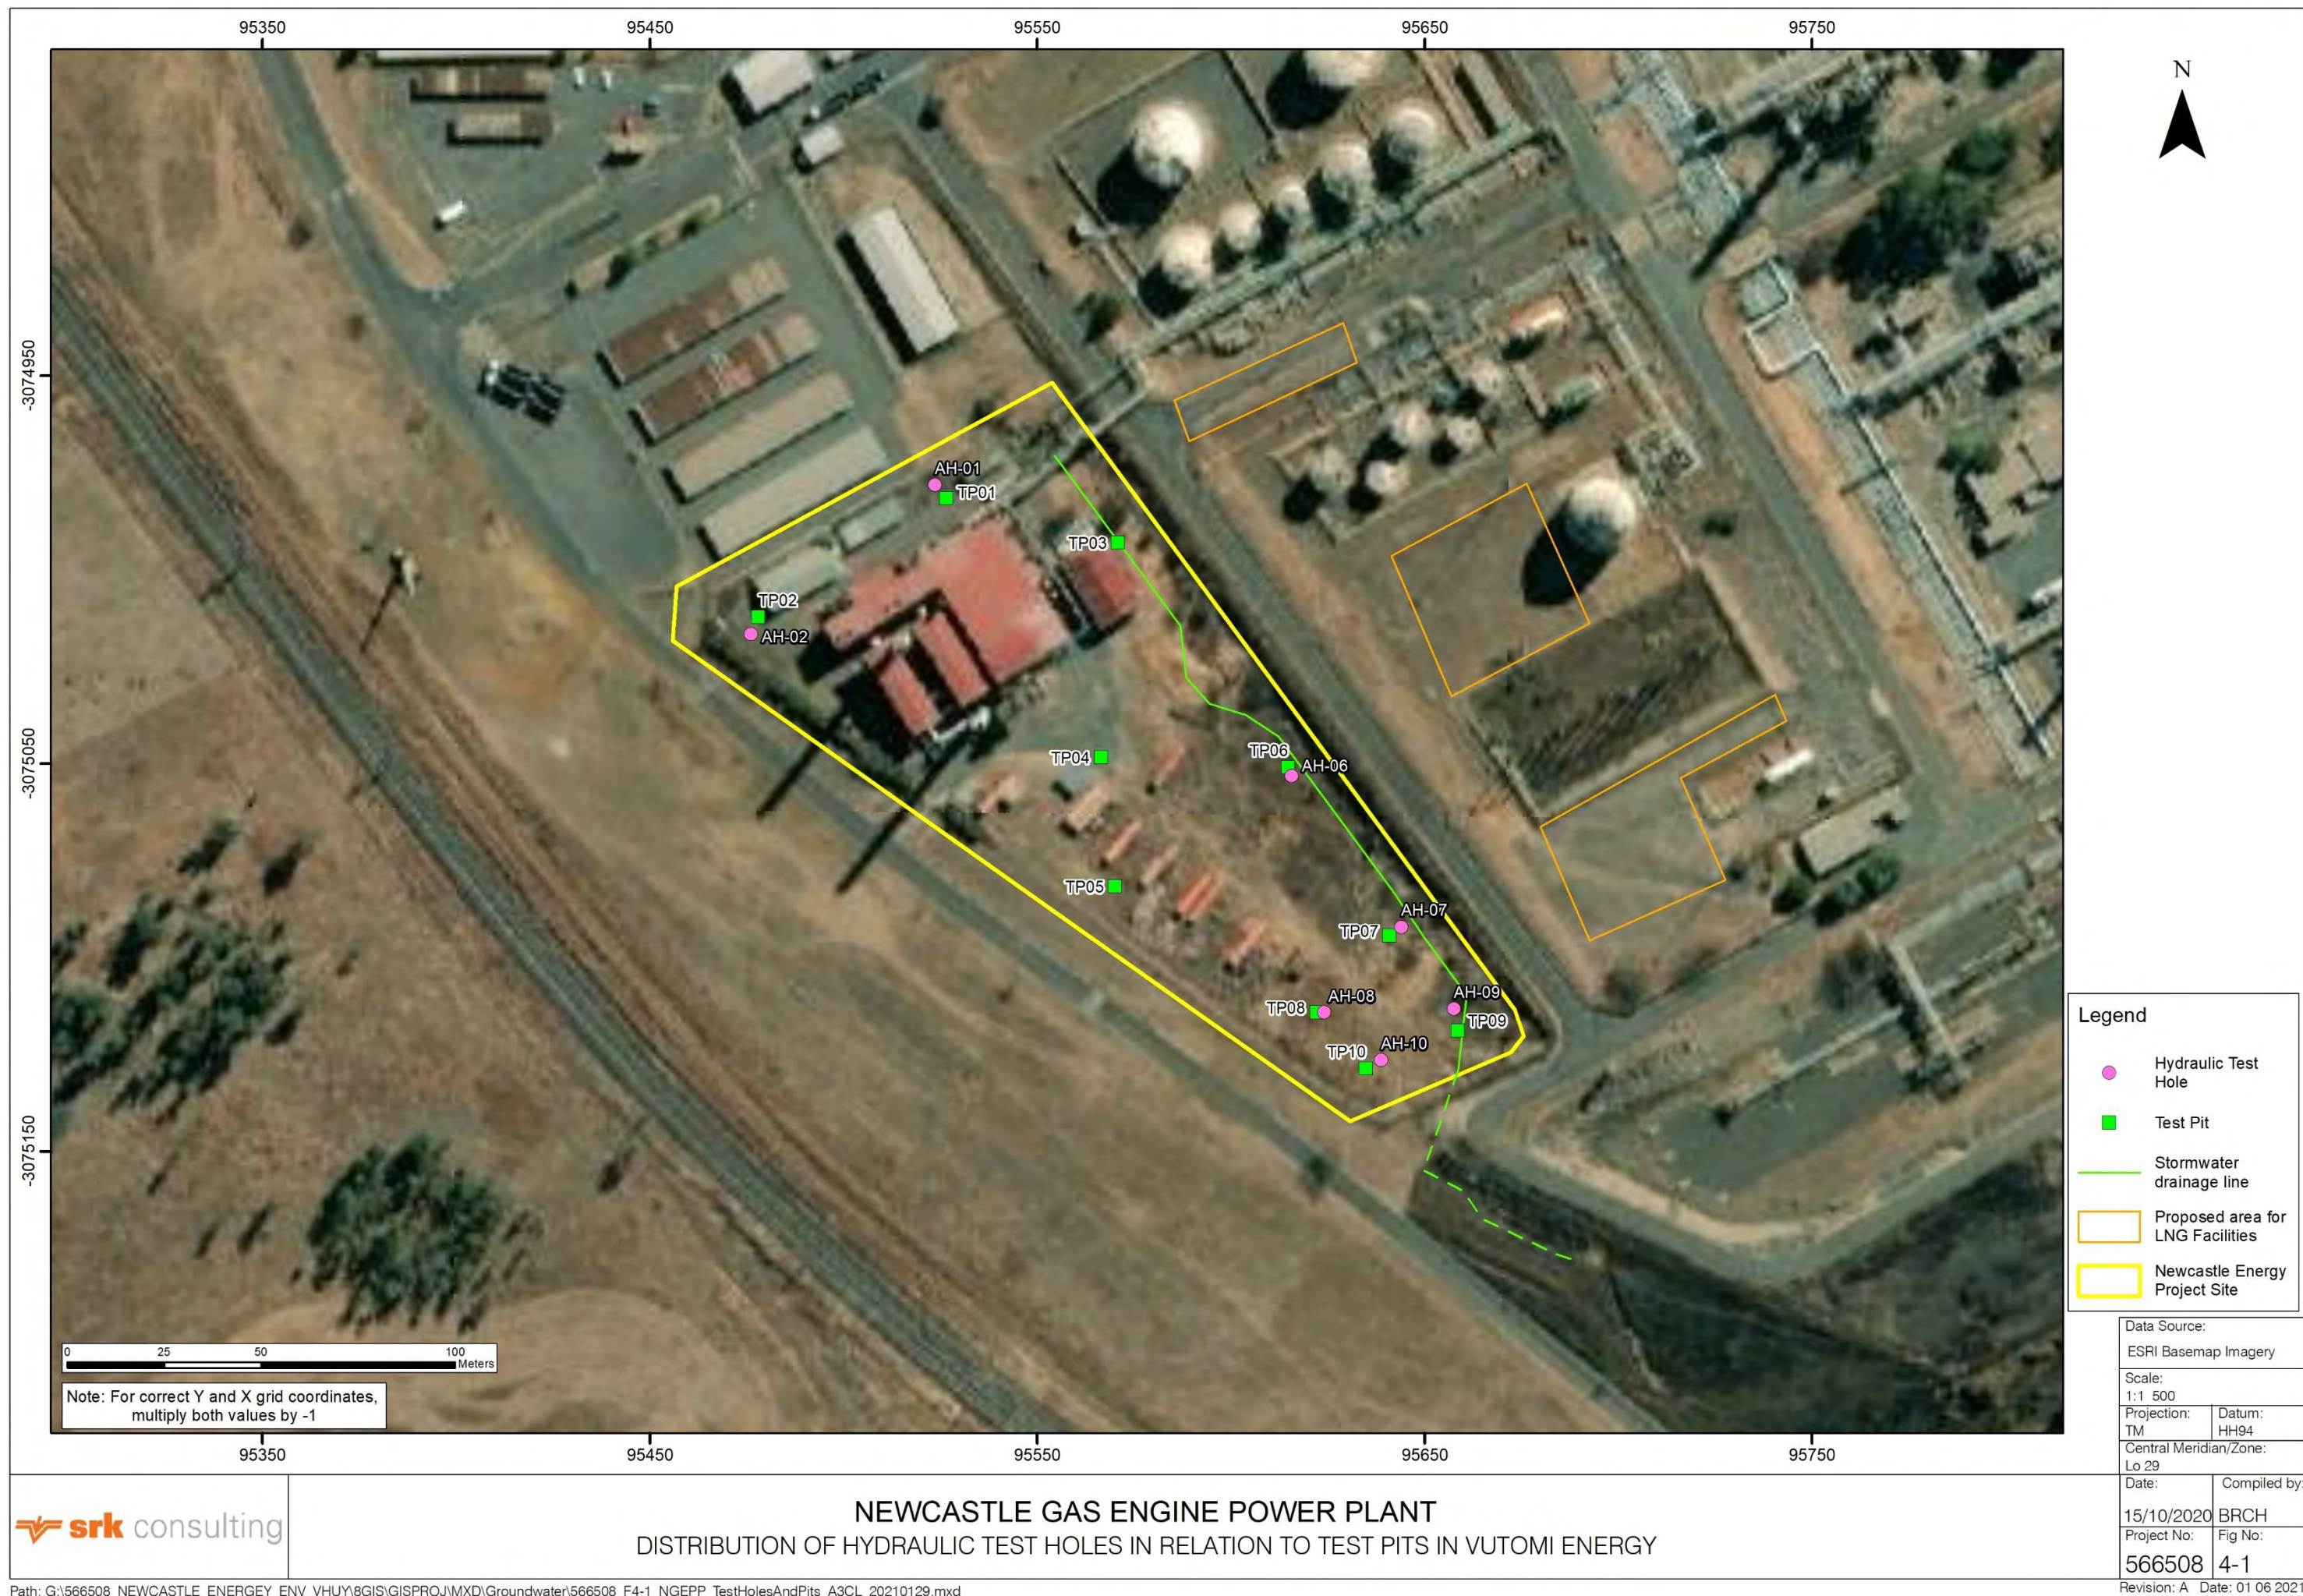
**Table 4-2 Summary of horizontal hydraulic conductivities of shallow aquifer material on site**

The permeability ranging from 0.5 to 0.036 m/d was calculated for the dry test holes. Seepage was recorded only from two test holes (AH-06 and AH07). The hydraulic conductivities of 0.14 and 0.0413 m/d was calculated for AH-06 and AH-07 respectively and is representative of the shallow aquifer in the area, Table 4-2. The large horizontal permeability range was also reported from the Karbochem shallow aquifer monitoring boreholes, and implies that within the fill and shallow aquifer material, groundwater would flow over a distance of at least 5 m to 51 m in a year, (See Table 4-2, after Bohlweki 1996). However slightly lower permeabilities are expected in areas where residual shale (clay/silty clay) dominate.

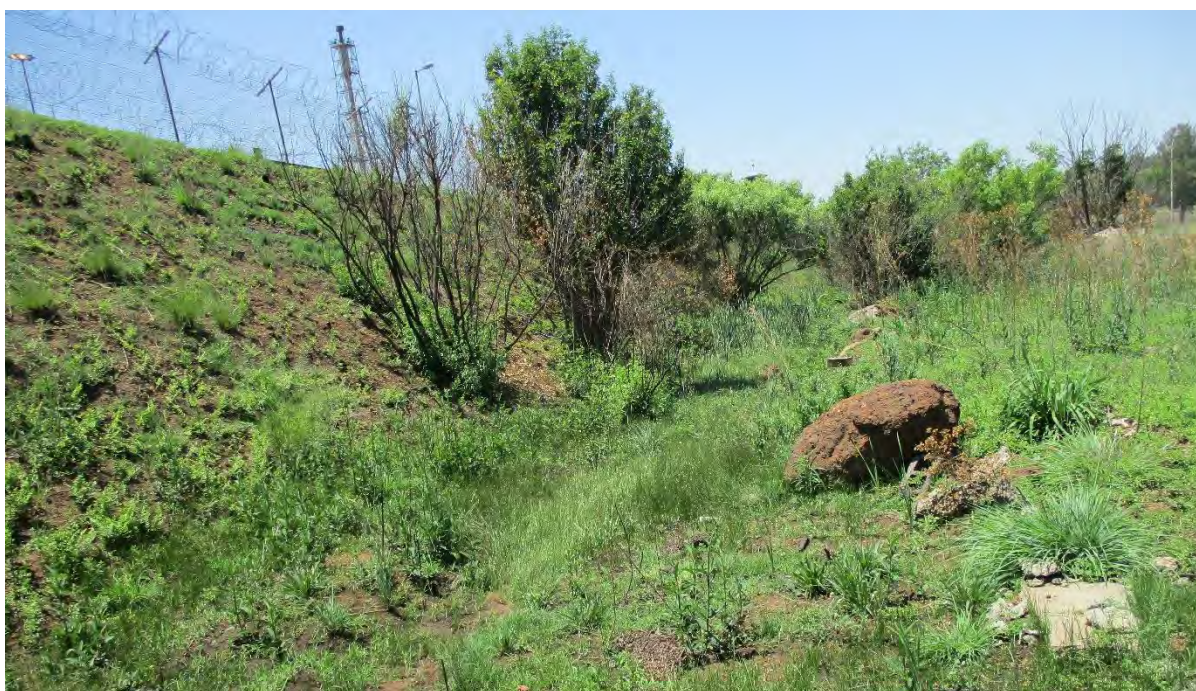
Figure 4-4 Stormwater drainage channel during dry season

During the dry season, flow in the stormwater drainage will cease (see Figure 4-4). The perched shallow groundwater occurrence condition around AH-06 and AH-07 is therefore likely to be seasonal and may not occur during dry season (when there is no rainfall recharge). Therefore, through effective management of stormwater in the area, this will eliminate shallow perched groundwater condition and may allow for the safe construction of the NGEPP to take place without extensive dewatering.

This study confirmed the shallow groundwater occurrence (seepage) in the vicinity of AH-06 (0.34 mbgl) and AH-07 (0.81 mbgl). These two holes are approximately 50m apart along the NW-SE orientated unlined stormwater drainage channel and the eastern boundary fence. Shallow groundwater was not recorded in any other Test holes and Test pits (including TP08, TP09 and TP10 which are downgradient of AH-07, and are excavated deeper than test holes to 4.3, 4.1 and 4m respectively). This may suggest some infiltration of stormwater to shallow groundwater resource in the vicinity of AH06 and AH-07 during rainfall period.

Significant amount of water drains from the Parking at the Karbochem main security gate and office buildings upgradient through the stormwater drainage during rainfall. The clean stormwater from offsite and from the roof must be collected, attenuated and piped/released downgradient of the site.
