**ASSESSMENT OF THE VEGETATION OF THE PROPOSED HEKPOORT-
CASHAN SUBSTATION AND POWERLINE SERVITUDE**

October 2013, Revised April 2014

Final October 2014

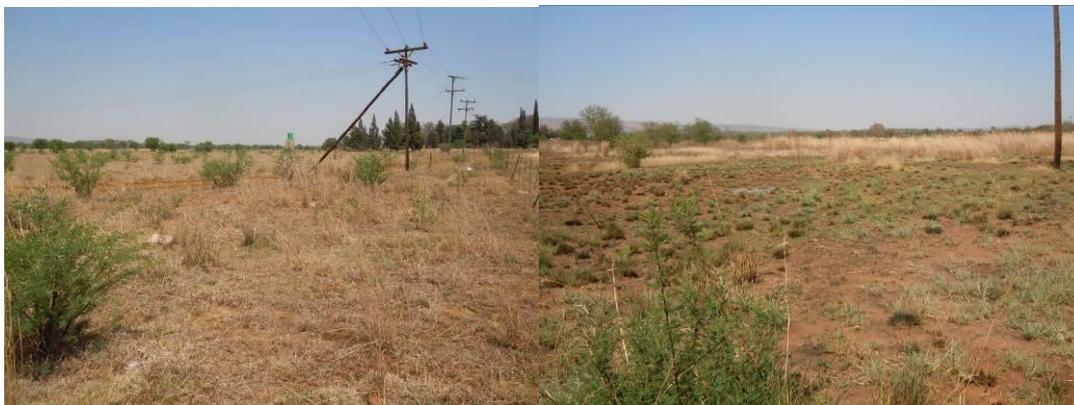
Figure 6: The Old fields with recovered secondary vegetation. Note the small *Vachellia karroo* shrubs

These patches of secondary grassland are quite widespread over both the transect routes. The conservation value and sensitivity in general are regarded as Low. The power lines can be supported in these habitats.

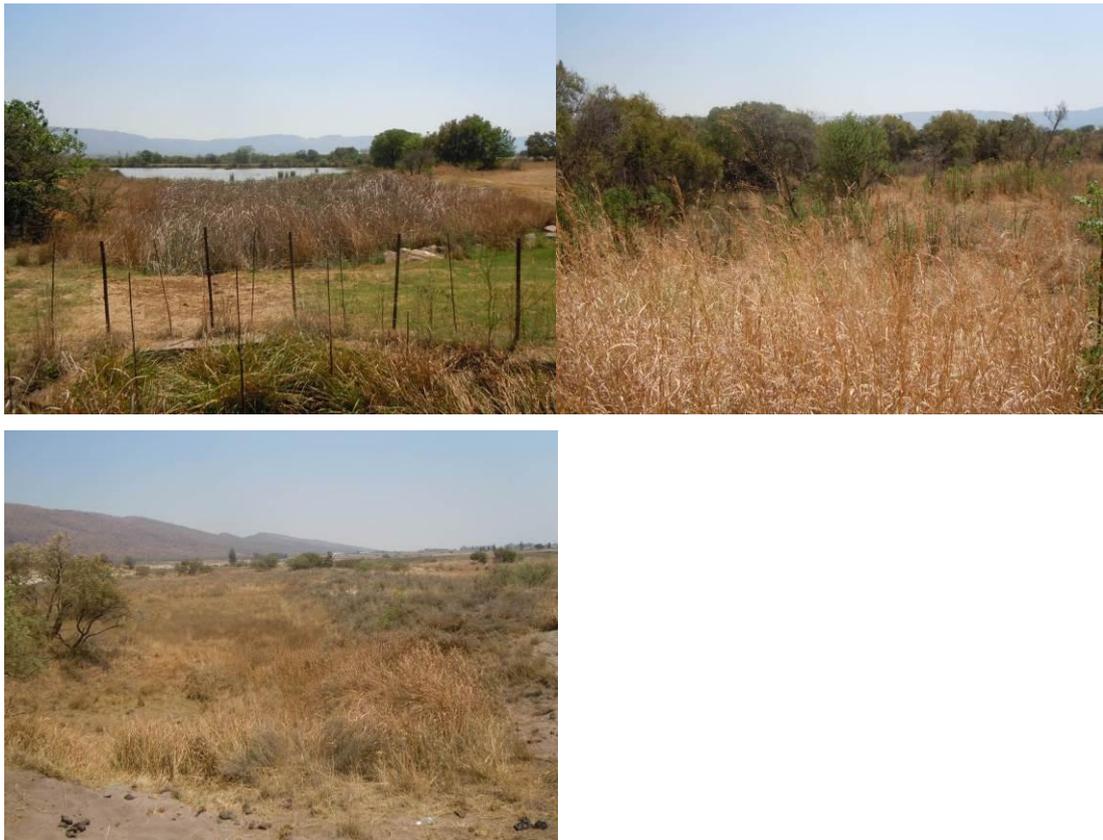
Figure 7: A collage of spruits close to spruit crossings: Top left:- the dam at spruit 1.2; top right:- dense bush at spruit crossing 1.3 and 2.3; bottom left:- the degraded spruit at 1.4 with *Stoebe vulgaris* on the banks.

The second spruit crossing just east of the first is at approximately 25° 52' 35.9" S; 27° 38' 06.2" E. Here the power line will cross the spruit close to a dam, the vegetation being mainly *Typha capensis*. On the banks of the river the alien *Pyracantha angustifolia* and *Morus alba* were found. These alien trees should be removed as they infest the rivers. On the sides of the river the grass was mowed, containing mainly *Eragrostis curvula* and *Cynodon dactylon*. Other herbaceous species present are *Plantago lanceolata* and *Oenothera rosea*. Just north-east of the spruit crossing is an alley (remains) of indigenous trees of *Searsia lancea* and *Combretum erythrophyllum*.

- **1.4** At the spruit crossing close to the Hekpoort substation at approximately 25° 51' 33.6" S; 27 40 53.3 E. The power line will cross the spruit just above a small dam. This spruit is highly disturbed; it is close to the Hekpoort substation and had been highly affected by the sand mining activities in this area. The river banks are covered with *Stoebe vulgaris*. Locally in wetter areas *Typha capensis*, *Phragmites australis*, *Paspalum dilatatum*, and *Imperata cylindrica* are found. Woody species on the banks include the indigenous *Searsia lancea*, *Searsia pyroides* and the alien *Melia azedarach*.

As they form part of the drainage system, all rivers and spruits are regarded as ecologically sensitive. The lines will, however, easily span across the spruits, and will not affect the vegetation of the banks negatively. At some crossings dense bush occur on the river banks – the bush will have to be cleared here. Care should be taken to avoid damage to the streams and stream banks. The pylons should be located far enough from the banks to avoid damage. Any damage caused to the spruits and spruit banks by the construction, should immediately be rehabilitated.

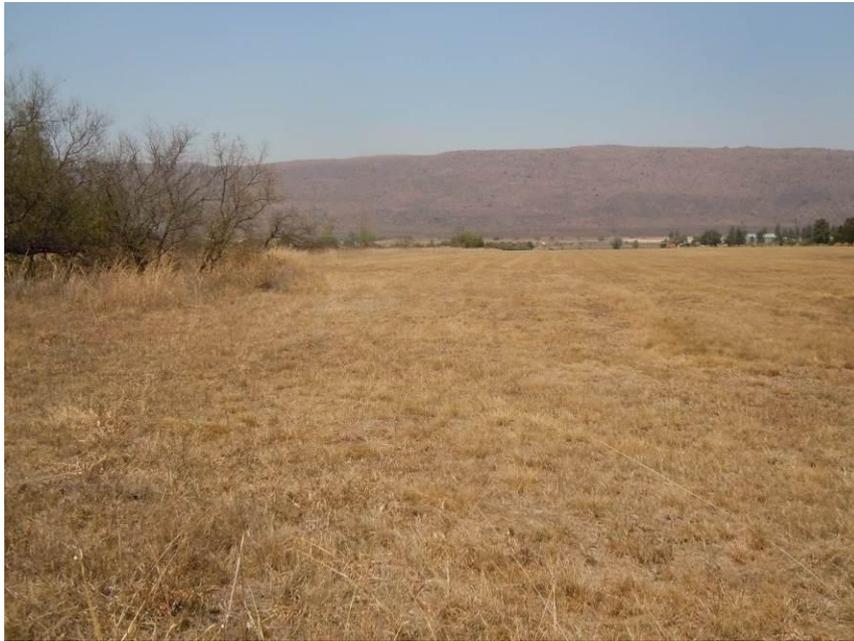
Figure 8: Old field with mowed grass

These areas seem to represent old fields some of which have been transformed to planted pasture where the grass is regularly mowed. The chicken farm is also in this area. Plant species richness is very low, with *Eragrostis curvula* prominent.

This is transformed area with low species richness and low sensitivity. The power lines can be supported.

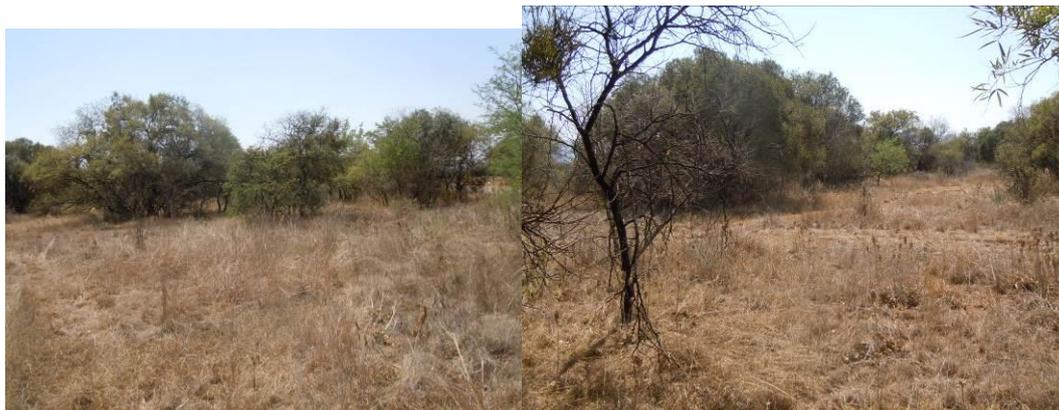
Figure 9: The dense bush

Dense woody vegetation occurs in the vicinity of spruit crossings 1.1, 1.2, 2.1 and 2.2 (Fig. 4). However, the herbaceous vegetation is in a disturbed and degraded condition. The most prominent woody species are *Vachellia karroo*, *Euclea natalensis*, *Searsia lancea* and *Vachellia robusta* (Fig. 9).

This dense bush is disturbed with low species richness and Medium sensitivity. Although some of the bush will have to be removed for the construction, the power lines can be supported.
