APPLICATION FORM NOTIFICATION OF INTENT TO DEVELOP SECTION 38 (1) AND SECTION 38 (8)

Name of property: Tronox Namakwa Sands Mine	
Street address or location (eg: off R44):	
Erf or farm number/s: farms: Rietfontein Extension, 151, Portion 1 Rietfontein Extension, 151, Remaining Extent Houtkraal 143, Portion 5 Hartebeeste Kom 156, Portion 1 Hartebeeste Kom 156, Portion 2 Graauwduinen 152, Remainder of Portion 1	Coordinates: \$31.24873 E17.934288 (A logical centre point. Format based on WG\$84.)
Town or District: Koekenaap, Vredendal	Municipality: Vredendal
Extent of property: Approx 3000 HA	Current use: Mining

The current project is a new EIA process for modifications to the project description. This will involve the demolition of the structures identified and graded in 2006 and the "East Mine House", as well as the construction of a 22 KV power line which lies entirely within the mining area (previously assessed and approved for mining). Aside from the structures all the surrounding areas have now been mined.

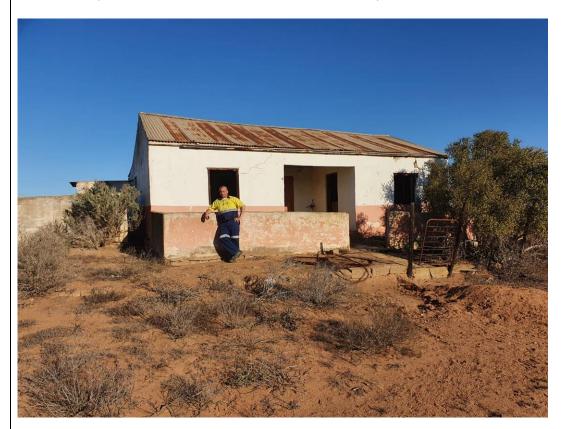
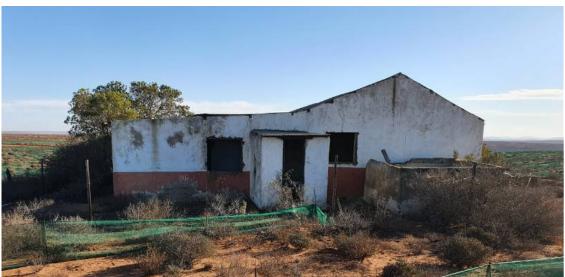
Figure 3 Two views of structure HK 12.

Description: This structure is a cottage most likely dating to the 1930's. It is in relatively poor condition due to a lack of maintenance. The house was built in two stages with the rear rooms and *stoep* having been added to the front, pitched roof section. The overall plan is roughly square with seven rooms, two stoeps and an external hearth. A tiny store room has been added to the left-hand side and a separate water tank is also located on the left side. The presence of older, non-residential structures nearby

suggests that an older house ruin may be present in the area.

Just in front of the house is a separate small ruin. All that remains of this is the stone foundation and cement floor at ground level.

Comments: The ruins of two other structures (HK13 & HK14) are located very nearby. Due to the poor condition of all structures the complex is not conservation worthy.

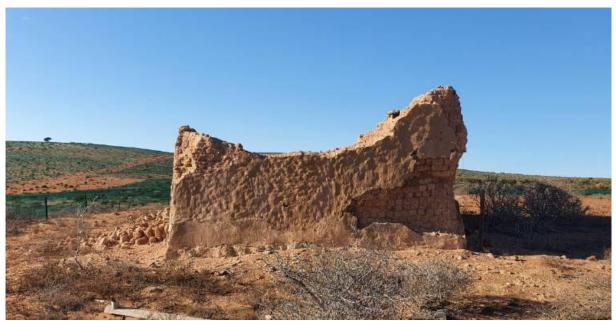
Figure 4 Standing walling of single room building at HK 13

Description: This structure is older than the cottage, probably dating from the 19th century. It is a one-roomed structure made from mud bricks. The roof is missing and the bricks are eroding rapidly. Plaster still clings to some of the outer wall surfaces. The structure is assumed to have been an outbuilding of the farm.

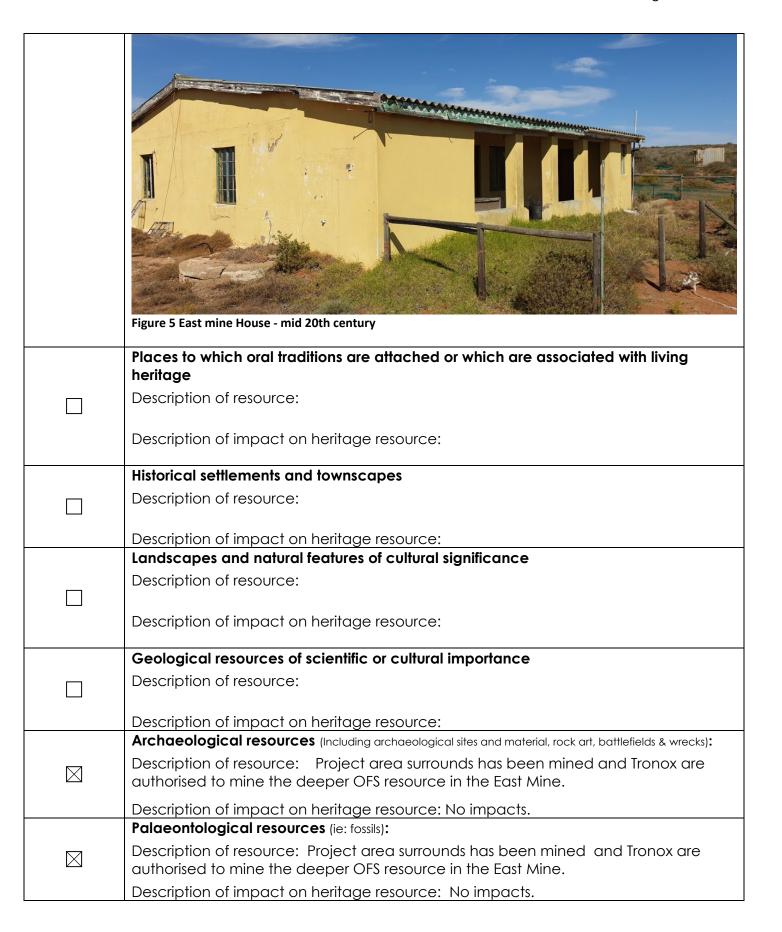
Description: This single-story bungalow situated on Farm Rietfontein extension 151 is built from 20th century material. The farm itself was first granted in 1880 and finally approved in 1926. The use of concrete and standard brick and cement throughout the house, the fibre-board ceilings and steel framed windows, a mid-20th century date of construction is suggested. The building, although at one time used as a temporary mine facility has been abandoned for many years.

The structure is not considered conservation-worthy.
