**ECOLOGICAL ASSESSMENT AND REHABILITATION PLAN
FOR THE PROPOSED UPGRADE OF BRIDGE STRUCTURES
TRAVERSING THE SKOENMAKERS RIVER NEAR
SOMERSET EAST IN THE EASTERN CAPE**

October 2014

Prepared by: Scientific Aquatic Services
Report authors: L. Zdanow (BSC Hons)
M. Hanekom
D. Crafford (Pr. Sci. Nat)
Report Reviewer S. van Staden (Pr. Sci. Nat.)
Report Reference: SAS 214121
Date: September 2014

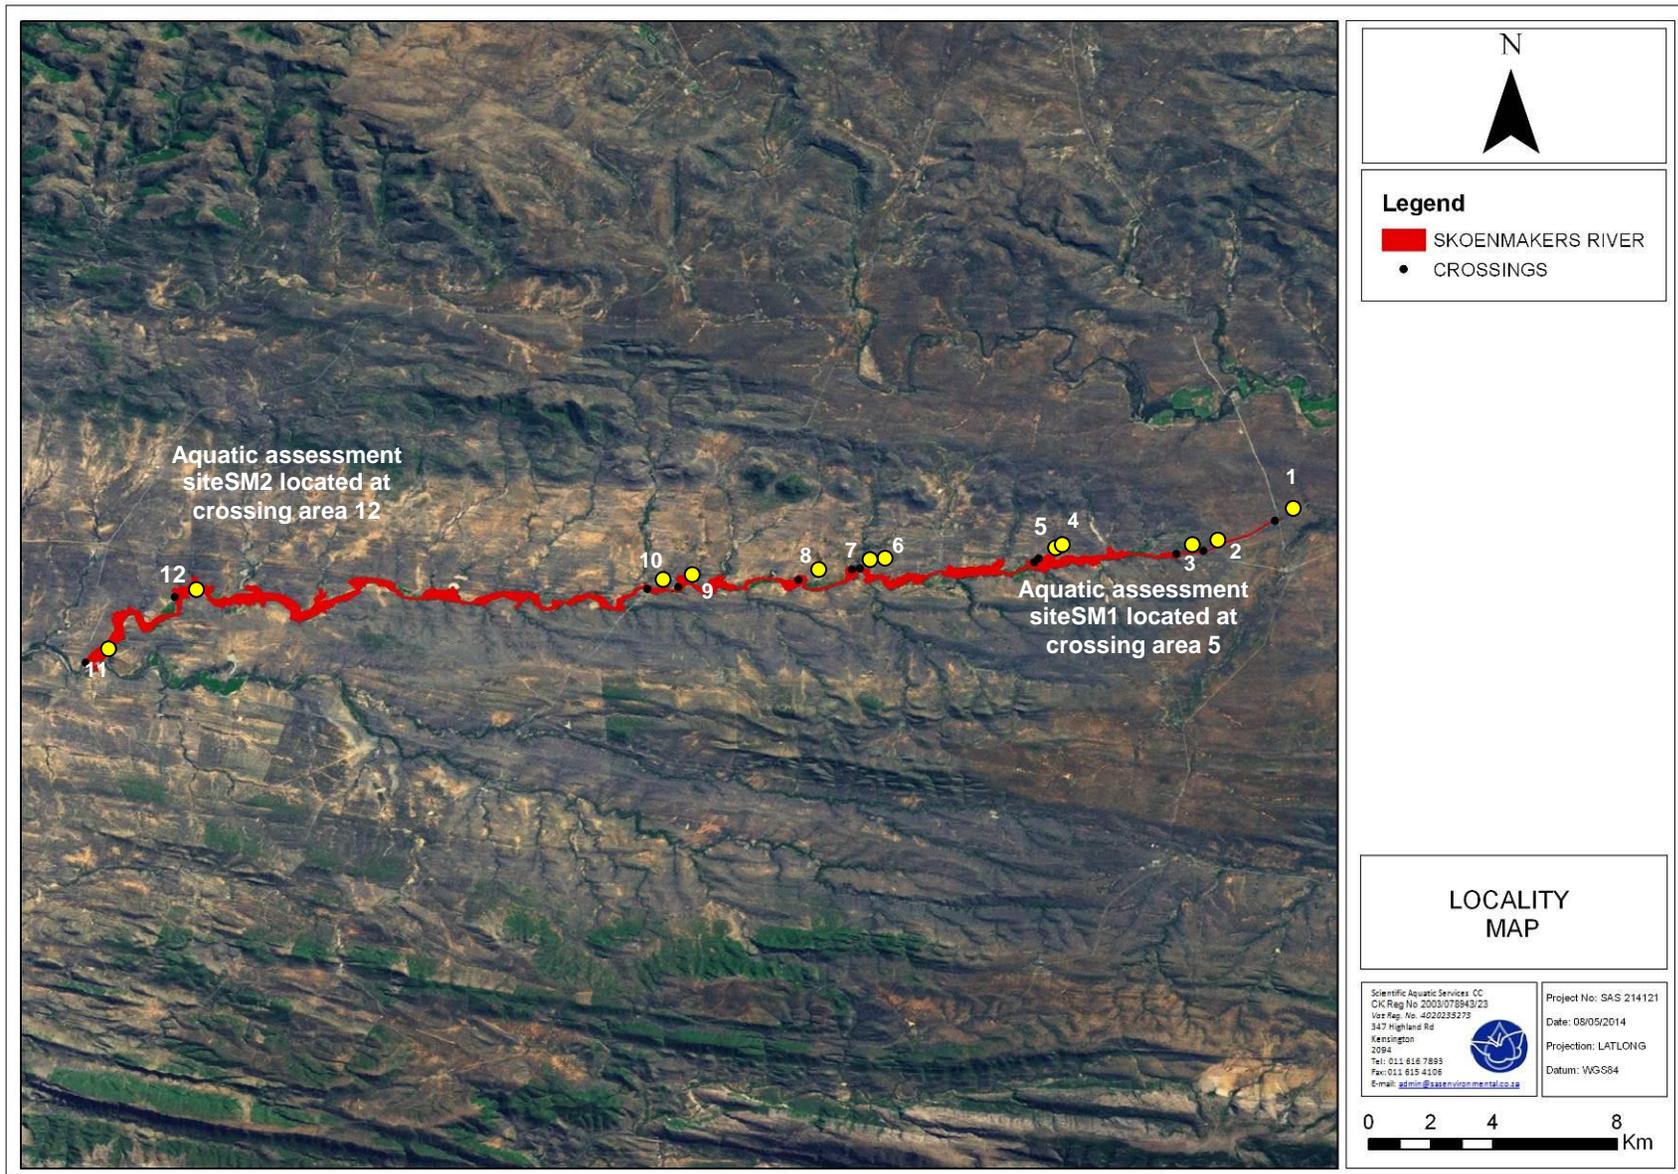
Figure 1: Digital satellite image depicting the location of the Skoenmakers River with associated crossing areas (1 to 12) and aquatic assessment sites SM1 and SM2(crossing areas 5 and 12 respectively).

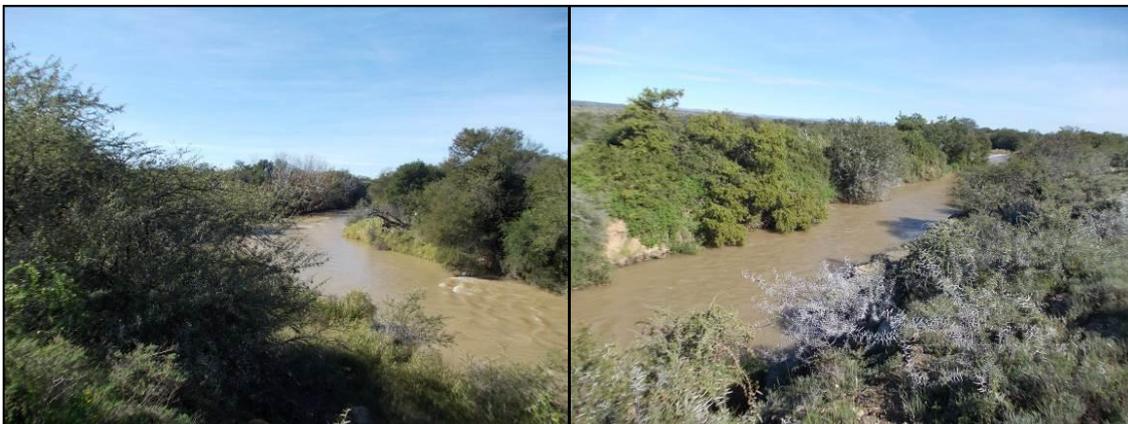
The majority of the Skoenmakers River can be defined as a riparian system due to the presence of alluvial soil as well as the presence of vegetation with a composition and physical structure distinct from adjacent areas. A distinctive change in vegetation abundance as well as diversity was noted in the lower and upper zones of the riparian habitat compared to the surrounding terrestrial zones. The woody vegetation component increased significantly within these areas when compared to surrounding terrestrial areas. The riparian habitat of the river is characterised by the dominance of tree and shrub species including *Acacia karroo*, *Lycium spp*, *Searsia lancea*, *Searsia longispina* and *Azima tetraantha*. The obligate wetland/riparian species *Phragmites australis*, *Typha capensis*, *Juncus sp.*, *Cyperus textilis*, *Cyperus esculentus*, *Cyperus dives* and *Cyperus rotundus* were also encountered in more sheltered areas within the active channel of the river.

Figure 9: Riparian areas associated with the Skoenmakers River

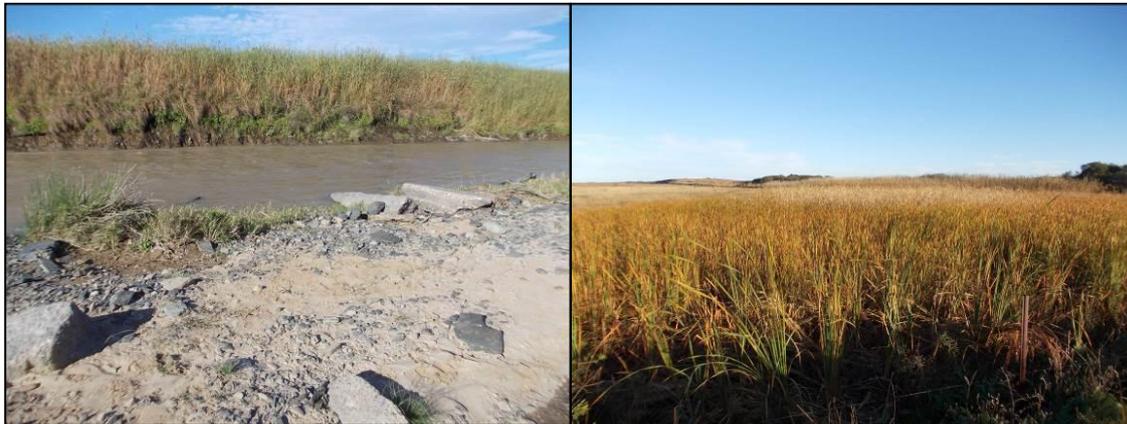
Although the majority of the Skoenmakers River is classified as a riparian system, small, isolated wetland areas are associated with the system. These wetland areas include seep wetlands, channelled valley bottom features and artificial depressions and are characterised by the presence of obligate wetland species such as *Typha capensis*, *Phragmites australis* and *Cyperus rotundus* (refer to Figures 6, 7 and 8 for an indication of the localities of wetland areas).

The majority of the wetland features are located within the riparian habitat, however, two seep wetlands, an artificial seep located to the south of site 1 and a natural seep located to the north west of site 11, are located outside of the riparian habitat.

Figure 10: Wetlands associated with the Skoenmakers River

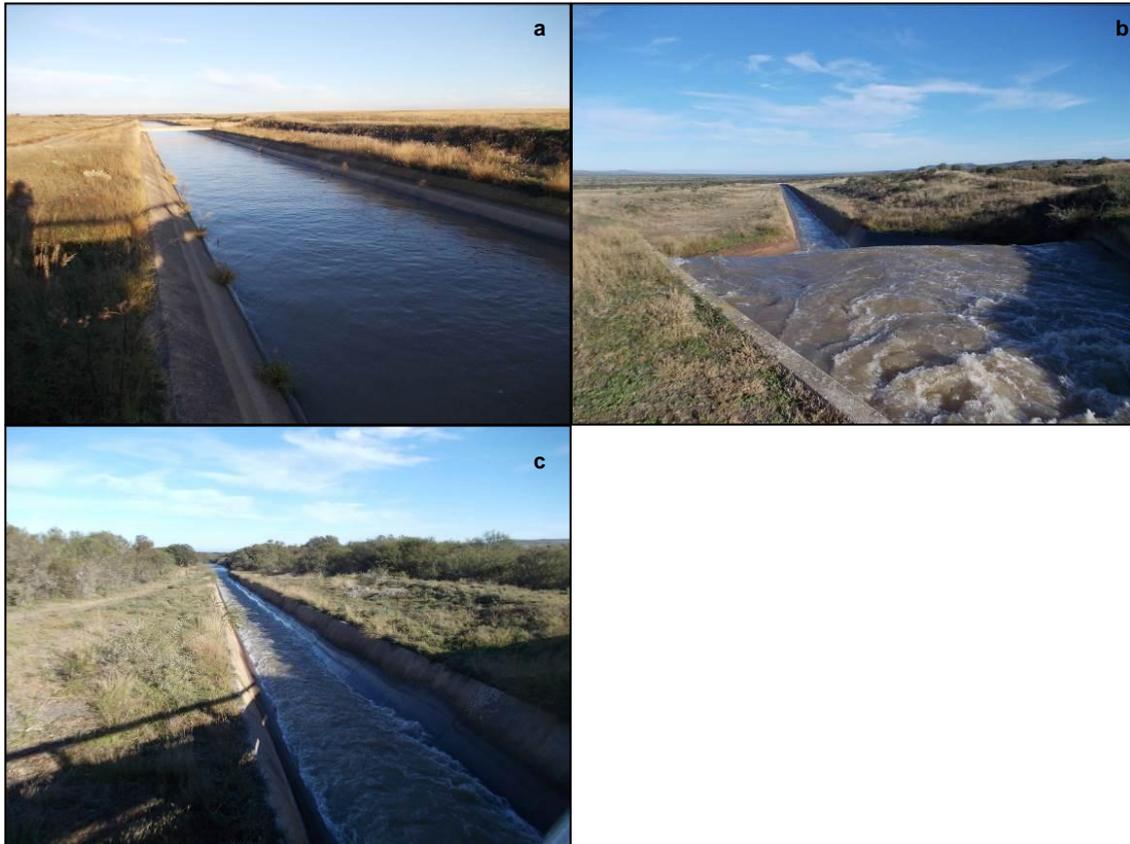
Sites 1, 2 and 3 are located within the interbasin transfer scheme. The interbasin transfer consists of an artificial concrete canal in which water is conveyed. Water does not appear to overtop the banks of this canal and vegetation surrounding the canal has been significantly degraded. A wetland area is however located to the south of site 1.

This wetland appears to have been created as a result of the seepage of water into the area from a leaking artificial canal and was characterised by the dominance of the obligate wetland species *Phragmites australis* and *Typha capensis*.

Site 3 is located just east of the boundary of the natural river system and is characterised by the emergence of riparian vegetation.

Figure 11: Site 1 (a), site 2 (b) and site 3 (c)

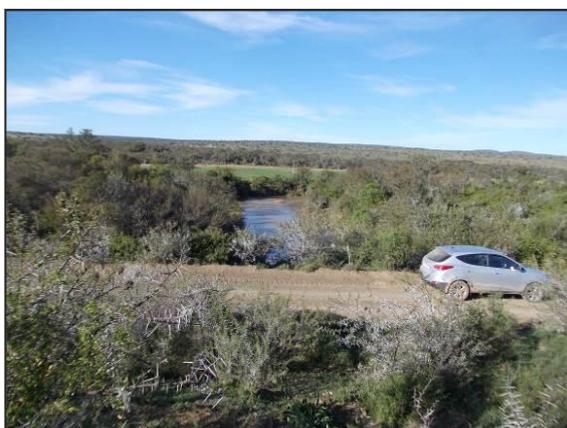
Site 4 is located on an existing gravel road which traverses riparian habitat. Disturbance to surrounding riparian habitat as a result of this gravel road appears to be minimal.

Figure 12: Site 4

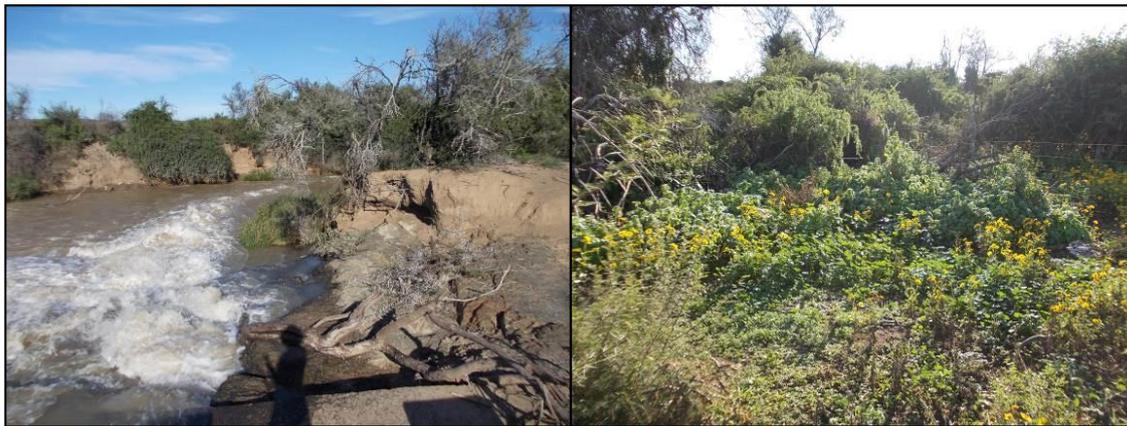
Site 5 is associated with an existing bridge structure which traverses the Skoenmakers River. The existing bridge structure has resulted in the obstruction of flow through the river and has caused ponding in upstream areas and erosion and incision in downstream areas. Vegetation associated with this crossing has been significantly disturbed and alien and invasive species including *Verbesina encelioides*, *Opuntia ficus-indica* and *Pennisetum clandestinum* have encroached into areas in the immediate vicinity of the bridge. Riparian habitat located to the east of the crossing has also been removed to make way for cultivation activities.

Figure 13: Incision and erosion downstream of the crossing (left) and alien and invasive vegetation encroachment (right).

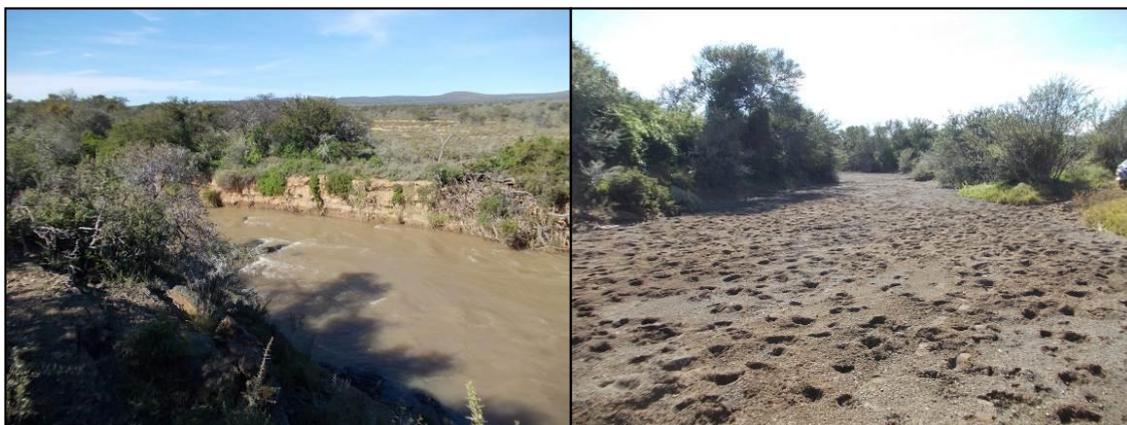
No bridge structures are currently present at **site 6 or 7**. The active channel of the river portion associated with site 6 has been significantly eroded and is characterised by steeply incised banks to either side of the river. Site 7 is located within the dry, sandy bed of a tributary which enters into the Skoenmakers River. Riparian habitat associated with this crossing point appears to be largely intact with exception of the existing gravel road which traverses the area.

Figure 14: Eroded and incised banks associated with site 6 (left) and dry, sandy tributary associated with site 7 (right).

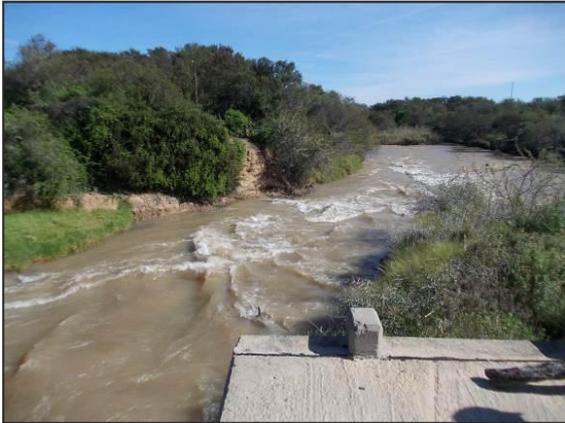
Site 8 is associated with an existing bridge structure which has been damaged as a result of the force of increased water velocities moving through the system and the southern portion of the bridge has been completely washed away.

The development of the bridge structure has resulted in an increase in the turbulence of water moving through the system which has caused the erosion and incision of downstream areas. Furthermore, areas of sediment accumulation within the active channel downstream of the bridge structure were also noted.

Figure 15: Turbulent flow and incised river banks associated with site 8

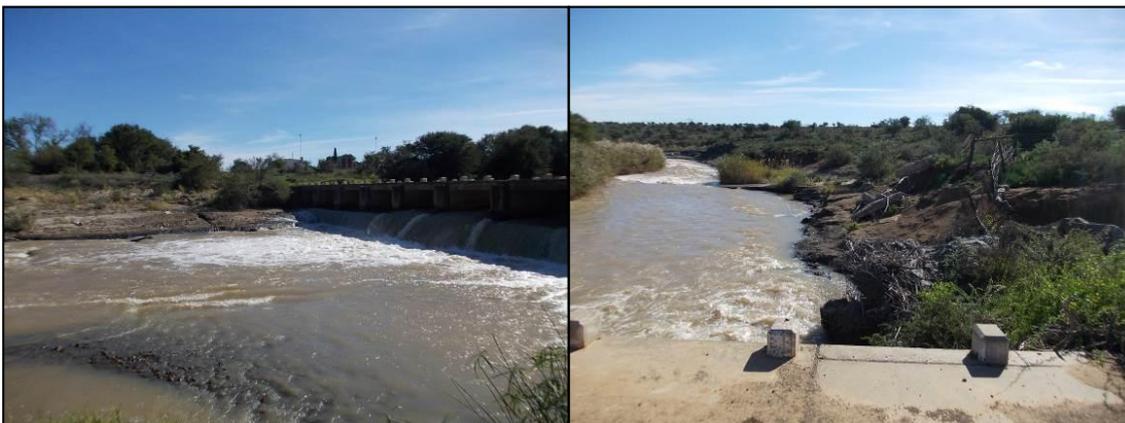
Sites 9 and 10 are associated with existing bridge structures. Both bridge structures have resulted in upstream ponding and downstream erosion and incision within the system. Site 9 is located in close proximity to an agricultural small holding and agricultural fields and the associated disturbance has resulted in the encroachment of alien invasive species such as *Tagetes minuta*, *Pennisetum setaceum*, *Solanum* sp, and *Pennisetum clandestinum*.

Figure 16: Turbulent flow, erosion and incision associated with sites 9 (left) and 10 (right).

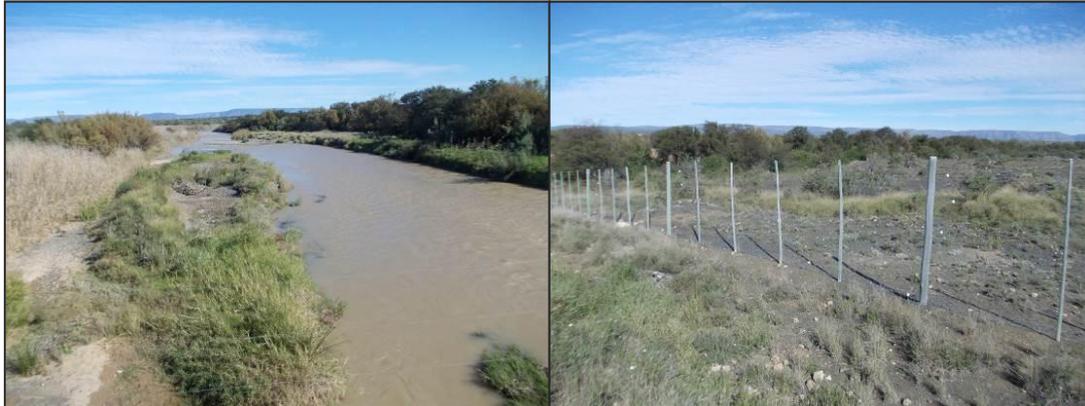
Site 11 is associated with an existing bridge structure which was developed as part of the R400 roadway. This site lies adjacent to the boundary of the Addo Elephant National Park. The erosion and incision of the river banks associated with this structure is not as severe as that associated with the other bridge structures assessed.

However, downstream sedimentation within the active channel was noted. An additional seep wetland feature also drains into the river to the north west of the crossing.

Figure 17: Less incised river banks associated with site 11 (left) and seep wetland entering into the riparian area from the north west (right).

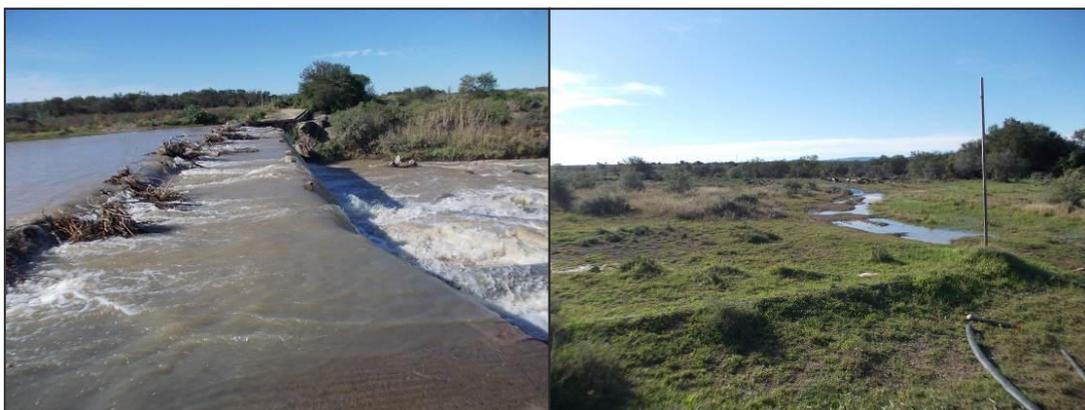
Site 12 is associated with an existing bridge structure which has been partially washed away by the river. The concrete pipes beneath the bridge have been completely blocked by debris and sediment which has caused ponding and flooding upstream of the crossing and has resulted in water flowing over the bridge instead of below it. The movement of water over the bridge has resulted in turbulent flow and in significant erosion and incision directly downstream of the bridge.

The riparian area located to the west of the crossing point has been significantly disturbed as a result of anthropogenic and agricultural activities. Furthermore, a leak in an artificial dam located to the west of the riparian area has resulted in the seepage of water through the area. However, the majority of surface water flows along existing gravel roads and other areas of surface water do not appear to have been present for a sufficient period of time to allow for the formation of wetland soils and the creation of wetland conditions.

Figure 18: Degraded, flooded bridge structure associated with site 12 (left) and seepage from dam (right).

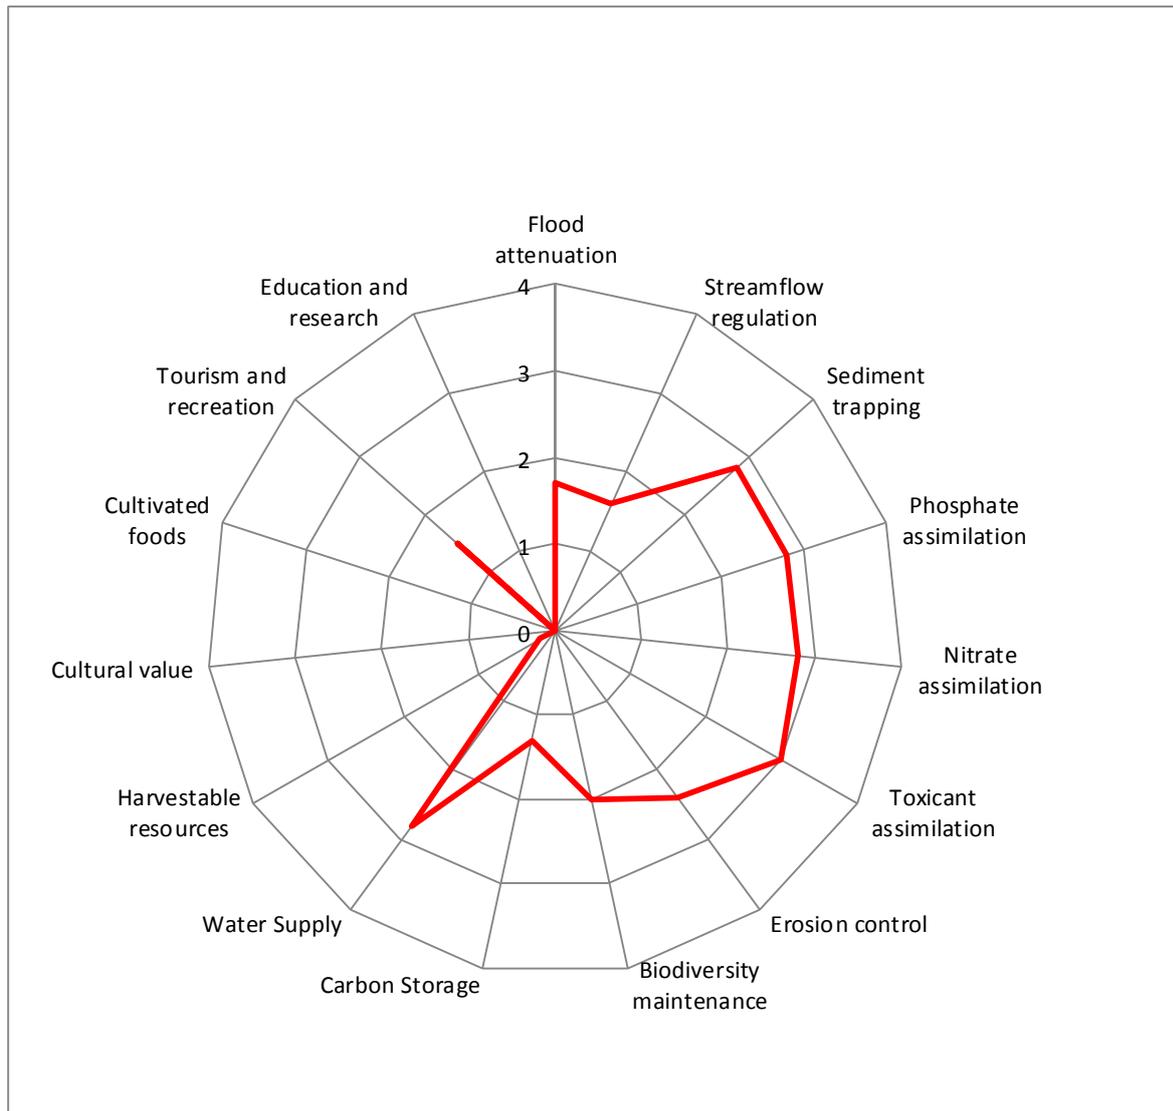
Figure 19: Radar plot of wetland services provided by the Skoenmakers River.

From the results of the assessment it is evident that wetland features associated with the Skoenmakers River can be considered of intermediate importance in terms of function and service provision. Wetland features are likely to play a moderate role in the attenuation of floodwater entering into the system. Flood water moving across the features is likely to be spread out and slowed down, however, the flood attenuating ability of the wetlands is decreased as a result of the small size of the features in relation to the overall size of the river and due to the already increased volumes of water which have been transferred into the system from the Little Fish River.

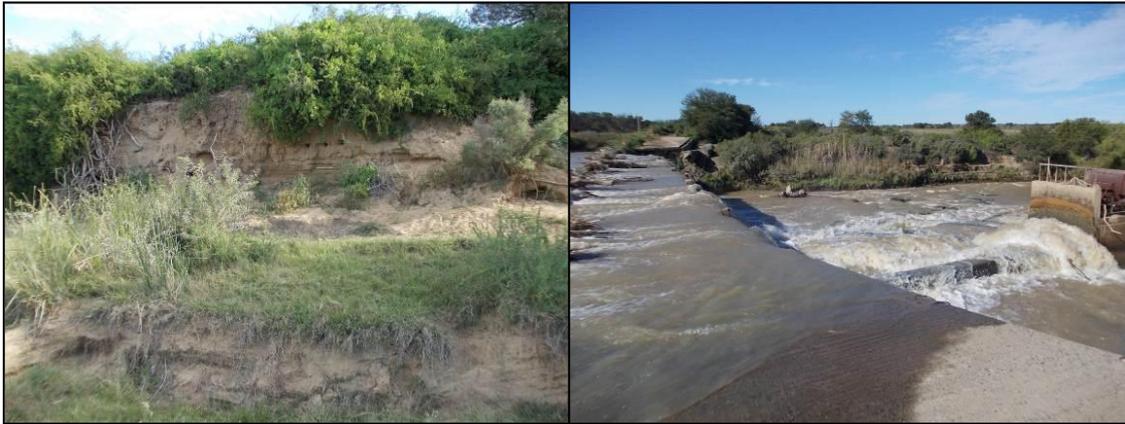
The main factor which may have impacted on water quality within wetland features is the modified flow conditions within the system. Increased flows have likely resulted in the alteration of the salt and nutrient contents in the system and the erosion created as a result of increased flows has likely resulted in an increase in the turbidity of the features. Furthermore, existing bridge structures have also resulted in an increase in water turbidity, and runoff from agricultural areas is likely to have altered the pH, salt content, nutrient content and turbidity of the system.

Figure 20: Erosion and incision of river banks (left) and bridge structure within the active channel of the river (right).

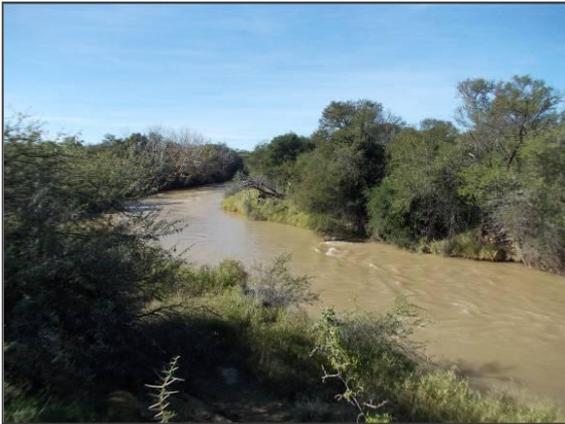
Figure 21: Dense woody vegetation associated with the Skoenmakers River riparian zone

- Riparian vegetation proved to be the most indicative of the boundary of the riparian zone with a distinctive change in vegetation abundance, as well as diversity noted in the lower and upper zones of the riparian habitat compared to the surrounding terrestrial zones. The woody vegetation component increased significantly within these areas when compared to surrounding terrestrial areas;
- Due to the Skoenmakers River flowing at the bottom of the topographical sequence as well as the incised nature of the river, terrain units were used in support of the vegetation or landscape characteristics;
- The presence of alluvial soils could be used to identify riparian zones;
- Surface water was mainly restricted to the active channel of the river. As a result, surface water and wet soils were of limited use as indicator during the riparian zone delineation.

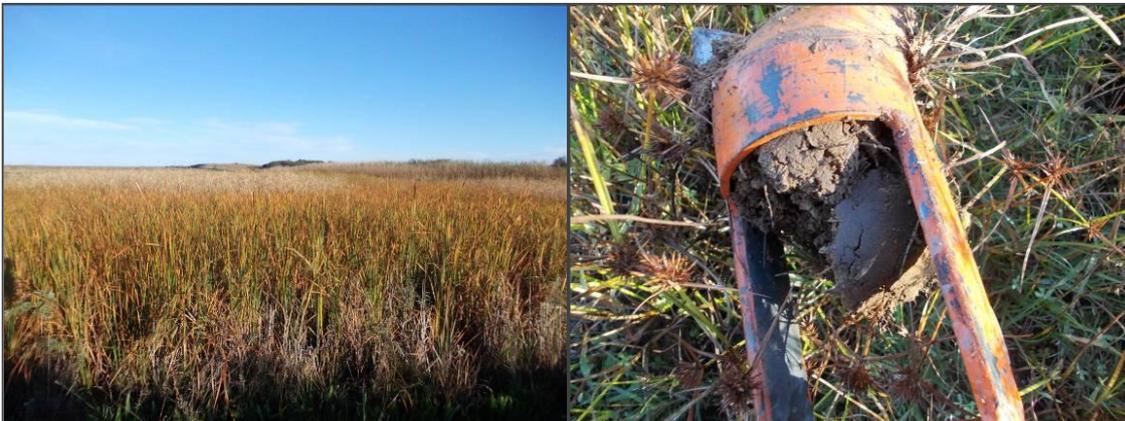
- Wetland vegetation and the presence of obligate and facultative wetland species was used as a primary indicator of the wetland temporary zones; and
- The presence of soils form indicators such as gleyed soils (most of the iron has been leached out of the soil leading to a low chroma greyish/greenish/bluish colour) were used as secondary indicators of the wetland boundary.

Figure 22: Obligate wetland species (left) and gleyed soils (right)

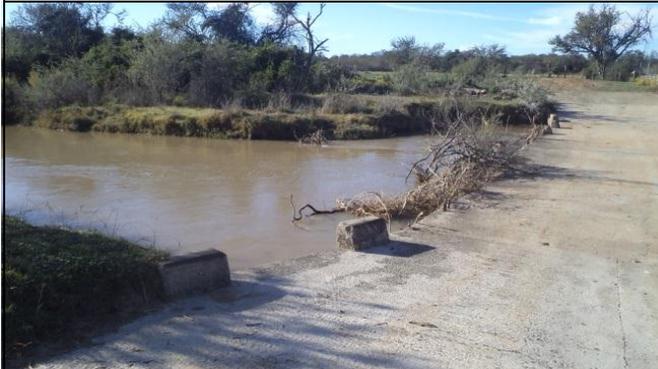
Figure 26: Upstream view of Site SM1 showing bridge infrastructure. The bridge is currently operational.

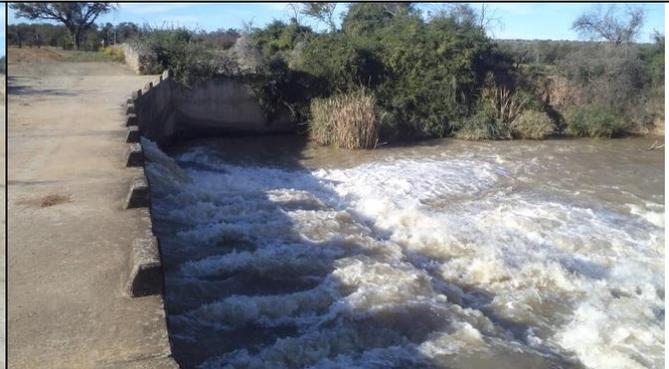
Figure 27: Downstream view of the Site SM1 also showing bridge infrastructure.

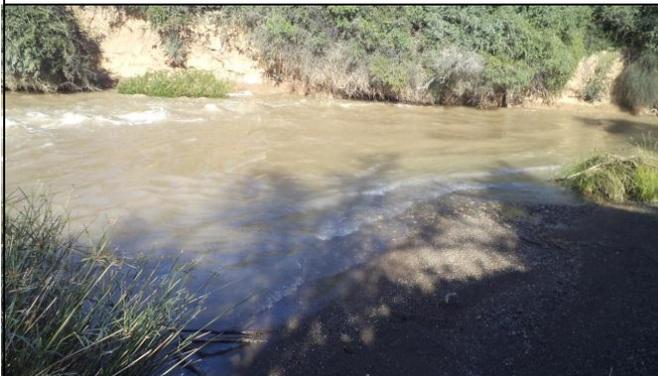
Figure 28: Habitat areas in the vicinity of site SM1 where SASS5 could be performed (SASS5 applied 50 to 200 m downstream of the bridge).

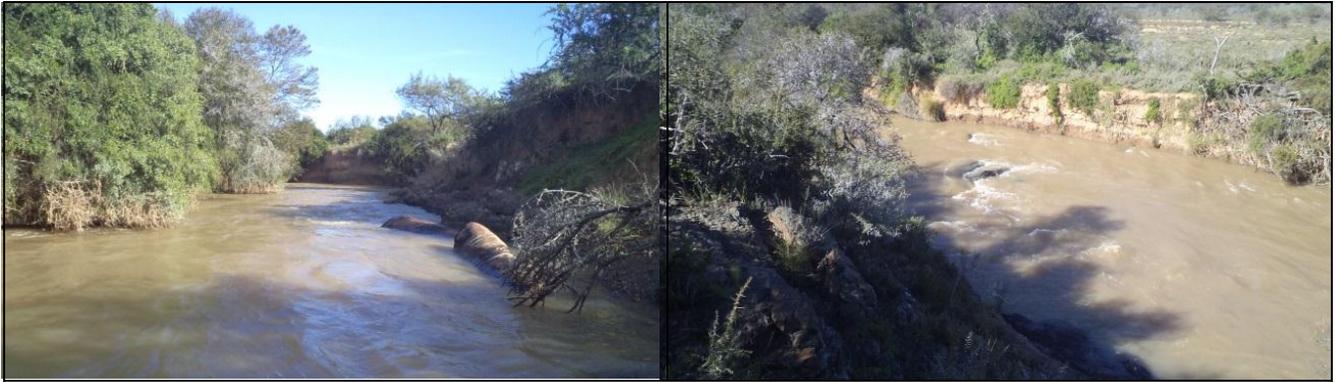
Figure 29: Habitat areas in the vicinity of site SM1 where fish sampling and SASS5 could be performed. Fish sampling was done both upstream and downstream of the bridge, whilst SASS5 was applied downstream of the bridge.

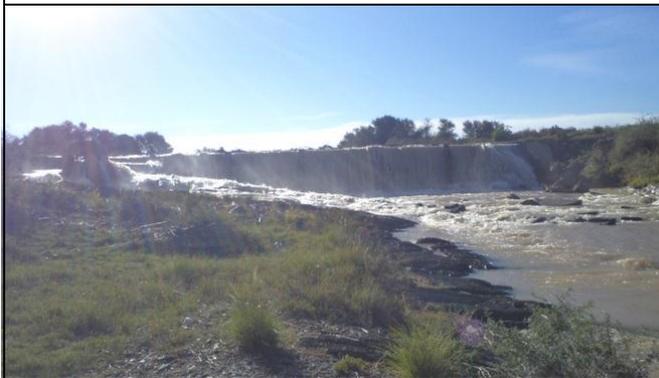
Figure 30: Upstream view of Site SM2.

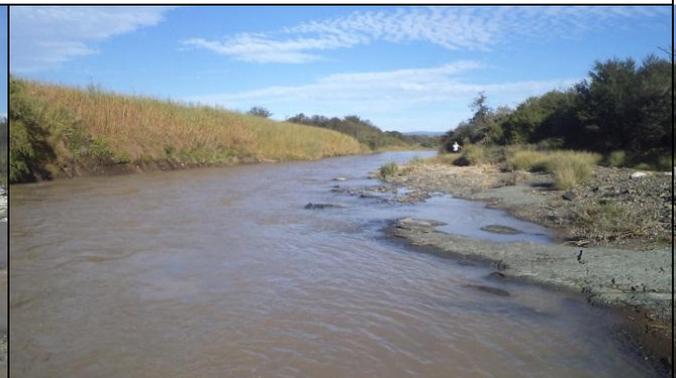
Figure 31: Downstream view of the Site SM2.

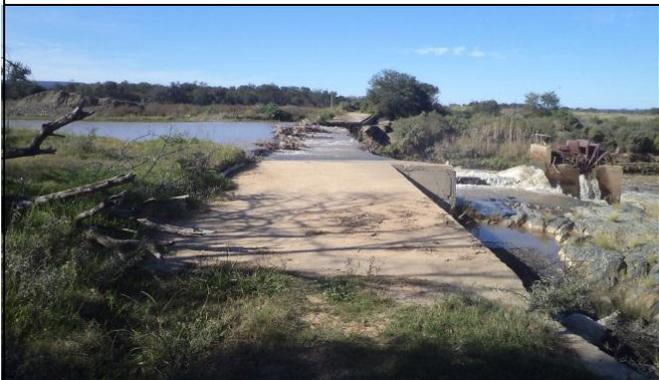
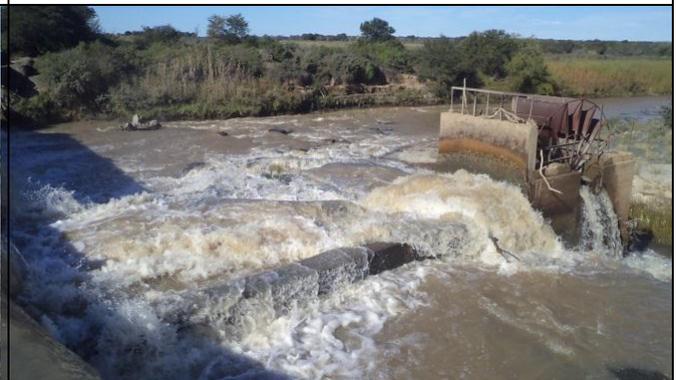
Figure 32: Bridge infrastructure at SiteSM2. The bridge is currently not operational.

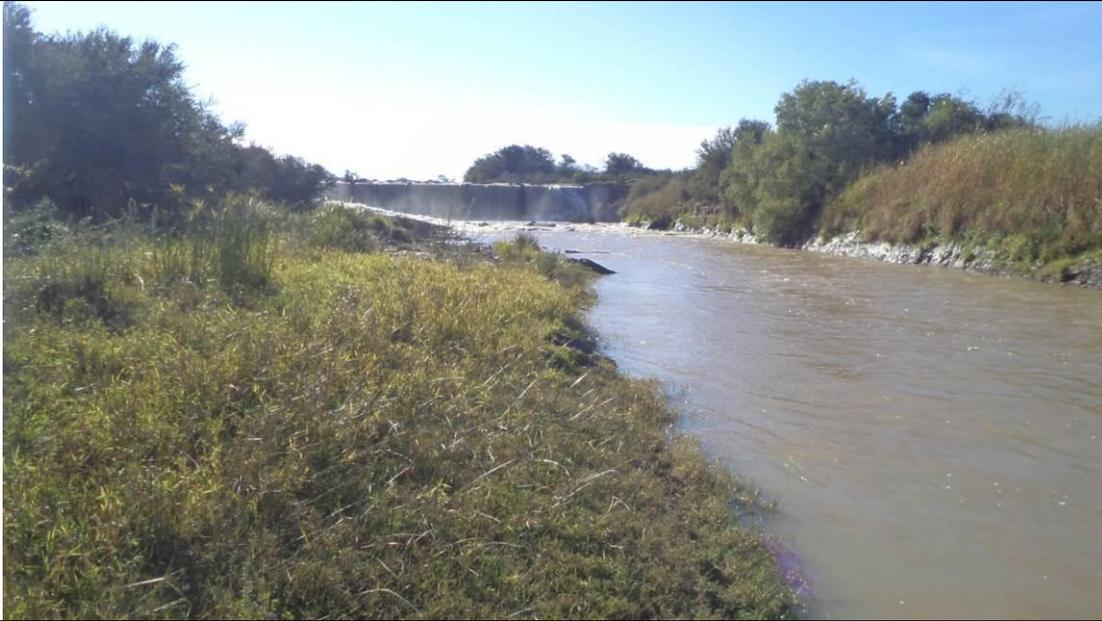
Figure 33: Habitat area in the vicinity of site SM2 where SASS5 could be performed (SASS5 applied 200 to 400 m downstream of the bridge). Fish sampling was done both upstream and downstream of the bridge, whilst SASS5 was applied downstream of the bridge.

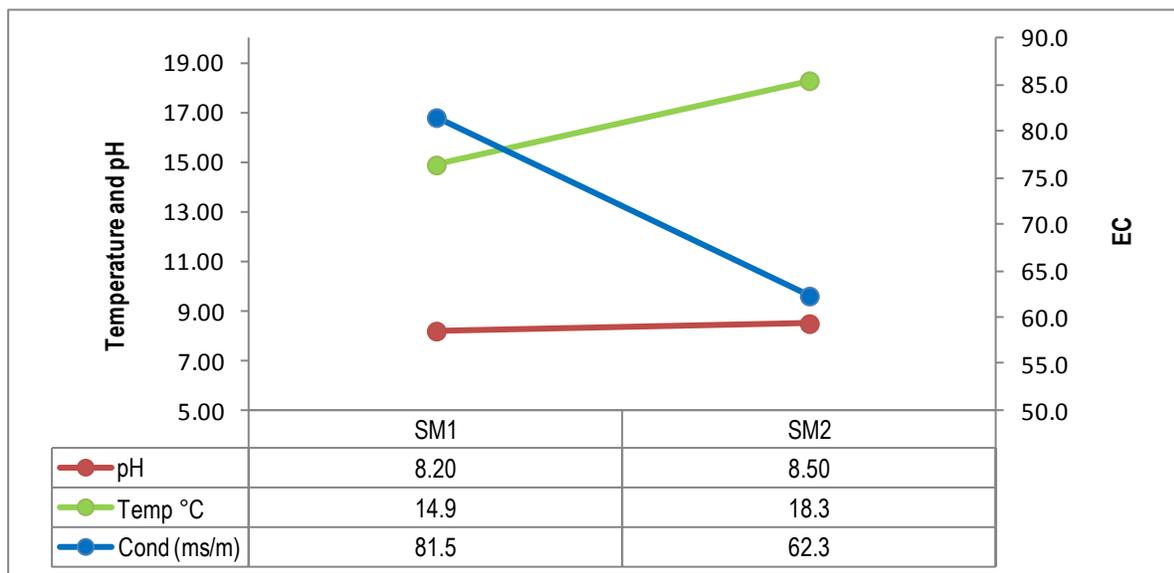
Figure 34: Graphic representation of the biota specific water quality data along the Skoenmakers River.

- Spatially, the EC level decreases by 23.6% between Sites SM1 and SM2 in a downstream direction. This degree of change exceeds the DWAF TWQR for aquatic ecosystems (DWAF, 1996) that stipulates that the EC level along a watercourse should not change by more than 15%, however, the reduction in EC can be

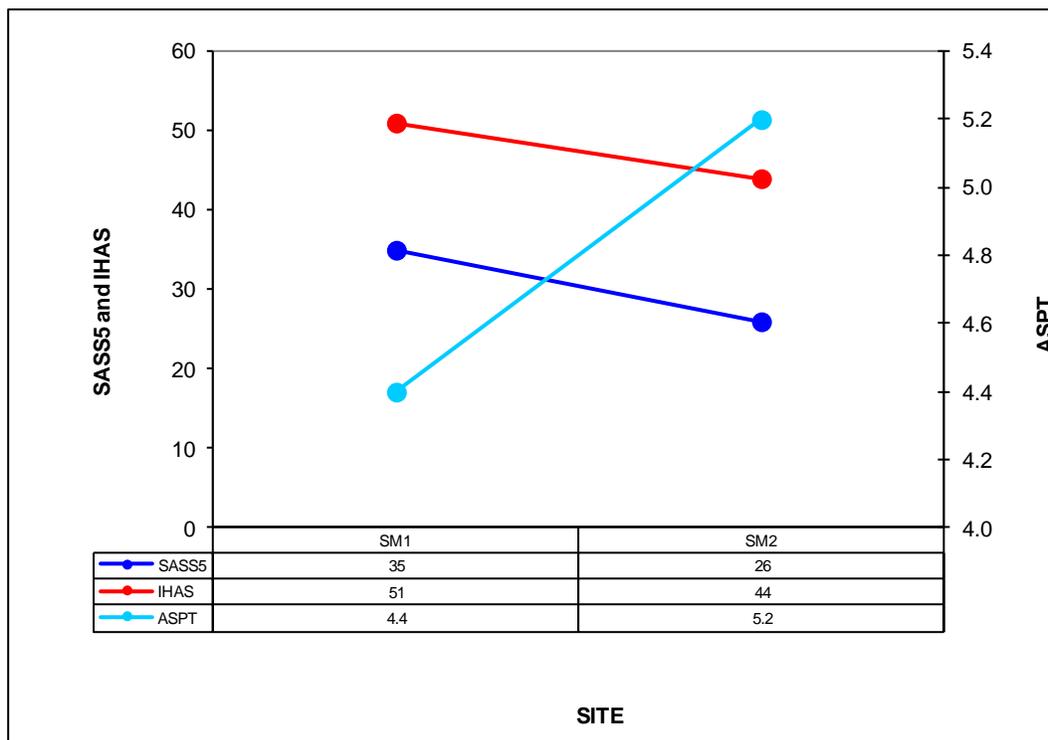
- Any reductions in SASS5 and ASPT scores in future monitoring should be noted and the causal factors identified.
- As more data on the system is collected, better inferences on the ecological condition of the community will be possible.

Figure 35: Graphic representation of the SASS5, ASPT and IHAS scores along the Skoenmakers River.

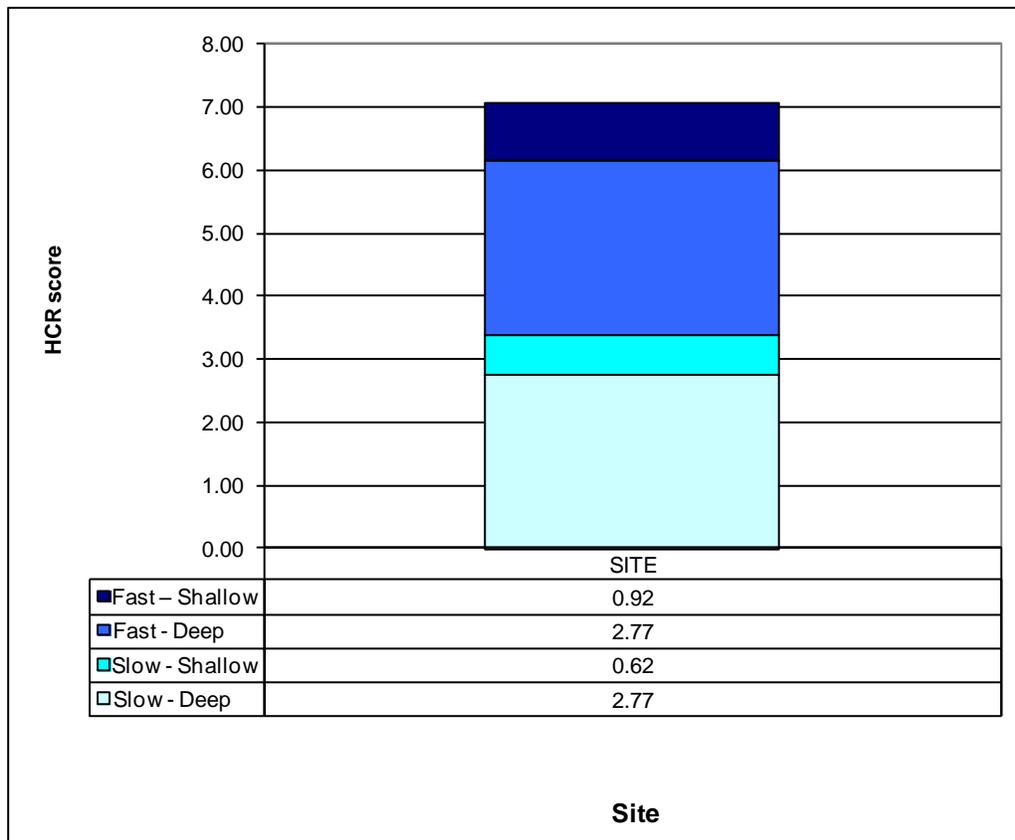
Figure 36: HCR score for the Skoenmaker River as represented by conditions at both Sites SM1 and SM2.

Results indicate that both slow-shallow and fast-deep conditions dominate the system. As variation in both depth (shallow and deep conditions) and flow speed (slow and fast conditions) is evident, a diverse fish community may be expected at Sites SM1 and SM2. However, fish that require fast-flowing rapid or riffle habitat (fast-shallow conditions) and hence demonstrate a high intolerance for deep or slow conditions, are expected to be less abundant.
