SKOENMAKERS RIVER REHABILITATION ASSESSMENT  
ZONE 9

Date:	08/02/2016	Compiled by:	PAUJ
Project No:	472748	Scale:	1:8,000

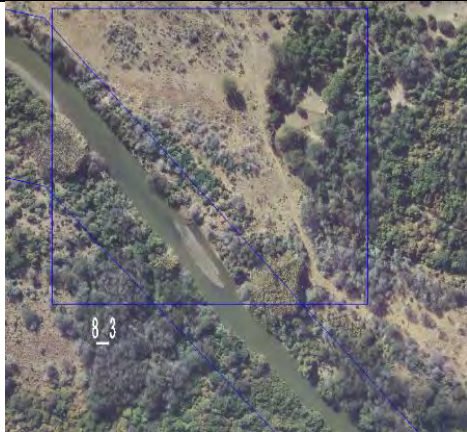
**Zone 8\_3** Flow in this region is on a wide floodplain and protection will constrict the flow further, thus not necessary.

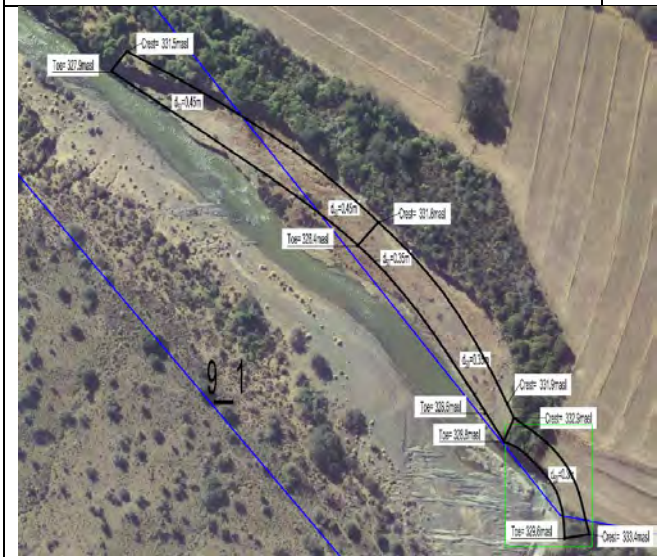
**Zone 9\_1** The zone has unstable banks crossing the servitude and encroaching onto farm land.

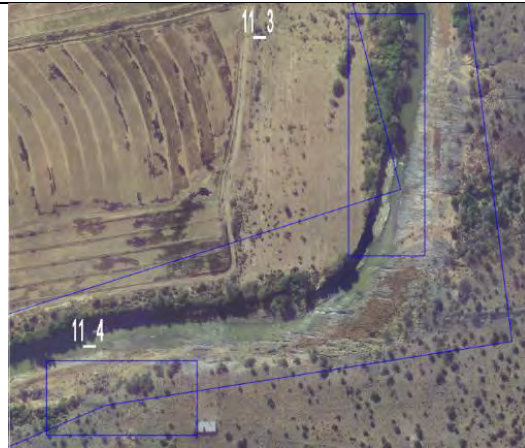
**Zone 11\_4** The zone has unstable banks within the servitude. Protection in this area is not necessary.
